Contract #: 04-0120F4Cty: SF/ALA Rte: 80 PM: 13.2/13.9File #: 13.28**WELDING INSPECTION REPORT****Resident Engineer:** Pursell, Gary**Address:** 333 Burma Road**City:** Oakland, CA 94607**Report No:** WIR-010725**Date Inspected:** 09-Dec-2009**Project Name:** SAS Superstructure**OSM Arrival Time:** 1000**Prime Contractor:** American Bridge/Fluor Enterprises, a JV**OSM Departure Time:** 1830**Contractor:** Oregon Iron Works Clackamas, Or.**Location:** Clackamas, OR**CWI Name:** M. Gregson, J. Salazar**CWI Present:** Yes No**Inspected CWI report:** Yes No N/A**Rod Oven in Use:** Yes No N/A**Electrode to specification:** Yes No N/A**Weld Procedures Followed:** Yes No N/A**Qualified Welders:** Yes No N/A**Verified Joint Fit-up:** Yes No N/A**Approved Drawings:** Yes No N/A**Approved WPS:** Yes No N/A**Delayed / Cancelled:** Yes No N/A**Bridge No:** 34-0006**Component:** Hinge K Pipe Beams**Summary of Items Observed:**

Hinge-K Pipe Beam Fuse Assembly 120A-1: 12/9/09

a124-6 Half Fuse to a124-7 Half Fuse

WELDING INSPECTION REPORT

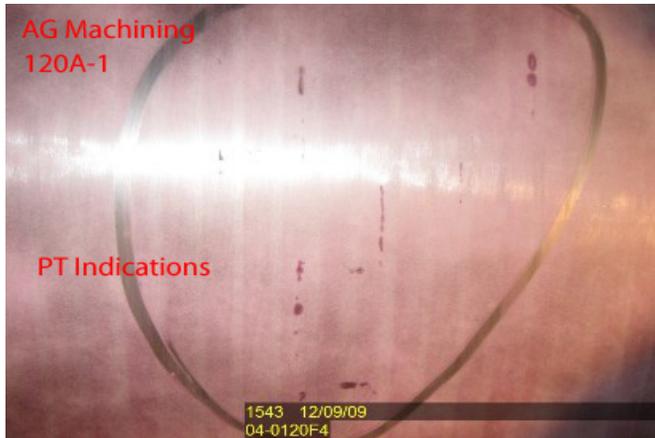
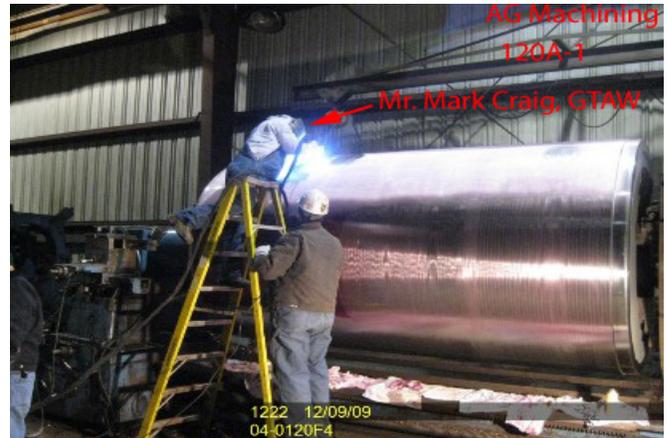
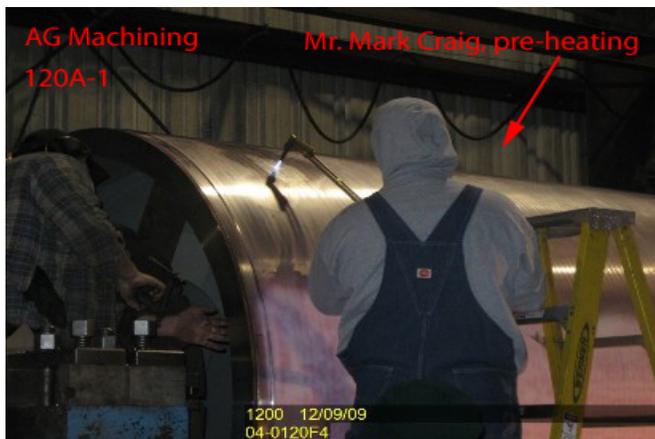
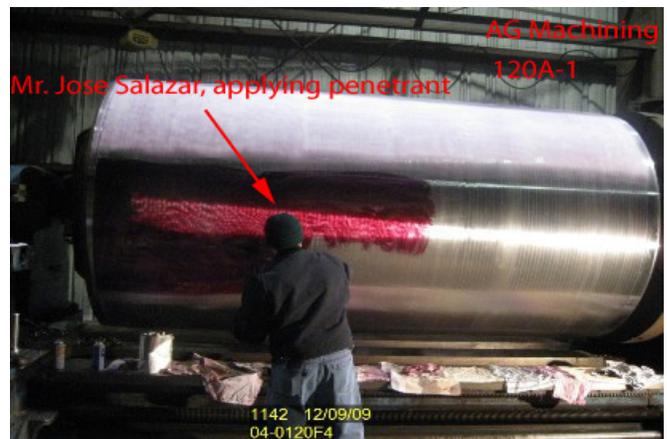
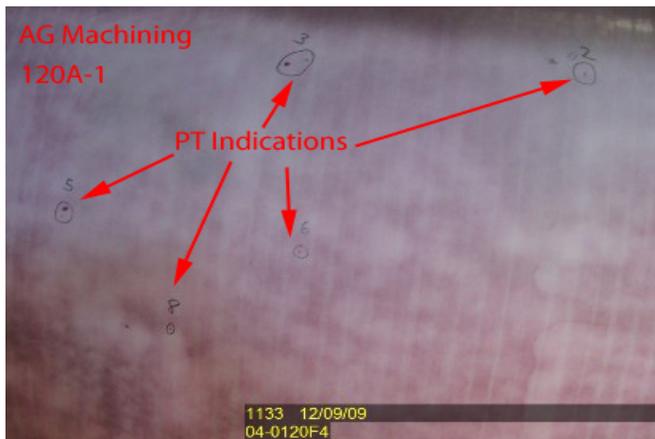
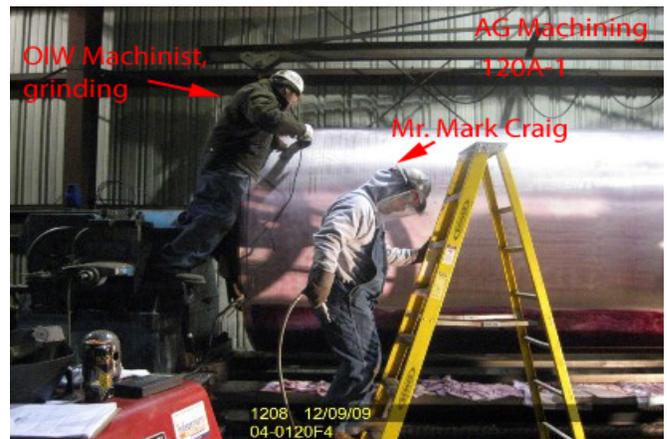
(See attached pictures below)

multiple indications were present which appeared to be small clusters of slag inclusions. The QA Inspector also witnessed Mr. Craig grinding out these indications, to a depth of .5-2 mm and then later setting up to perform the GTAW.

The QA Inspector noted that Mr. Craig was currently qualified to perform these repairs and would be utilizing welding procedure specification (WPS 8022). The QA Inspector witnessed Mr. Craig performing the pre-heat required, utilizing a torch and then observed a temperature of approximately 150 degrees Fahrenheit, after the pre-heat was complete. The QA Inspector noted that 125 degrees Fahrenheit minimum was required, per WPS 8022. The QA Inspector witnessed AG Machinist rotating the fuse assembly to access the weld repair areas in the flat position. The QA Inspector then observed Mr. Mark Craig performing the GTAW on the previously excavated repair areas. The QA Inspector also observed QC Inspector Jose Salazar recording the in-process welding parameters of 121 amps and 15.5 volts. The QA Inspector also verified these welding parameters. The QA Inspector noted that after completion of these weld repair areas, the OIW Machinist performed the grinding with a buffer wheel on the completed weld repair to "flush" with the finished overlay surface. The QA Inspector observed that the Fuse was then rotated and the QC Inspector performed 100% informational PT Inspection on another section of the finished overlay. The QA Inspector also observed several more indications that would need to go through the above mentioned repair procedure.

The QA Inspector later spoke with QC Inspector Salazar and Mr. Salazar explained that the informational PT testing is complete and there were approximately 19 weld repair "areas", with some cluster of small indications per "area". The QA Inspector observed that Mr. Salazar was present the entire time in which the GTAW welding was being performed.
