**DEPARTMENT OF TRANSPORTATION**

Contract #: 04-0120F4Cty: SF/ALA Rte: 80 PM: 13.2/13.9File #: 13.28**WELDING INSPECTION REPORT****Resident Engineer:** Pursell, Gary**Address:** 333 Burma Road**City:** Oakland, CA 94607**Report No:** WIR-010740**Date Inspected:** 10-Dec-2009**Project Name:** SAS Superstructure**OSM Arrival Time:** 1000**Prime Contractor:** American Bridge/Fluor Enterprises, a JV**OSM Departure Time:** 1830**Contractor:** Oregon Iron Works Clackamas, Or.**Location:** Clackamas, OR**CWI Name:** M. Gregson, J. Salazar**CWI Present:** Yes No**Inspected CWI report:** Yes No N/A**Rod Oven in Use:** Yes No N/A**Electrode to specification:** Yes No N/A**Weld Procedures Followed:** Yes No N/A**Qualified Welders:** Yes No N/A**Verified Joint Fit-up:** Yes No N/A**Approved Drawings:** Yes No N/A**Approved WPS:** Yes No N/A**Delayed / Cancelled:** Yes No N/A**Bridge No:** 34-0006**Component:** Hinge K Pipe Beams**Summary of Items Observed:**

Hinge-K Pipe Beam Assembly 102A-3: 12/10/09

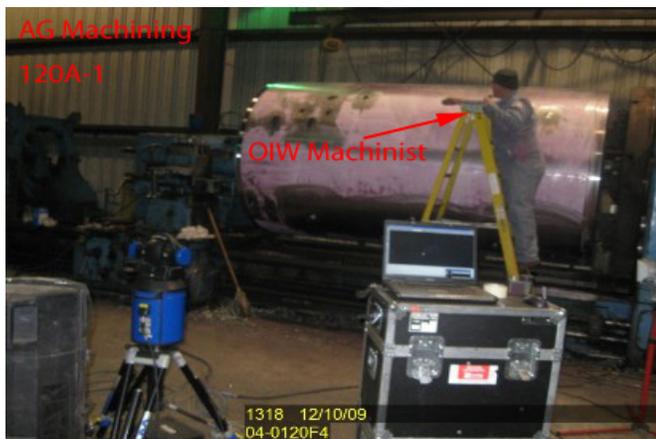
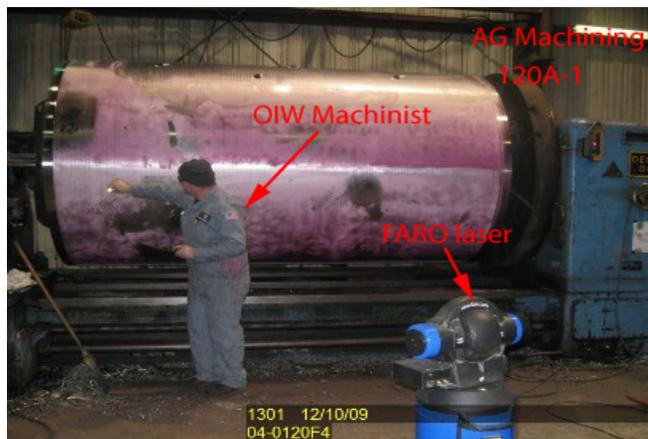
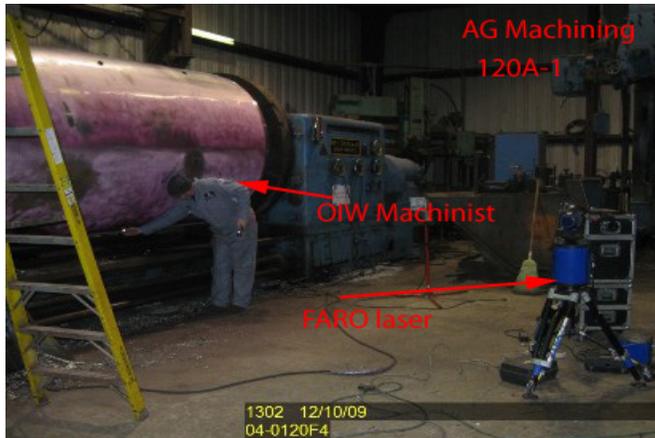
Hinge-K Pipe Beam Fuse Assembly 120A-1: 12/10/09

On this date, the QA Inspector arrived at AG Machine shop to observe OIW perform the FARO laser measurements, on the Fuse 120A-1. The QA Inspector arrived at approximately 1230 and met with OIW Machinist Matt Ackerson. Mr. Ackerson explained to the QA Inspector that he had previously arrived at AG and had completed the set up, on the FARO laser equipment. Mr. Ackerson explained to QA Inspector that the finished outside diameter and cylindricity (concentricity) of this fuse assembly 120A-1, will be measured. The QA Inspector witnessed Mr. Ackerson performing these measurements and QA Inspector noted that at approximately 1330, Mr. Ackerson was complete. Mr. Ackerson explained to the QA Inspector that the finished outside diameter was measured at 1920.6915mm and the cylindrical deviation was measured at .2497mm. Mr. Ackerson explained to the QA Inspector that these measurements were calculated, based upon a theoretical surface temperature of 68 degrees Fahrenheit (20 C) and that the actual temperature of the fuse assembly was measured at 40 degrees Fahrenheit (4 C). QA Inspector noted that the contract requires a finished outside diameter of 1920mm (+/- 1mm) and cylindricity (+/1 mm). QA Inspector noted that the above mentioned FARO measurements, on this Fuse 120A-1, appeared to be in compliance with the specified tolerances, per the contract requirements. Mr. Ackerson explained to the QA Inspector that a final FARO test report will be completed and a copy will be provided to QA Inspector. See attached pictures below.
