**DEPARTMENT OF TRANSPORTATION**

Contract #: 04-0120F4Cty: SF/ALA Rte: 80 PM: 13.2/13.9File #: 13.28**WELDING INSPECTION REPORT****Resident Engineer:** Pursell, Gary**Address:** 333 Burma Road**City:** Oakland, CA 94607**Report No:** WIR-010788**Date Inspected:** 17-Dec-2009**Project Name:** SAS Superstructure**OSM Arrival Time:** 1000**Prime Contractor:** American Bridge/Fluor Enterprises, a JV**OSM Departure Time:** 1830**Contractor:** Oregon Iron Works Clackamas, Or.**Location:** Clackamas, OR**CWI Name:** M. Gregson, J. Salazar**CWI Present:** Yes No**Inspected CWI report:** Yes No N/A**Rod Oven in Use:** Yes No N/A**Electrode to specification:** Yes No N/A**Weld Procedures Followed:** Yes No N/A**Qualified Welders:** Yes No N/A**Verified Joint Fit-up:** Yes No N/A**Approved Drawings:** Yes No N/A**Approved WPS:** Yes No N/A**Delayed / Cancelled:** Yes No N/A**Bridge No:** 34-0006**Component:** Hinge K Pipe Beams**Summary of Items Observed:**

# WELDING INSPECTION REPORT

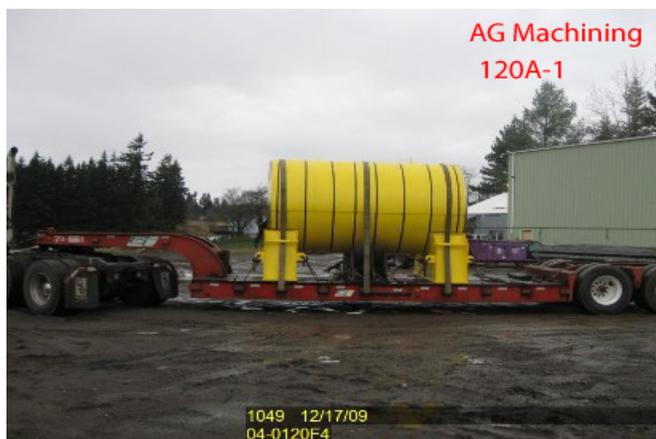
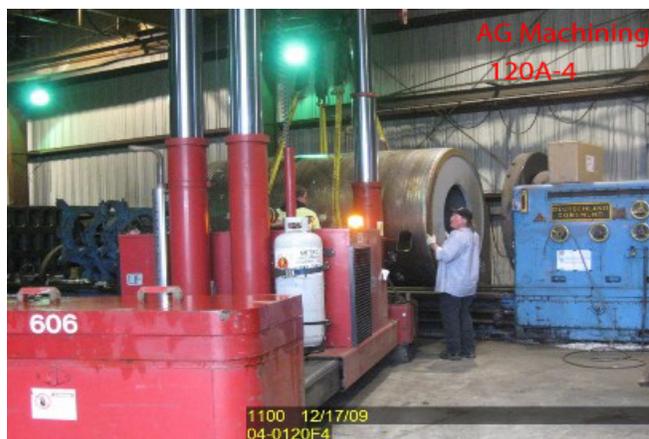
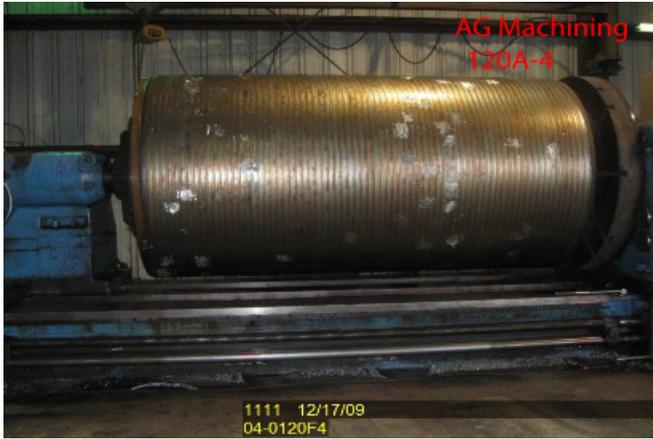
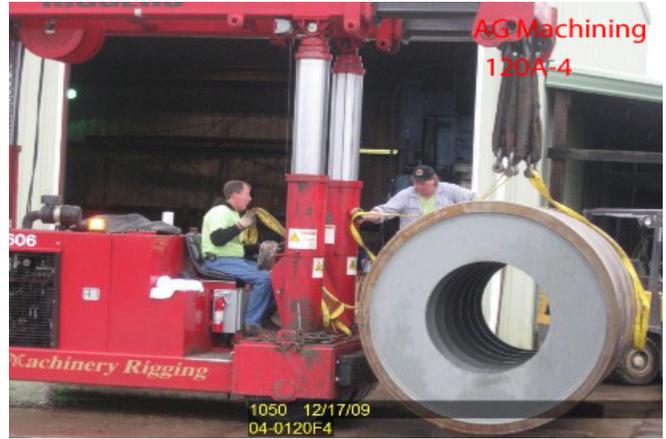
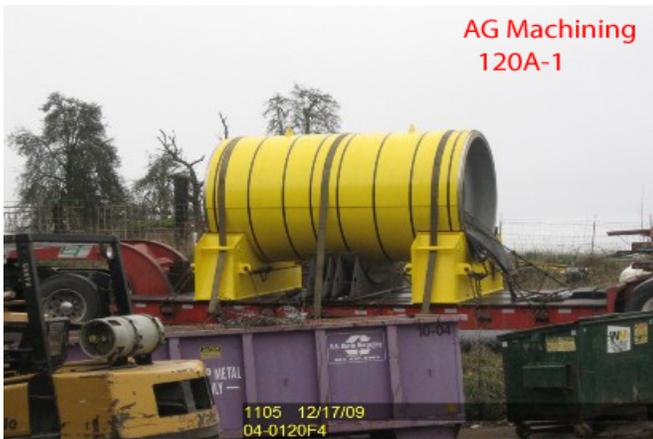
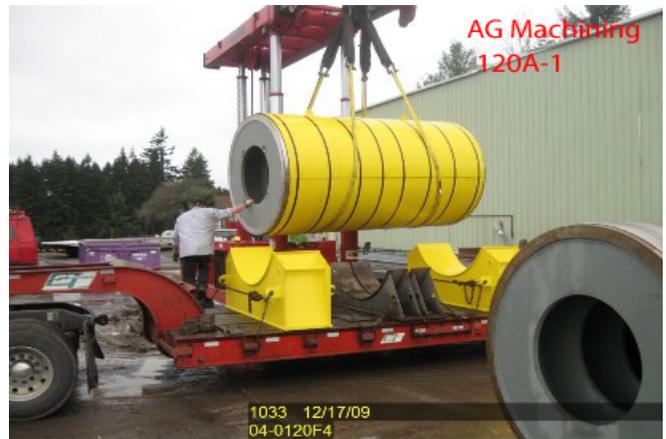
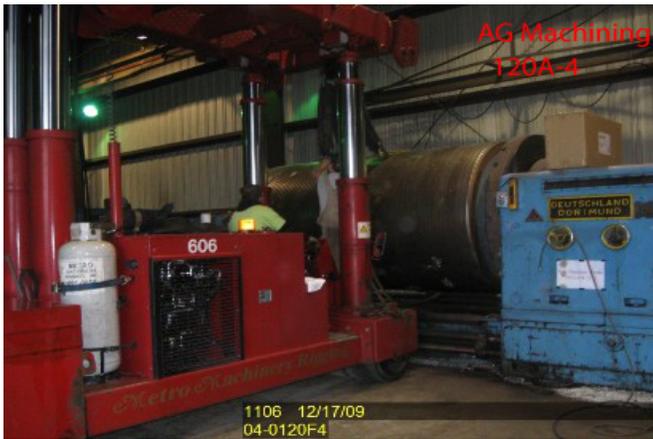
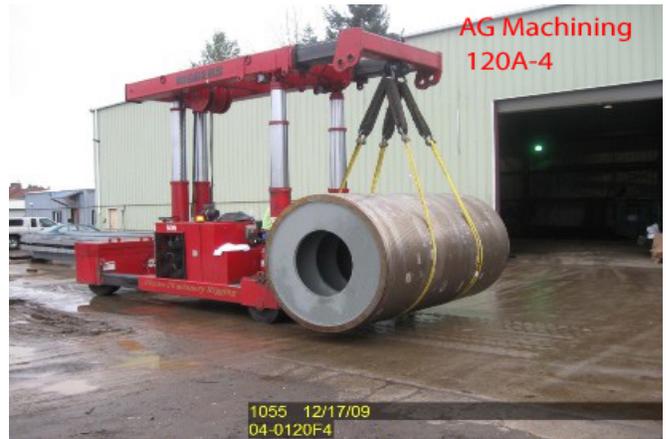
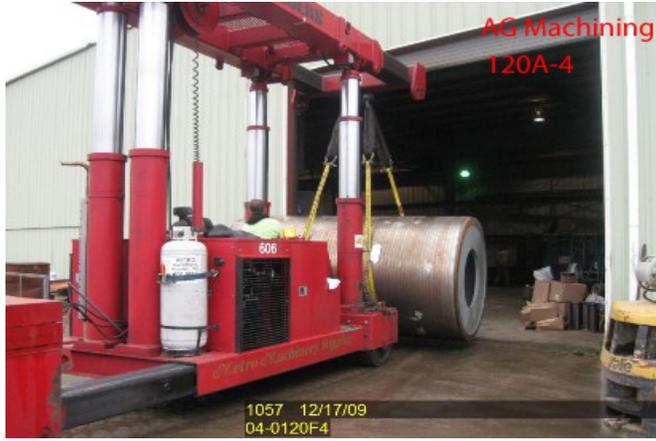
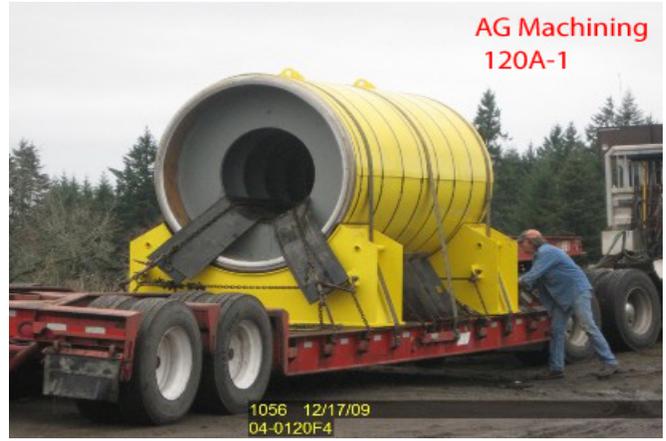
On this date, the QA Inspector arrived at AG Machine shop, to witness OIW switch out Fuse 120A-1 and Fuse 120A-4, for final machining. The QA Inspector arrived at approximately 1000 and witnessed Metro Machinery Rigging picking up the Fuse 120A-1, from the horizontal lathe. The QA Inspector witnessed Metro place two slings around the Fuse 120A-1 and attach to a forklift, with a hydraulic lifting boom. The QA Inspector witnessed Metro Machinery then placing this Fuse 120A-1, on a flatbed trailer. The QA Inspector noted that two saddles with rubber cushions had been previously placed on the flatbed trailer. The QA Inspector then witnessed Metro personell using two come-a-longs to anchor the Fuse to trailer. The QA Inspector witnessed Metro Personell placing rubber cushions on the interior of Fuse 120A-1 and securing with more come-a-longs. The QA Inspector noted that the Fuse 120A-1 was being transferred back to OIW, after final machining and 100% penetrant testing was complete and OIW accepted. The QA Inspector then witnessed Metro picking up the Fuse 120A-4 from a separate trailer, utilizing two chokers. The QA Inspector then witnessed Metro placing the Fuse 120A-4, into the horizontal lathe. The QA Inspector noted that the AG Machinist tightened the lathe chucks, to secure the Fuse 120A-4 in place. The QA Inspector spoke with the AG Machinist and AG explained that the 1st cut pass, for final machining, on this Fuse 120A-4, should start on 12/18/09 or 12/21/09. See attached sequence of pictures below.
