**DEPARTMENT OF TRANSPORTATION**

Contract #: 04-0120F4Cty: SF/ALA Rte: 80 PM: 13.2/13.9File #: 13.28**WELDING INSPECTION REPORT****Resident Engineer:** Pursell, Gary**Address:** 333 Burma Road**City:** Oakland, CA 94607**Report No:** WIR-010790**Date Inspected:** 21-Dec-2009**Project Name:** SAS Superstructure**OSM Arrival Time:** 1000**Prime Contractor:** American Bridge/Fluor Enterprises, a JV**OSM Departure Time:** 1830**Contractor:** Oregon Iron Works Clackamas, Or.**Location:** Clackamas, OR**CWI Name:** M. Gregson, J. Salazar**CWI Present:** Yes No**Inspected CWI report:** Yes No N/A**Rod Oven in Use:** Yes No N/A**Electrode to specification:** Yes No N/A**Weld Procedures Followed:** Yes No N/A**Qualified Welders:** Yes No N/A**Verified Joint Fit-up:** Yes No N/A**Approved Drawings:** Yes No N/A**Approved WPS:** Yes No N/A**Delayed / Cancelled:** Yes No N/A**Bridge No:** 34-0006**Component:** Hinge K Pipe Beams**Summary of Items Observed:**

Hinge-K Pipe Beam Assembly 102A-3: 12/21/09

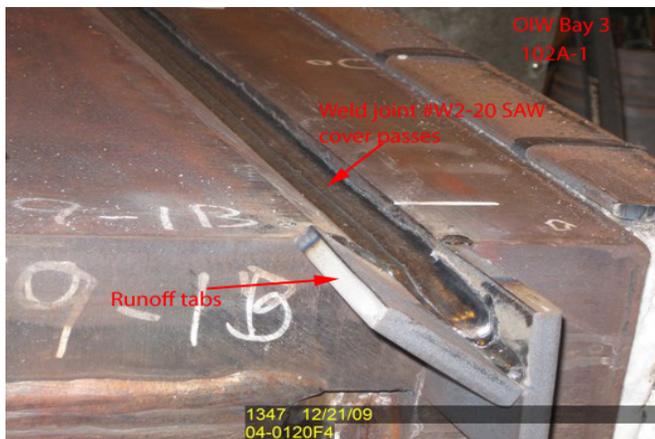
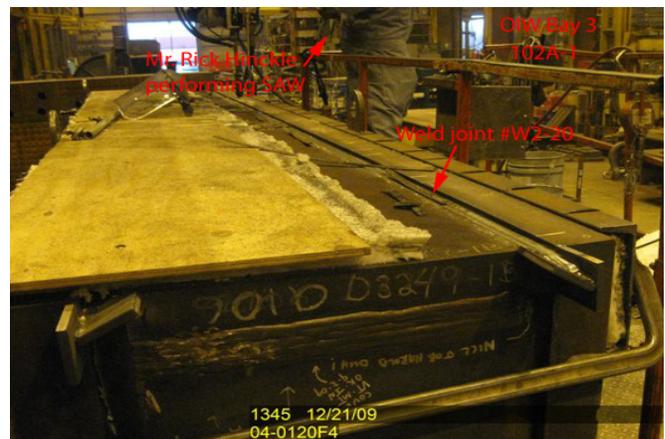
The QA Inspector randomly noticed that the 12 each. 1 3/4", threaded rods had been inserted back into the a109 Post Tension Cap Plate. The QA Inspector spoke with QC Inspector Jose Salazar and Mr. Salazar explained that welder #J6, Mr. Craig Jacobson, had inserted the rods earlier in the a.m. Mr. Salazar explained that the 12 rods were then tightened, utilizing an air impact wrench. The QA Inspector randomly took measurements on the completed HPS 485W stiffeners to a109 Post Tension Cap Plate. The QA Inspector noted that gaps were still present, with maximum gaps of 2mm, utilizing a taper gauge, closest to the a111-3 forging. The QA Inspector noted that OIW had previous gaps, up to 4mm, between the above mentioned stiffeners and Cap Plate, with the rods removed. The QA Inspector was informed by Mr. Salazar that OIW intends to torque the rods further, utilizing a torque wrench, to possibly eliminate the gaps. The QA Inspector noted that the contract requires a mill to bear surface on the HPS 485W stiffeners to a109 Cap Plate. See attached picture below.
