Contract #: 04-0120F4Cty: SF/ALA Rte: 80 PM: 13.2/13.9File #: 13.28**WELDING INSPECTION REPORT****Resident Engineer:** Pursell, Gary**Address:** 333 Burma Road**City:** Oakland, CA 94607**Report No:** WIR-010829**Date Inspected:** 23-Dec-2009**Project Name:** SAS Superstructure**OSM Arrival Time:** 1000**Prime Contractor:** American Bridge/Fluor Enterprises, a JV**OSM Departure Time:** 1830**Contractor:** Oregon Iron Works Clackamas, Or.**Location:** Clackamas, OR**CWI Name:** M. Gregson, J. Salazar**CWI Present:** Yes No**Inspected CWI report:** Yes No N/A**Rod Oven in Use:** Yes No N/A**Electrode to specification:** Yes No N/A**Weld Procedures Followed:** Yes No N/A**Qualified Welders:** Yes No N/A**Verified Joint Fit-up:** Yes No N/A**Approved Drawings:** Yes No N/A**Approved WPS:** Yes No N/A**Delayed / Cancelled:** Yes No N/A**Bridge No:** 34-0006**Component:** Hinge K Pipe Beams**Summary of Items Observed:**

Hinge-K Pipe Beam Assembly 102A-3: 12/23/09

WELDING INSPECTION REPORT

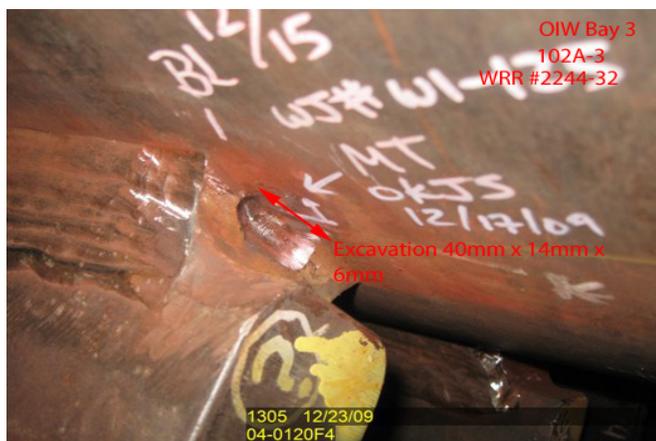
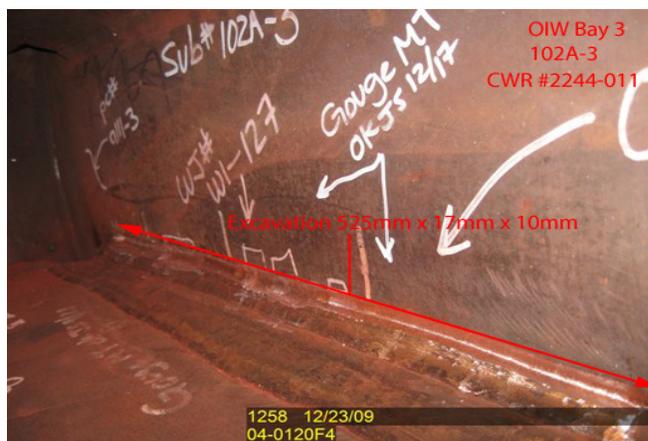
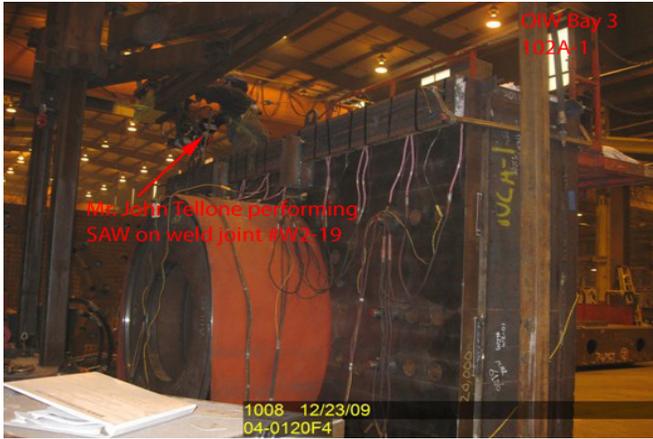
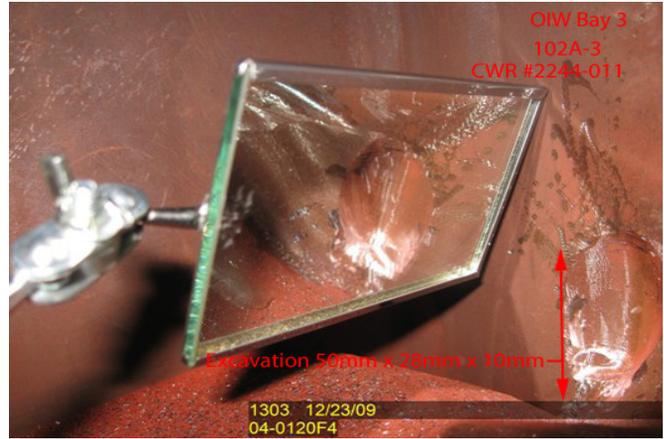
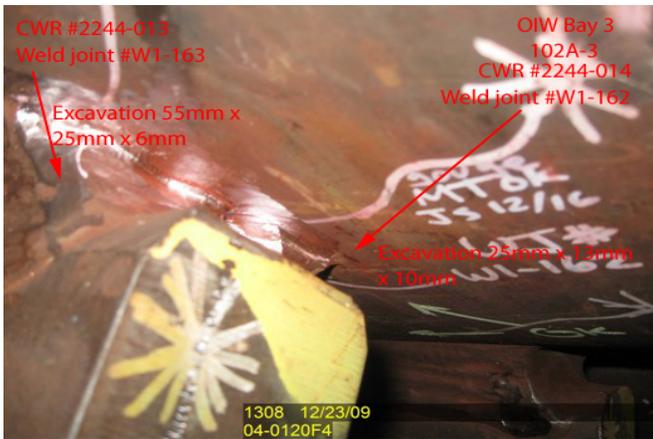
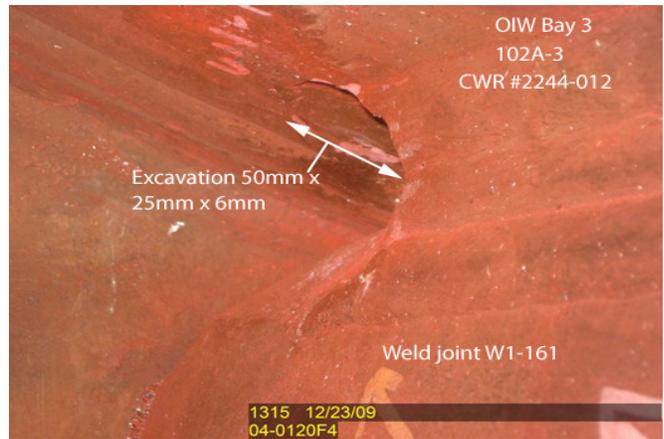
The QA Inspector was previously notified by QC Inspector Jose Salazar that this assembly 102A-3, will remain idle, pending the submittal and approval of the critical weld repairs (CWR's) #2244-009 thru 014. The QA Inspector noted that the excavations were previously completed on the CWR's and 100% visual/magnetic particle testing had been previously performed, by OIW QC Inspector Jose Salazar. The QA Inspector noted that the excavation was complete on the non-critical weld repair (WRR #3244-32) and 100% visual/magnetic particle testing had been previously performed, by OIW QC Inspector Jose Salazar. The QA Inspector noted that no rejectable indications were found by Mr. Salazar, on the above mentioned excavations and that OIW will start the flux core arc welding (FCAW) on the repairs, after submittal and approval of the CWR's. The QA Inspector noted that QC Inspector Jose Salazar had previously measured the excavations and recorded the measurements as follows: CWR #2244-01, approximately 525mm L x 17mm W x 10mm D (excavation #1) and 50mm L x 28mm W x 10mm D (excavation #2). CWR #2244-012, approximately 50mm L x 25mm W x 6mm D. CWR #2244-013, approximately 55mm L x 25mm W x 6mm D. CWR #2244-014, approximately 25mm L x 13mm W x 10mm D. The QA Inspector noted that QC Inspector Jose Salazar had previously measured the excavation, designated as WRR #2244-32, to be approximately 40mm L x 14mm W x 6mm D. The QA Inspector verified the above

measurements and performed 100% visual/magnetic particle testing on the excavations, designated as weld joints # W1-127 (CWR # 2244-011), #W1-161 (CWR #2244-012) # W1-163 (CWR # 2244-013), # W1-162 (CWR # 2244-014) and #W1-125 (WRR#2244-32). The QA Inspector found no rejectable indications and completed the applicable magnetic testing report (TL 6028), on this date. See attached pictures below.
