Contract #: 04-0120F4Cty: SF/ALA Rte: 80 PM: 13.2/13.9File #: 13.28**WELDING INSPECTION REPORT****Resident Engineer:** Pursell, Gary**Address:** 333 Burma Road**City:** Oakland, CA 94607**Report No:** WIR-010939**Date Inspected:** 29-Dec-2009**Project Name:** SAS Superstructure**OSM Arrival Time:** 1000**Prime Contractor:** American Bridge/Fluor Enterprises, a JV**OSM Departure Time:** 1830**Contractor:** Oregon Iron Works Clackamas, Or.**Location:** Clackamas, OR**CWI Name:** M. Gregson, J. Salazar**CWI Present:** Yes No**Inspected CWI report:** Yes No N/A**Rod Oven in Use:** Yes No N/A**Electrode to specification:** Yes No N/A**Weld Procedures Followed:** Yes No N/A**Qualified Welders:** Yes No N/A**Verified Joint Fit-up:** Yes No N/A**Approved Drawings:** Yes No N/A**Approved WPS:** Yes No N/A**Delayed / Cancelled:** Yes No N/A**Bridge No:** 34-0006**Component:** Hinge K Pipe Beams**Summary of Items Observed:**

WELDING INSPECTION REPORT

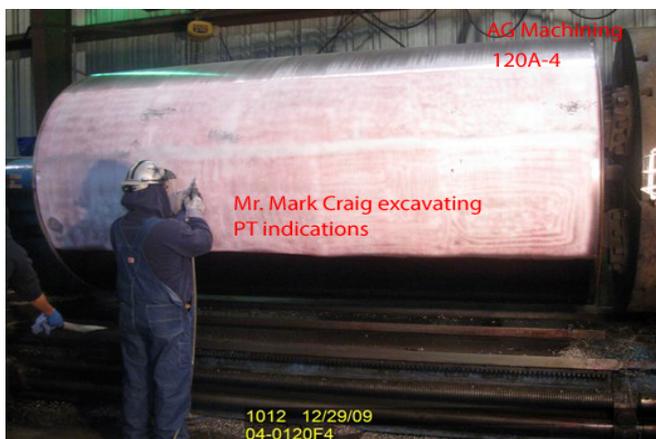
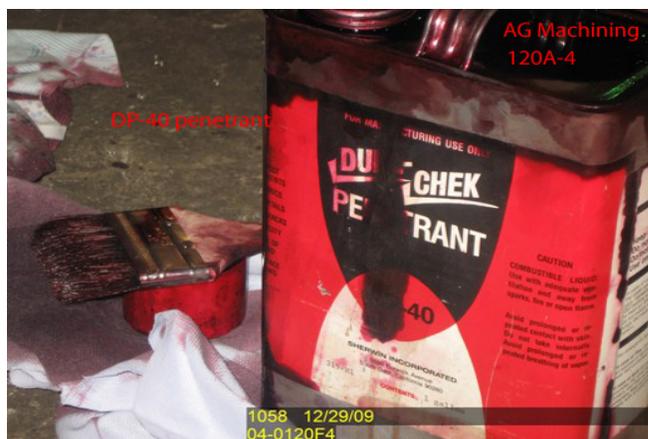
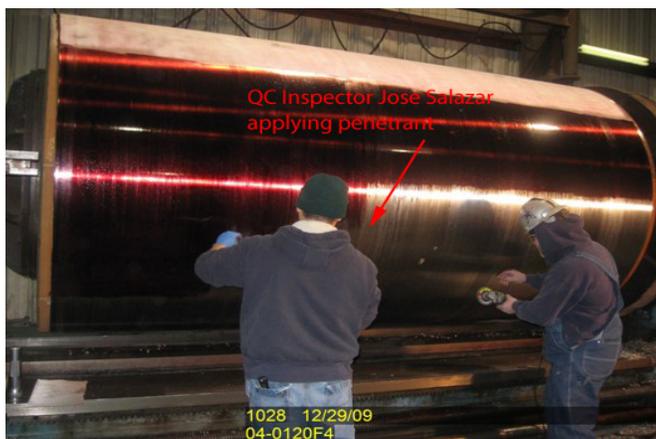
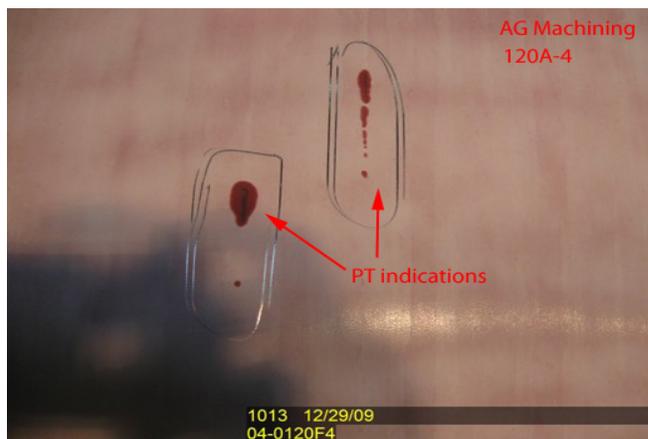
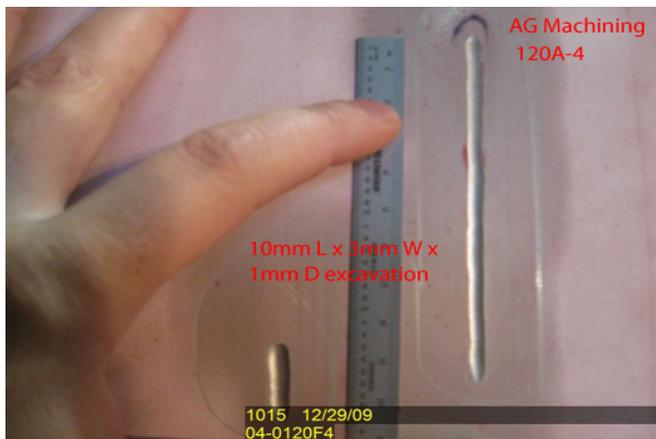
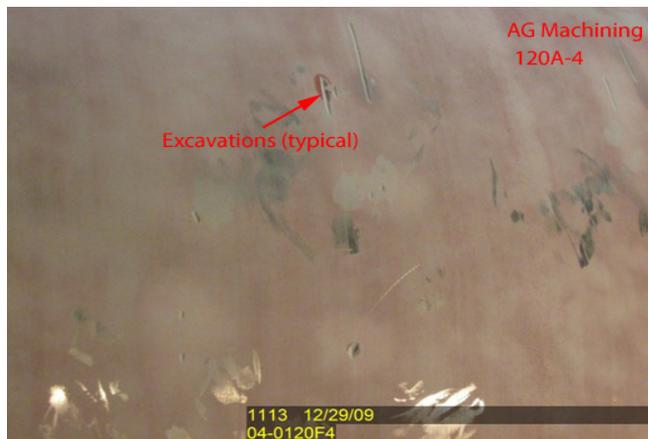
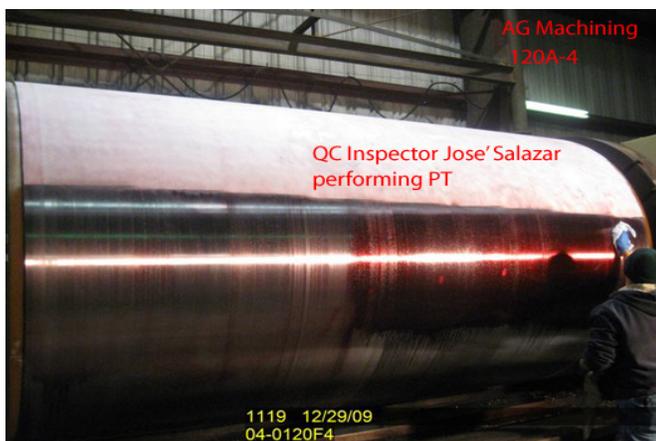
On this date, the QA Inspector arrived at AG Machine, to observe the informal PT inspection of Fuse 120a-4, to verify indications presently visible on the overlay surface. The QA Inspector met with OIW QC Inspector Jose Salazar, OIW welder (WID #C34) Mark Craig & an OIW Machinist. QC Inspector Salazar informed the QA Inspector, that per the approved OIW Liquid Penetrant testing (PT) procedure QC-114, the Fuse 120A-4 to be examined, should be at a minimum of 70 degrees Fahrenheit (21 C). The QA Inspector noted that the fuse was at approximately 40 degrees Fahrenheit (4 C). For this inspection, OIW are attempting to locate any discrepancy that would need to be repaired prior to final inspection. Once all repairs are complete, OIW will later perform a formal PT inspection, on 100% of the Fuse overlay, per the approved PT procedure, QC-114. The QA Inspector noted that AG currently has a third and final cut pass, of approximately .5mm deep and finish honing, prior to OIW completing the final inspection and final PT. The QA Inspector witnessed QC Inspector Jose Salazar in process of cleaning "sections" on the overlay with acetone/cleaner and also later applying DP40 penetrant and D100 spray can type developer. The QA Inspector spoke with Mr. Salazar who explained that any surface indications that were present during the informational PT testing, would be marked for repairing and OIW welder Mark Craig would then grind out and perform GTAW on the repairs. The QA Inspector later noted that after the first "section" of penetrant testing had been completed, Mr. Salazar stated that multiple indications were present, which appeared to

be small clusters of slag inclusions. The QA Inspector witnessed QC Inspector Salazar mark these areas for repairs and welder Mark Craig, excavating these areas out. The QA Inspector witnessed Mr. Salazar measuring the excavations and Mr. Salazar explained that the excavations were approximately .5mm-2.5mm deep, with various lengths measured at 1mm-4mm. The QA Inspector then witnessed Mr. Salazar continue the informational PT on other “sections” of the Fuse 120A-4 overlay. Mr. Salazar later explained that approximately 75% of the informational PT was complete and there were approximately 61 individual GTAW repairs. Mr. Salazar explained that all of the indications appeared to be small clusters of slag inclusions. The QA Inspector later spoke with QC Inspector Salazar and Mr. Salazar explained that 100% of the info. PT was complete with a total of 91 individual repairs. Mr. Salazar explained that the excavations were complete and ready for the GTAW. Mr. Salazar explained that he and welder Mark Craig, would be arriving at AG on 12/30/09, in the a.m., to perform this. See attached pictures below.
