DEPARTMENT OF TRANSPORTATION

Contract #: 04-0120F4Cty: SF/ALA Rte: 80 PM: 13.2/13.9File #: 13.28**WELDING INSPECTION REPORT****Resident Engineer:** Pursell, Gary**Address:** 333 Burma Road**City:** Oakland, CA 94607**Report No:** WIR-010940**Date Inspected:** 30-Dec-2009**Project Name:** SAS Superstructure**OSM Arrival Time:** 1000**Prime Contractor:** American Bridge/Fluor Enterprises, a JV**OSM Departure Time:** 1830**Contractor:** Oregon Iron Works Clackamas, Or.**Location:** Clackamas, OR**CWI Name:** M. Gregson, J. Salazar**CWI Present:** Yes No**Inspected CWI report:** Yes No N/A**Rod Oven in Use:** Yes No N/A**Electrode to specification:** Yes No N/A**Weld Procedures Followed:** Yes No N/A**Qualified Welders:** Yes No N/A**Verified Joint Fit-up:** Yes No N/A**Approved Drawings:** Yes No N/A**Approved WPS:** Yes No N/A**Delayed / Cancelled:** Yes No N/A**Bridge No:** 34-0006**Component:** Hinge K Pipe Beams**Summary of Items Observed:**

WELDING INSPECTION REPORT

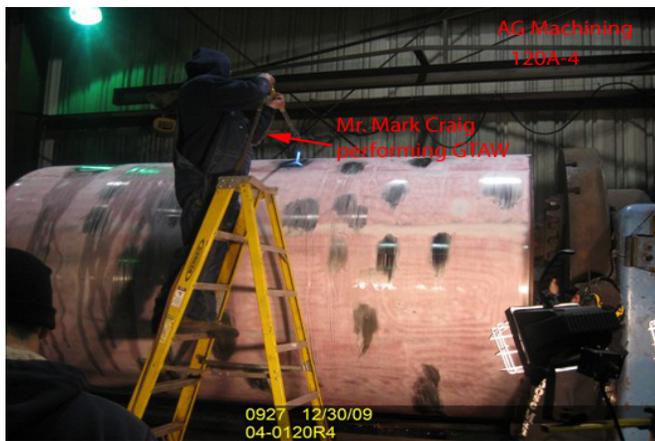
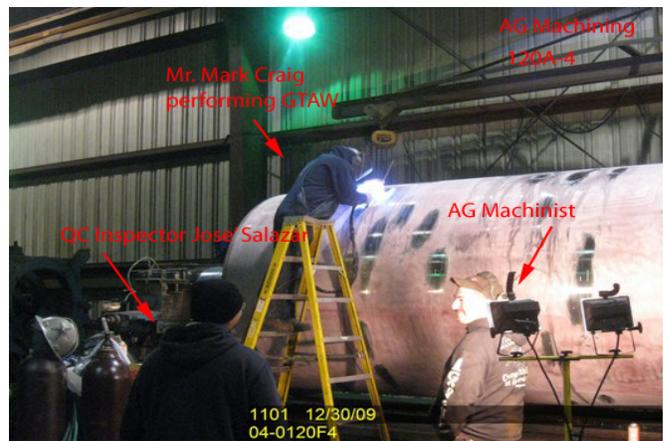
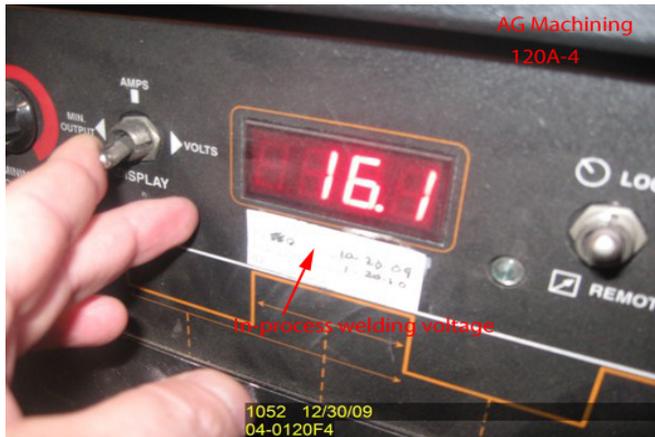
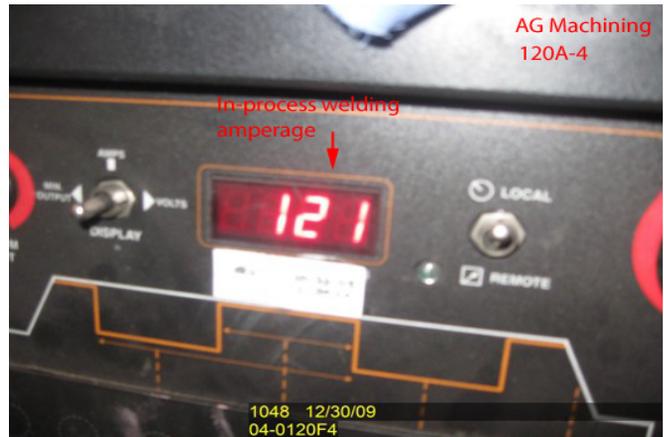
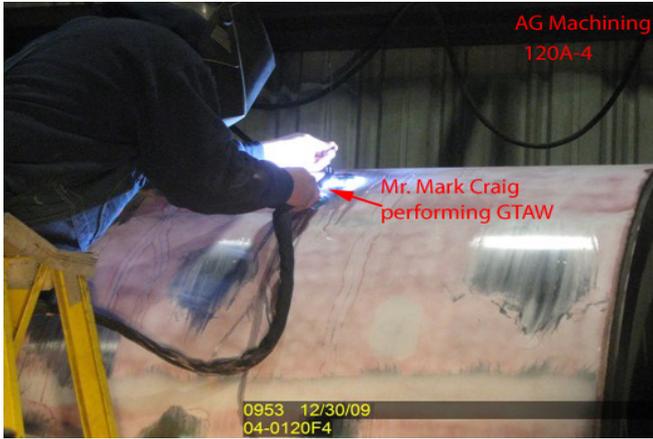
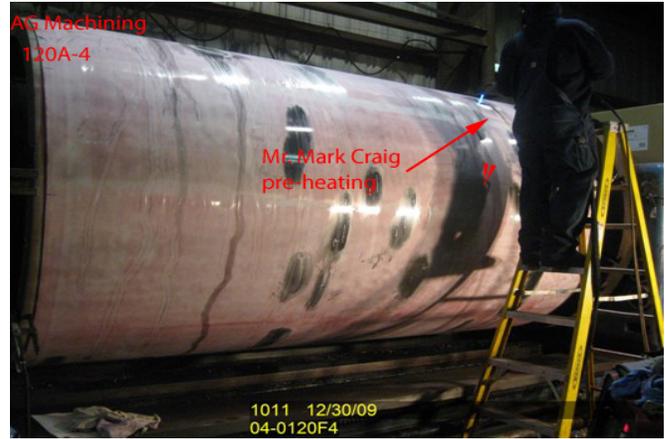
On this date, the QA Inspector arrived at AG Machine, to observe the gas tungsten arc welding (GTAW) on the previously excavated areas, that were discovered during the informal PT by OIW QC Inspector Jose´ Salazar. The QA Inspector met with QC Inspector Salazar, OIW welder (WID# C34) Mark Craig & an OIW Machinist. QC Inspector Salazar explained that the GTAW will be performed by Mr. Craig, utilizing OIW welding procedure specification (WPS) 8022. The QA Inspector noted that Mr. Craig was currently qualified to perform these repairs and Mr. Salazar explained that the position will be rotated to flat, per the procedure. The QA Inspector witnessed Mr. Craig performing the pre-heat required, utilizing a torch and then observed a temperature of approximately 150 degrees Fahrenheit, after the pre-heat was complete. The QA Inspector noted that 125 degrees Fahrenheit minimum was required, per WPS 8022. The QA Inspector witnessed AG Machinist rotating the fuse assembly to access the weld repair areas in the flat position. The QA Inspector then observed Mr. Mark Craig performing the GTAW on the previously excavated repair areas. The QA Inspector also observed QC Inspector Jose Salazar recording the in-process welding parameters of 121 amps and 16.1 volts. The QA Inspector also verified these welding parameters. The QA Inspector also observed several more indications that would need to go through the above mentioned repair procedure. The QA Inspector noted that there were approximately 91 individual repairs on the overlay and that OIW would complete all of these by end of shift. The QA Inspector observed that Mr. Salazar

was present the entire time in which the GTAW welding was being performed. AG explained to the QA Inspector that they will start cutting the third and final pass, on 12/31/09. AG explained the depth will be set to approximately .005" (.13mm), to achieve the final outside diameter measurement of 1921mm, per the contract requirements. AG explained that the honing will start after this, to achieve the required surface finish of .8um. The QA Inspector noted that the GTAW performed by Mr. Craig, appeared to be in compliance with AWS D1.5 and WPS 8022. See attached pictures below.
