DEPARTMENT OF TRANSPORTATION

Contract #: 04-0120F4Cty: SF/ALA Rte: 80 PM: 13.2/13.9File #: 13.28**WELDING INSPECTION REPORT****Resident Engineer:** Pursell, Gary**Address:** 333 Burma Road**City:** Oakland, CA 94607**Report No:** WIR-010960**Date Inspected:** 04-Jan-2010**Project Name:** SAS Superstructure**OSM Arrival Time:** 1000**Prime Contractor:** American Bridge/Fluor Enterprises, a JV**OSM Departure Time:** 1830**Contractor:** Oregon Iron Works Clackamas, Or.**Location:** Clackamas, OR**CWI Name:** M. Gregson, J. Salazar**CWI Present:** Yes No**Inspected CWI report:** Yes No N/A**Rod Oven in Use:** Yes No N/A**Electrode to specification:** Yes No N/A**Weld Procedures Followed:** Yes No N/A**Qualified Welders:** Yes No N/A**Verified Joint Fit-up:** Yes No N/A**Approved Drawings:** Yes No N/A**Approved WPS:** Yes No N/A**Delayed / Cancelled:** Yes No N/A**Bridge No:** 34-0006**Component:** Hinge K Pipe Beams**Summary of Items Observed:**

Hinge-K Pipe Beam Assembly 102A-3

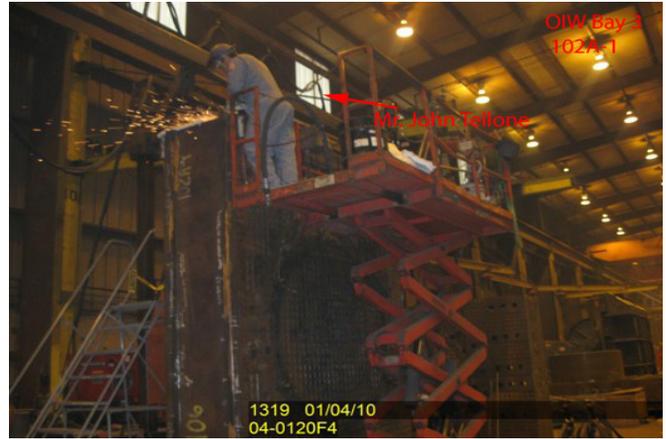
Hinge-K Pipe Beam Assembly 102A-1

a111-1 Forging to a110-1 Base Plate

The QA Inspector witnessed welder #T23, Mr. John Tellone, performing the submerged arc welding (SAW) on the a110-3 Base plate to b106 HPS 485W stiffener. The QA Inspector noted that this weld joint was designated as a partial joint penetration (AWS D1.5 TC-P4-S), weld joint #W2-02 and Mr. Tellone was performing the SAW in the flat (1G) position. The QA Inspector noted that Mr. Tellone was currently performing the SAW root pass and

noted that Mr. Tellone was utilizing OIW approved welding procedure specification (WPS 4020). The QA Inspector noted that QC Inspector Jose Salazar, was present and Mr. Salazar explained to the QA Inspector that the in-process welding parameters/pre-heat temperatures, were intermittently verified. Mr. Salazar explained that average welding parameters for the SAW root pass, was recorded at 560 amps/35 volts, with a pre-heat of approximately 350 degrees Fahrenheit (177 C). The QA Inspector randomly verified pre-heat of approximately 350 degrees Fahrenheit (177 C) and welding parameters to be in compliance with the WPS 4020. The QA Inspector noted that the SAW performed by Mr. Tellone, appeared to be in-compliance with AWS D1.5 and the applicable WPS 4020. See attached picture below.

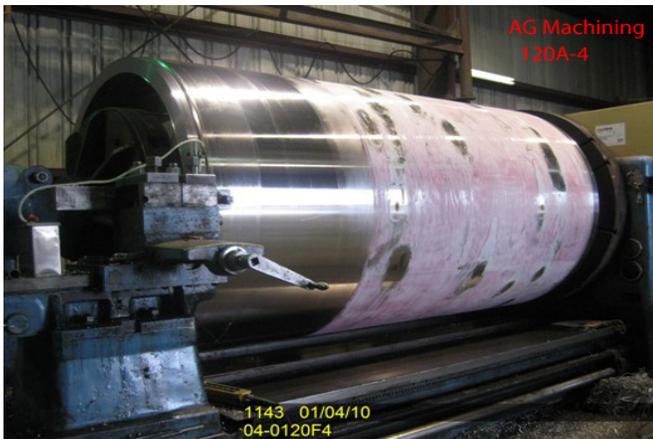
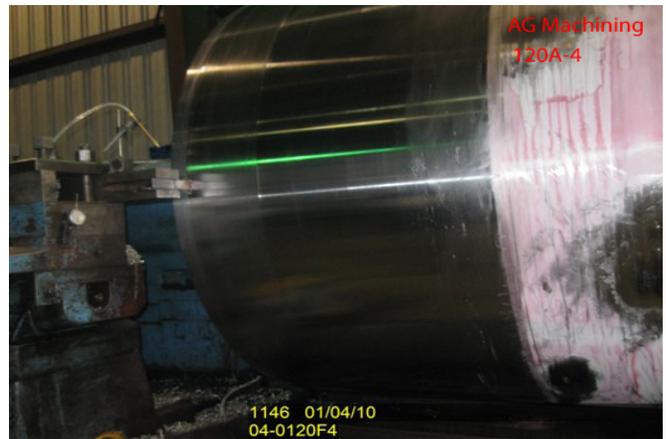
AG Machining (Boring, OR)

On this date, the QA Inspector arrived at AG Machining to witness the final machining on Fuse 120A-4. The QA Inspector met with the AG machinist and AG explained that the third and final cut pass was currently in-process. AG explained that this cut pass was set to remove the overlay material, to achieve a final outside diameter measurement of 1920.4mm. AG explained that during the initial final cut pass, that some minor inclusions were still present in the overlay. AG explained that the indications were shallow enough to machine out and chose to machine a deeper cut pass. The QA Inspector noted that the final fished outside diameter contract requirement is 1920mm (+/- 1mm). AG explained that this final cut pass should be complete on 1/6/09 and then the entire overlay surface will be honed with a "superfinisher". AG explained that the "superfinisher" will smooth the surface to a minimum .8um, per the contract requirements. The QA Inspector noted that after AG performs the honing, OIW will arrive at AG, to perform the FARO laser measurements and final visual/PT testing, on the Fuse. See attached pictures below.
