Quality Assurance and Source Inspection

Contract #: 04-0120F4Cty: SF/ALA Rte: 80 PM: 13.2/13.9File #: 13.28**WELDING INSPECTION REPORT****Resident Engineer:** Pursell, Gary**Address:** 333 Burma Road**City:** Oakland, CA 94607**Report No:** WIR-011361**Date Inspected:** 11-Jan-2010**Project Name:** SAS Superstructure**OSM Arrival Time:** 1000**Prime Contractor:** American Bridge/Fluor Enterprises, a JV**OSM Departure Time:** 1830**Contractor:** Oregon Iron Works Clackamas, Or.**Location:** Clackamas, OR**CWI Name:** M. Gregson, J. Salazar**CWI Present:** Yes No**Inspected CWI report:** Yes No N/A**Rod Oven in Use:** Yes No N/A**Electrode to specification:** Yes No N/A**Weld Procedures Followed:** Yes No N/A**Qualified Welders:** Yes No N/A**Verified Joint Fit-up:** Yes No N/A**Approved Drawings:** Yes No N/A**Approved WPS:** Yes No N/A**Delayed / Cancelled:** Yes No N/A**Bridge No:** 34-0006**Component:** Hinge K Pipe Beams**Summary of Items Observed:**

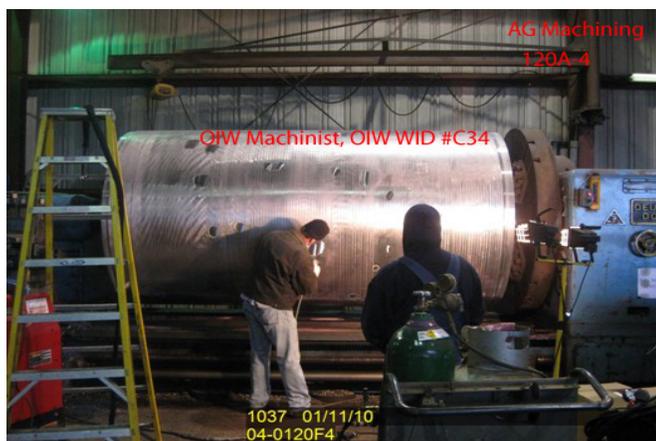
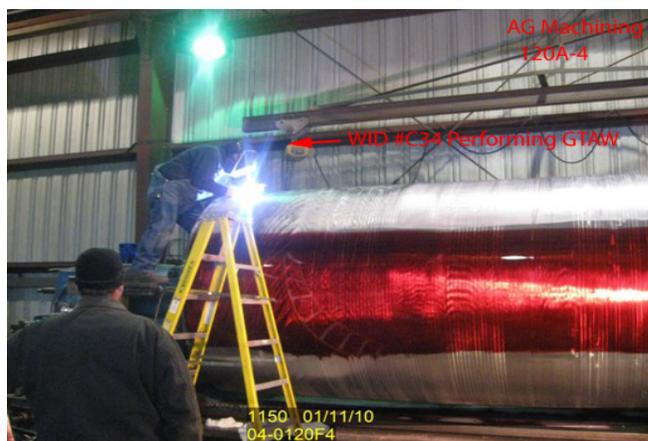
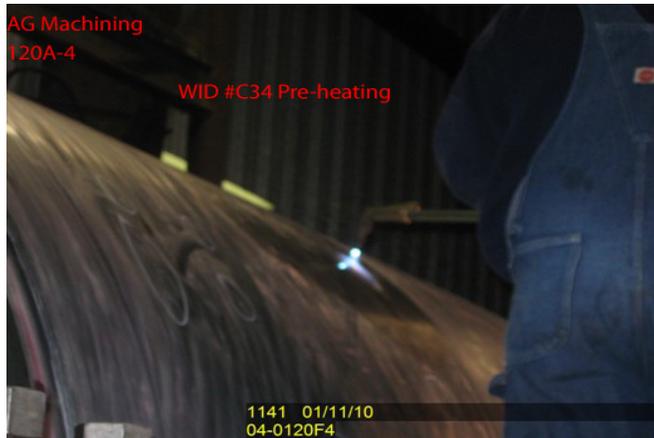
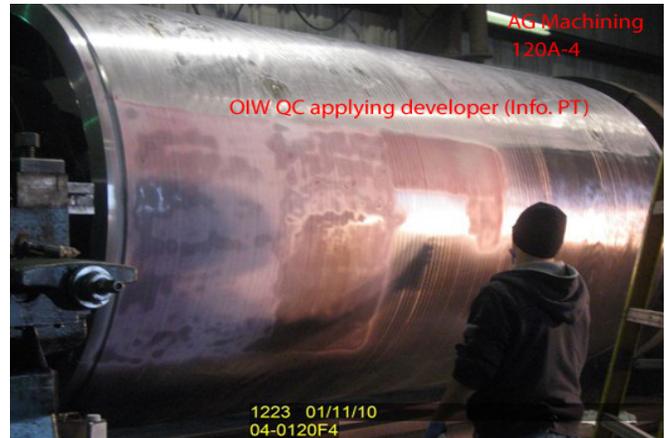
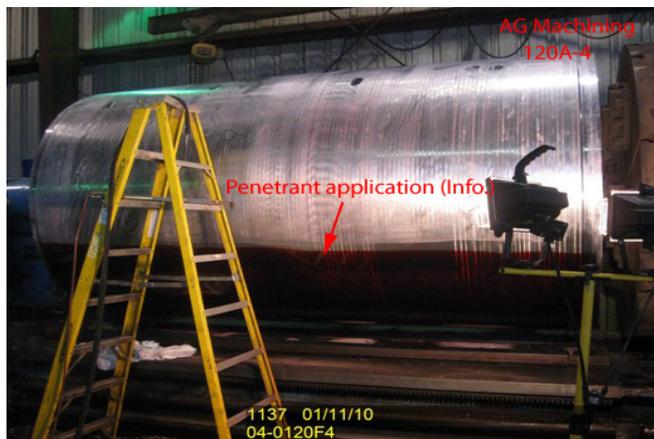
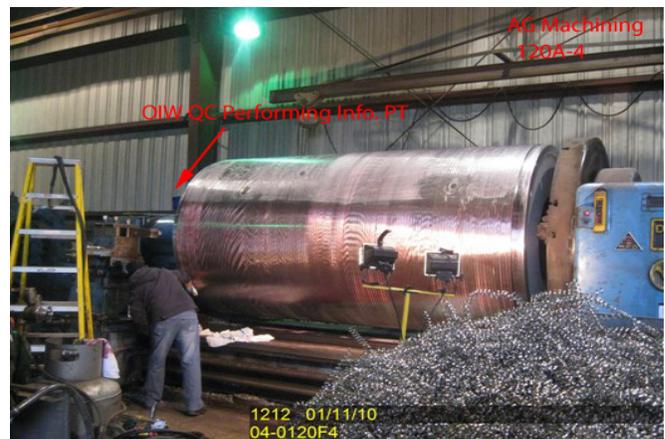
On this date, the QA Inspector arrived at AG Machine to observe OIW perform additional informal penetrant testing and weld repairs, on the finished overlay surface, on this Fuse 120A-4. The QA Inspector met with OIW QC Inspector Jose Salazar, OIW welder (WID# C34) Mark Craig an OIW and AG Machinist. QC Inspector Salazar explained to the QA Inspector that he was continuing to perform additional informal PT on 100% of the overlay and Mr. Craig will continue to perform the GTAW weld repairs. The QA Inspector noted that the indications, currently present in the overlay, appeared after AG completed the final cut pass and finish honing. QC Inspector Salazar informed the QA Inspector that per the approved OIW Liquid Penetrant testing (PT) procedure QC-114 the piece to be examined should be at a minimum of 70 degrees Fahrenheit. For this inspection OIW are attempting to locate any discrepancy that would need to be repaired prior to final inspection. Once all repairs are complete, OIW will later perform a formal PT inspection on 100% of the Fuse overlay per the approved PT procedure. The QA Inspector witnessed QC Inspector Jose Salazar in process of cleaning "sections" on the overlay with acetone/cleaner and also later applying penetrant and developer. The QA Inspector spoke with Mr. Salazar who explained that any surface indications that were present during the informational PT testing would be marked for repairing and OIW welder Mark Craig would then grind out and perform GTAW on the repairs. QC Inspector Salazar informed the QA Inspector that multiple indications were present, during the PT testing, which appeared to

be small clusters of slag inclusions. The QA Inspector witnessed Mr. Craig grinding out these indications, to a depth of .5-1 mm and then later setting up to perform the GTAW.

The QA Inspector noted that Mr. Craig was currently qualified to perform these repairs and would be utilizing welding procedure specification (WPS 8022). The QA Inspector witnessed Mr. Craig performing the pre-heat required, utilizing a torch and then observed a temperature of approximately 150 degrees Fahrenheit, after the pre-heat was complete. The QA Inspector noted that 125 degrees Fahrenheit minimum was required, per WPS 8022. The QA Inspector witnessed AG Machinist rotating the fuse assembly to access the weld repair areas in the flat position. The QA Inspector then observed Mr. Mark Craig performing the GTAW on the previously excavated repair areas. The QA Inspector also observed QC Inspector Jose Salazar recording the in-process welding parameters of 123 amps and 15.5 volts. The QA Inspector also verified these welding parameters. The QA Inspector noted that after completion of these weld repair areas, the OIW Machinist performed the grinding with a buffer wheel on the completed weld repair to "flush" with the finished overlay surface. The QA Inspector observed that the Fuse was then rotated and the QC Inspector performed 100% informational PT Inspection on another section of the finished overlay. The QA Inspector also observed several more indications that would need to go through the above mentioned repair procedure. The QA Inspector observed that Mr. Salazar was present the entire time in which the GTAW welding was being performed.

The QA Inspector later spoke with QC Inspector Salazar and Mr. Salazar explained that the informational PT testing was complete and OIW will be arriving the following day on 1/12/10, to finish the weld repairs. Mr. Salazar explained that the repairs should be completed in approximately 2 hrs. (See attached pictures below)
