DEPARTMENT OF TRANSPORTATION

Contract #: 04-0120F4Cty: SF/ALA Rte: 80 PM: 13.2/13.9File #: 13.28**WELDING INSPECTION REPORT****Resident Engineer:** Pursell, Gary**Address:** 333 Burma Road**City:** Oakland, CA 94607**Report No:** WIR-011466**Date Inspected:** 12-Jan-2010**Project Name:** SAS Superstructure**OSM Arrival Time:** 1000**Prime Contractor:** American Bridge/Fluor Enterprises, a JV**OSM Departure Time:** 1830**Contractor:** Oregon Iron Works Clackamas, Or.**Location:** Clackamas, OR

Hinge-K Pipe Beam Fuse Assembly 120A-8

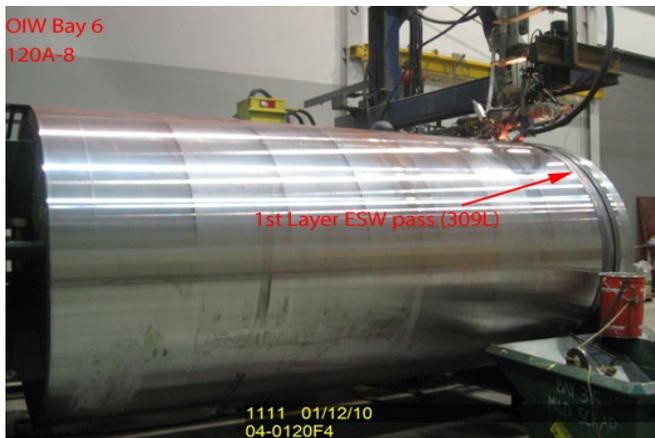
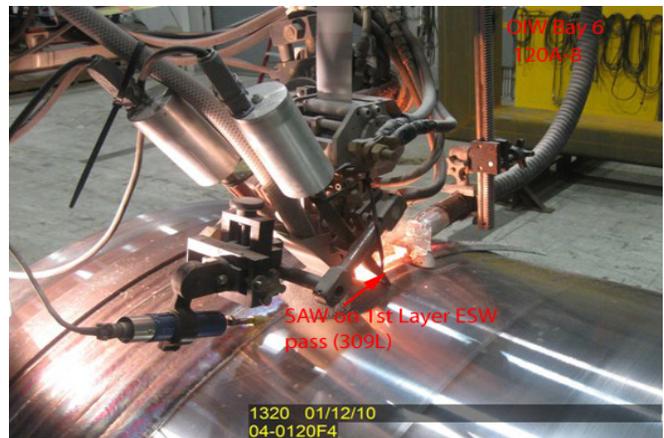
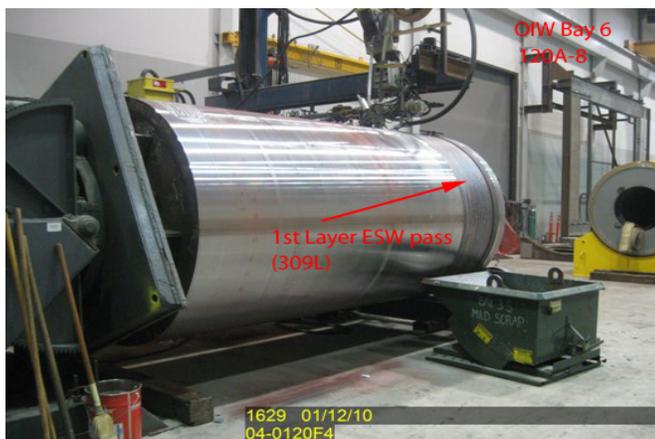
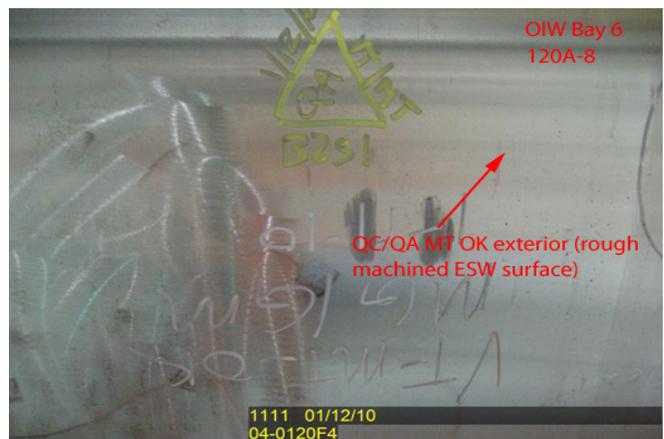
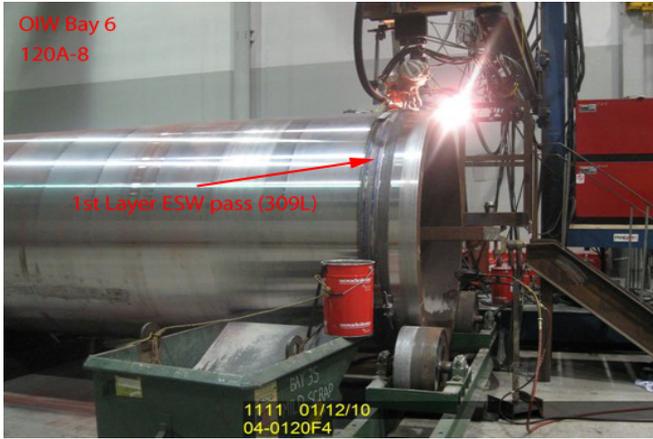
The QA Inspector later performed approximately 10% MT testing on random areas of this Fuse 120A-8, on the exterior rough machined surface. The QA Inspector found no rejectable indications and completed the applicable magnetic particle testing report. See TL6028, for details. The QA Inspector notified QC Inspector Gregson of the testing results and QC Inspector Gregson then explained that OIW production will begin the 1st layer electro slag

welding (ESW) passes. The QA Inspector later witnessed welder WID #F17, Mr. Igor Frolov performing electro slag welding (ESW) on the third layer welding passes, in the flat position. The QA Inspector noted that approximately 10 ESW passes were completed on the 1st layer, utilizing the 309L stainless steel consumable strip. The QA Inspector randomly noticed QC Inspector Jose Salazar was present, to verify in-process welding parameters (amps/volts) and monitor in-process continuous pre-heat temperatures. QC Inspector Salazar explained to the QA Inspector that welding amperage was previously recorded at 1200 amps/24.5 volts, travel speed at 229mm/min. and a pre-heat temperature recorded at 225 degrees Fahrenheit (100 C). The QA Inspector verified the welding parameters and the minimum pre-heat temperatures were in compliance with the applicable WPS 7003. The QA Inspector verified Mr. Igor Frolov was currently qualified for this welding process and position. The QA Inspector noted that the ESW being performed appeared to be in compliance with WPS 7003.

The QA Inspector was present on this swing shift and witnessed WID#V7, Mr. Vincent Vue continuing to perform electro slag welding (ESW) on the 1st layer ESW welding passes, utilizing the 309L stainless steel consumable strip, in the flat position. The QA Inspector randomly noticed QC Inspector Gary Mundt was present, to verify in-process welding parameters (amps/volts) and monitor in-process continuous pre-heat temperatures. QC Inspector Mundt explained to the QA Inspector that welding amperage was previously recorded at 1200 amps/24.5 volts, travel speed of 229mm/min. and a pre-heat temperature recorded at 225 degrees Fahrenheit (100 C). The QA Inspector noted that the ESW being performed appeared to be in compliance with WPS 7003.
