Contract #: 04-0120F4Cty: SF/ALA Rte: 80 PM: 13.2/13.9File #: 13.28**WELDING INSPECTION REPORT****Resident Engineer:** Pursell, Gary**Address:** 333 Burma Road**City:** Oakland, CA 94607**Report No:** WIR-011582**Date Inspected:** 20-Jan-2010**Project Name:** SAS Superstructure**OSM Arrival Time:** 1000**Prime Contractor:** American Bridge/Fluor Enterprises, a JV**OSM Departure Time:** 1530**Contractor:** Oregon Iron Works Clackamas, Or.**Location:** Clackamas, OR

CWI Name:	M. Gregson, J. Salazar, G. Mundt	CWI Present:	Yes	No
Inspected CWI report:	Yes No N/A	Rod Oven in Use:	Yes	No N/A
Electrode to specification:	Yes No N/A	Weld Procedures Followed:	Yes	No N/A
Qualified Welders:	Yes No N/A	Verified Joint Fit-up:	Yes	No N/A
Approved Drawings:	Yes No N/A	Approved WPS:	Yes	No N/A
		Delayed / Cancelled:	Yes	No N/A
Bridge No:	34-0006	Component:	Hinge K Pipe Beams

Hinge-K Pipe Beam Fuse Assembly 120A-8

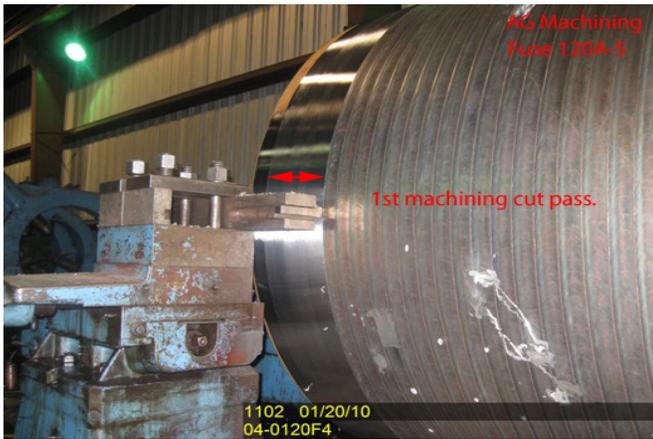
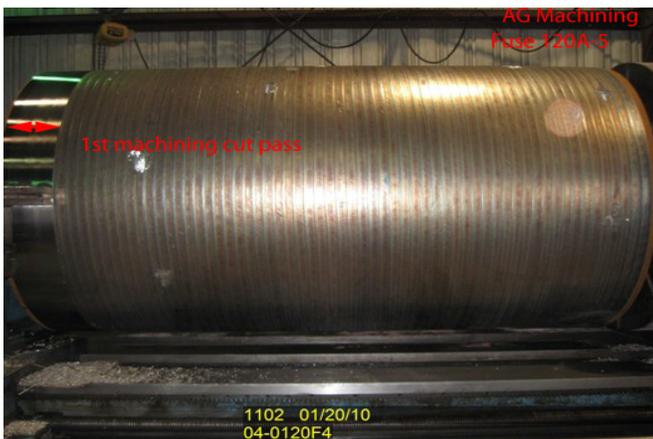
On this date, the QA Inspector arrived at AG Machine shop, to witness the final machining of the Fuse 120A-5. The QA Inspector met with an AG Machinist and he stated that the first cut pass, for final machining, was in-process. The AG Machinists explained to the QA Inspector that the cutting depth was set to remove approximately 1/4" (6mm) of overlay material. The AG Machinists also informed the QA Inspector that this first cut pass was started in the a.m. and no visible indications were present in the overlay, at this time. The QA Inspector noted that the contract requires a final outside diameter finish of 1920mm (+1mm) with a surface finish of .8 μ m. See attached pictures below.
