Contract #: 04-0120F4Cty: SF/ALA Rte: 80 PM: 13.2/13.9File #: 13.28**WELDING INSPECTION REPORT****Resident Engineer:** Pursell, Gary**Address:** 333 Burma Road**City:** Oakland, CA 94607**Report No:** WIR-011658**Date Inspected:** 27-Jan-2010**Project Name:** SAS Superstructure**OSM Arrival Time:** 1000**Prime Contractor:** American Bridge/Fluor Enterprises, a JV**OSM Departure Time:** 1830**Contractor:** Oregon Iron Works Clackamas, Or.**Location:** Clackamas, OR

WELDING INSPECTION REPORT

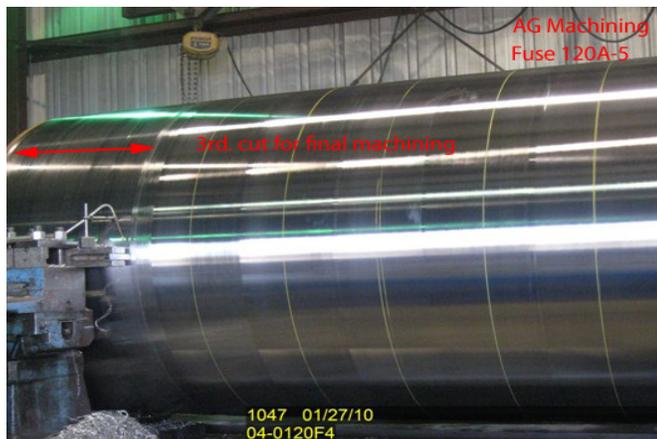
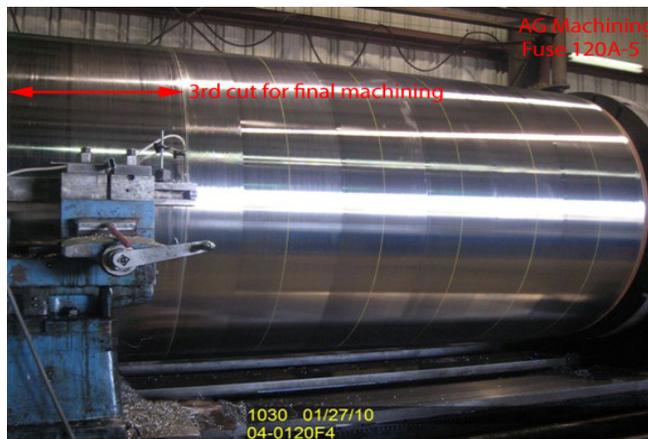
On this date, the QA Inspector arrived at AG Machine shop, to witness the final machining of the Fuse 120A-5. The QA Inspector met with the AG Machinist and AG explained that he was in process performing the third and final cut pass, for final machining. The AG machinist explained to the QA Inspector that the cutting depth was previously set to remove approximately 1mm of overlay material and that this cut pass will machine the Fuse to the final outside diameter, per the contract requirements. AG explained that this cut pass should be completed in the a.m. on 1/28/10 and honing will then start. AG explained that the honing, or superfinishing, will smooth the entire finished overlay to the required surface finish. The QA Inspector noted that the contract requires a final outside diameter finish of 1920 mm (+1mm) with a surface finish of .8µm. See attached pictures below.
