**DEPARTMENT OF TRANSPORTATION**

Contract #: 04-0120F4Cty: SF/ALA Rte: 80 PM: 13.2/13.9File #: 13.28**WELDING INSPECTION REPORT****Resident Engineer:** Pursell, Gary**Address:** 333 Burma Road**City:** Oakland, CA 94607**Report No:** WIR-011855**Date Inspected:** 03-Feb-2010**Project Name:** SAS Superstructure**OSM Arrival Time:** 1000**Prime Contractor:** American Bridge/Fluor Enterprises, a JV**OSM Departure Time:** 1630**Contractor:** Oregon Iron Works Clackamas, Or.**Location:** Clackamas, OR

<b>CWI Name:</b>	M. Gregson, J. Salazar, G. Mundt	<b>CWI Present:</b>	<b>Yes</b>	<b>No</b>			
<b>Inspected CWI report:</b>	<b>Yes</b>	<b>No</b>	<b>N/A</b>	<b>Rod Oven in Use:</b>	<b>Yes</b>	<b>No</b>	<b>N/A</b>
<b>Electrode to specification:</b>	<b>Yes</b>	<b>No</b>	<b>N/A</b>	<b>Weld Procedures Followed:</b>	<b>Yes</b>	<b>No</b>	<b>N/A</b>
<b>Qualified Welders:</b>	<b>Yes</b>	<b>No</b>	<b>N/A</b>	<b>Verified Joint Fit-up:</b>	<b>Yes</b>	<b>No</b>	<b>N/A</b>
<b>Approved Drawings:</b>	<b>Yes</b>	<b>No</b>	<b>N/A</b>	<b>Approved WPS:</b>	<b>Yes</b>	<b>No</b>	<b>N/A</b>
				<b>Delayed / Cancelled:</b>	<b>Yes</b>	<b>No</b>	<b>N/A</b>
<b>Bridge No:</b>	34-0006	<b>Component:</b>	Hinge K Pipe B

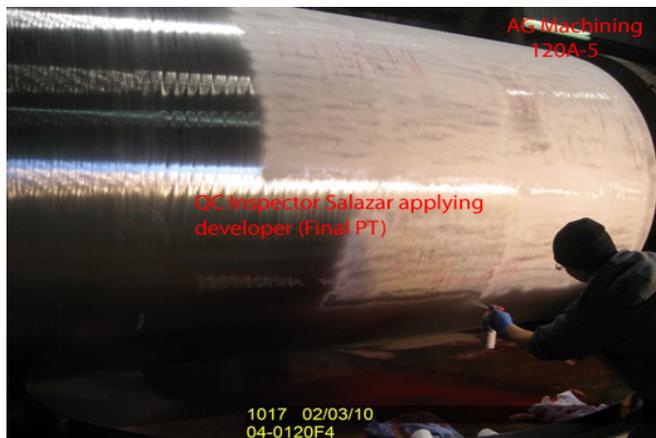
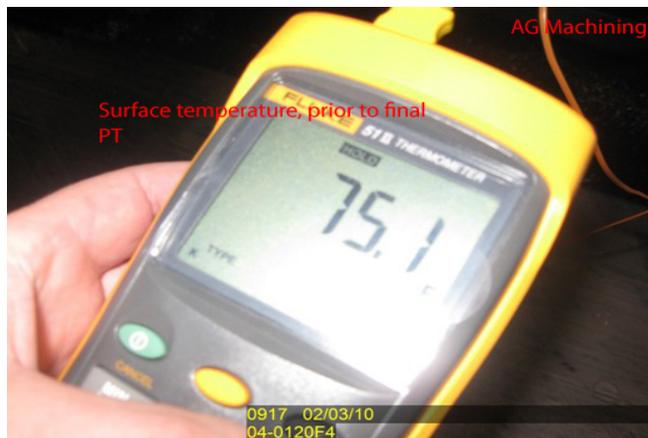
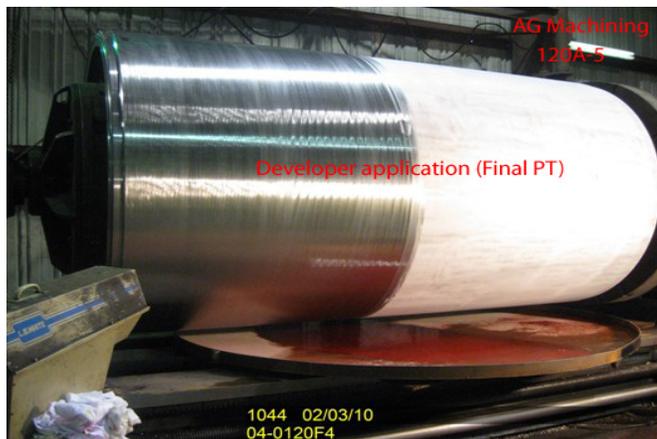
On this date, the QA Inspectors Sean Vance and Joe Adame, arrived at AG Machine shop to observe OIW perform the final penetrant testing (PT) and surface finish testing, on the Fuse 120A-5. The QA Inspectors arrived at approximately 0900 and met with OIW QC Inspector Jose Salazar and an AG Machinist. The AG Machinist explained that he had previously arrived at approximately 0600 to apply heat to the Fuse 120A-5, utilizing 2 propane heaters, prior to the penetrant testing to be performed by QC Inspector Salazar. QC Inspector Salazar explained to the QA Inspectors that he had previously arrived at AG at approximately 0800, to verify surface temperature of the Fuse, prior to the penetrant testing. QC Inspector Salazar explained to the QA Inspectors that the final PT testing will be done utilizing OIW's procedure QC-114, sect. 8.0, Water Washable Visible Die Penetrant. QC Inspector Salazar explained that he had brought a profilometer and that the final surface finish, will also be checked, after the final PT is completed. QA Inspectors witnessed Mr. Salazar cleaning the entire Fuse 120A-5 with acetone, to remove all surface irregularities, which would otherwise mask the indications of unacceptable indications. QA Inspectors witnessed Mr. Salazar performing pre-heat checks, utilizing a digital thermometer and noted that the surface temperature was approximately 75 degrees Fahrenheit (24 C). QA Inspectors witnessed Mr. Salazar then applying DP50 penetrant, utilizing a hand pump sprayer, to approximately one-half of the entire surface finish. QA Inspectors noted that the penetrant was applied evenly and Mr. Salazar

explained that the DP 50 will sit for approximately 25-30 minutes (dwell time). QA Inspectors then verified the dwell time to be approximately 25 minutes and noted that Mr. Salazar had started to wipe the penetrant off with lint free rags. QA Inspectors then witnessed Mr. Salazar applying water, with a hand sprayer, to remove the excess DP50. QA Inspectors then witness Mr. Salazar applying D-100 spray can type developer, over the entire one-half surface, in a thin uniform coating. QA Inspectors noted that during the application of the D-100, that no relevant indications were present at the time. After approximately 20 minutes dwell time, QA Inspectors witnessed Mr. Salazar performing visual testing on the tested area. Mr. Salazar then explained to QA Inspectors that no relevant indications were present and was acceptable. QA Inspectors then witnessed Mr. Salazar cleaning off the applied developer with a water hose. The QA Inspector noted that Mr. Salazar performed the final PT testing, on the remaining one-half surface, in the same manner as mentioned above. Mr. Salazar explained to the QA Inspector that the remaining one-half was acceptable. QA Inspector noted that Mr. Salazar had performed 100% PT testing on this Fuse 120A-4 and found no rejectable indications. QA Inspector noted that Mr. Salazar appeared to be in compliance with AWS D1.5 visual acceptance criteria and QC-114. The QA Inspector then witnessed QC Inspector Salazar perform the final surface testing, utilizing a profilometer. The QA Inspectors verified that the profilometer had a calibration sticker and had been calibrated by OIW on 12/10/09, with a next due date of 12/10/10. QA Inspectors Sean Vance and Joe Adame then witnessed QC Inspector Salazar perform random testing on the surface finish and noted the surface profile readings averaged .5um. The QA Inspectors witnessed QC Inspector Salazar perform surface finish testing on the previously repaired and smoothed surfaces on the overlay. QA Inspectors noted that the contract requires a surface finish of .8um. QA Inspectors noted that this surface finish appears to be in compliance with the contract requirements. See attached pictures below.
