**DEPARTMENT OF TRANSPORTATION**

Contract #: 04-0120F4Cty: SF/ALA Rte: 80 PM: 13.2/13.9File #: 69.28**WELDING INSPECTION REPORT****Resident Engineer:** Pursell, Gary**Address:** 333 Burma Road**City:** Oakland, CA 94607**Report No:** WIR-011947**Date Inspected:** 03-Feb-2010**Project Name:** SAS Superstructure**OSM Arrival Time:** 700**Prime Contractor:** American Bridge/Fluor Enterprises, a JV**OSM Departure Time:** 1900**Contractor:** Zhenhua Port Machinery Company, Ltd (ZPMC), Changxing Island **Location:** Shanghai, China**CWI Name:** Mr. An Qing Xiang**CWI Present:** Yes No**Inspected CWI report:** Yes No N/A**Rod Oven in Use:** Yes No N/A**Electrode to specification:** Yes No N/A**Weld Procedures Followed:** Yes No N/A**Qualified Welders:** Yes No N/A**Verified Joint Fit-up:** Yes No N/A**Approved Drawings:** Yes No N/A**Approved WPS:** Yes No N/A**Delayed / Cancelled:** Yes No N/A**Bridge No:** 34-0006**Component:** Tower**Summary of Items Observed:**

## WELDING INSPECTION REPORT

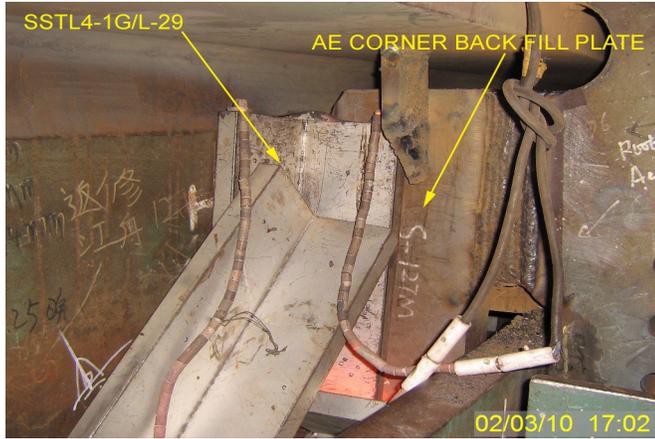
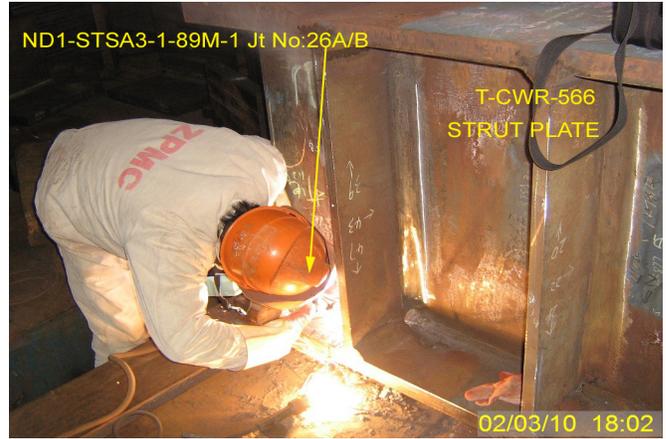
SMAW welding of weld joint no: ND1-STSA3-1-89M-1-26A/B located on Strut Plate. Welder is identified as 057258. ZPMC CWI is identified as Mr. Xu Le Feng. Welding was been performed against Critical Weld Repair Report T-CWR566 and UT report number: T787-UT-2533R1-2 .The welding variables recorded by QC appeared to comply with the WPS-485-SMAW-2G(2F)-FCM-Repair-1.

SMAW welding of weld joint no: SSTL4-1G/L-29 located on “AE” Corner Back Fill Plate. Welder is identified as 052493.ZPMC CWI is identified as Mr.Du zhiquan. The welding variables recorded by QC appeared to comply with the WPS-B-T-3213-B-U2a-1.

SMAW welding of weld joint no: SSTL4-1G/L-98 located on “AE” Corner Back Fill Plate. Welder is identified as 050289.ZPMC CWI is identified as Mr.Du zhiquan. The welding variables recorded by QC appeared to comply with the WPS-B-T-3213-B-U2a-1.

SAW welding of weld joint no: ESD1-TL5-2B/F-24A located on “DE” Corner Seam. Welder is identified as 044552.ZPMC CWI is identified as Mr.An Qing Xiang. The welding variables recorded by QC appeared to comply with the WPS-B-T-3221-C-U2b-S.

SAW welding of weld joint no: ESD1-TL5-2B/F-40B located on “DE” Corner Seam. Welder is identified as 040699.ZPMC QC is identified as Mr. An Qing Xiang. The welding variables recorded by QC appeared to comply with the WPS-B-T-3221-C-U2b-S.
