Contract #: 04-0120F4Cty: SF/ALA Rte: 80 PM: 13.2/13.9File #: 19.28**WELDING INSPECTION REPORT****Resident Engineer:** Pursell, Gary**Address:** 333 Burma Road**City:** Oakland, CA 94607**Report No:** WIR-012032**Date Inspected:** 16-Feb-2010**Project Name:** SAS Superstructure**OSM Arrival Time:** 1500**Prime Contractor:** American Bridge/Fluor Enterprises, a JV**OSM Departure Time:** 1130**Contractor:** American Bridge/Fluor Enterprises, a JV**Location:** Job Site

At the start of the shift the Quality Assurance Inspector (QAI) traveled to the project site and observed the following operation performed at the E1/E2 field splice:

WELDING INSPECTION REPORT

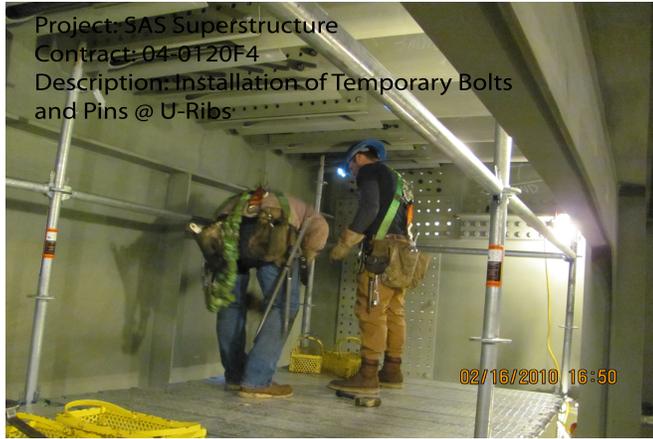
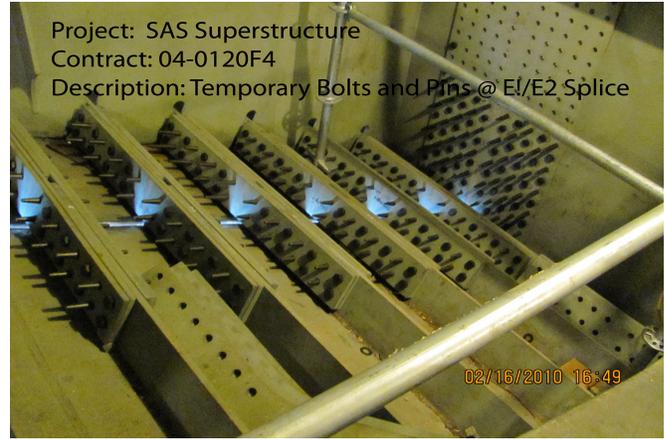
See digital photographs on page 2 of this report.

A). Installation of the temporary ASTM A325 High Strength Bolts (HSB) and pins.

The initial installation of the temporary bolts was performed by four (4) American Bridge/Fluor personnel located at the deck and side plates. It appeared the connections were brought into alignment by driving drift pins through the various plies of splice plates to bring the bolt holes in their proper alignment. The QAI observed this task performed at the U-Ribs located at the deck plate and the plate stiffeners located at the side plates. The QAI also observed the Quality Control (QC) inspector Mike Johnson performing a visual observance regarding the alignment of the bolt holes at these connections.

The work performed during this shift was not completed on this date and appeared to comply with the contract documents.
