**DEPARTMENT OF TRANSPORTATION**

Contract #: 04-0120F4Cty: SF/ALA Rte: 80 PM: 13.2/13.9File #: 13.28**WELDING INSPECTION REPORT****Resident Engineer:** Pursell, Gary**Address:** 333 Burma Road**City:** Oakland, CA 94607**Report No:** WIR-012145**Date Inspected:** 16-Feb-2010**Project Name:** SAS Superstructure**OSM Arrival Time:** 1000**Prime Contractor:** American Bridge/Fluor Enterprises, a JV**OSM Departure Time:** 1630**Contractor:** Oregon Iron Works Clackamas, Or.**Location:** Clackamas, OR

**Hinge-K Pipe Beam Assembly 102A-3**

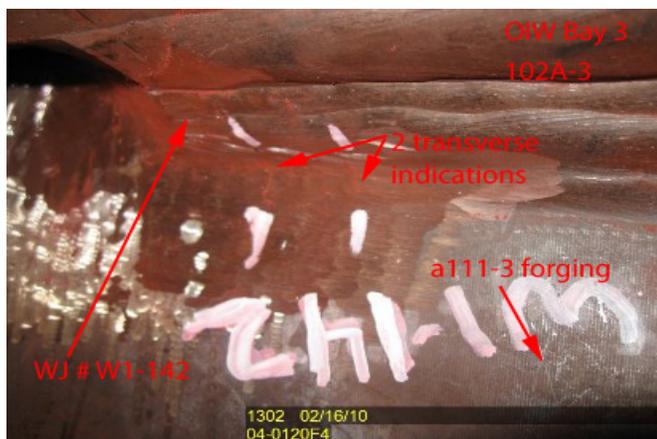
The QA Inspector was notified by OIW QC Inspector Jose Salazar that the final Magnetic Particle testing (MT) had been performed on the previously completed Critical Weld Repairs (CWR's 2244-016 and 2244-017). QC Inspector Salazar explained that linear indications were discovered during the final MT. QC Inspector Salazar explained that the indications appeared in separate areas, away from the weld repair areas. The QA Inspector performed 100% MT on the completed CWR's and verified the indications were present. The QA Inspector noted that the MT testing revealed 2 transverse indications on the weld joint #W1-142 and indications in the toe of the weld joint # W1-145. The QA Inspector measured the two transverse indications to be approximately 12 mm long each and the weld toe indication to be approximately 210 mm long. See attached pictures below.

The QA Inspector was present on this swing shift and noted that OIW QC Inspector Gary Mundt was present to monitor welding and production activities. The QA Inspector was later informed by QC Inspector Mundt that production was in process of performing the excavations on the above mentioned CWR's. The QA Inspector then met with QC Inspector Mundt and OIW welding supervisor Carl Johnston and it was explained that the two transverse indications (WJ #142) were excavated out by Troy Smith at the end of today's shift and swing shift was instructed to continue with the excavations. The QA Inspector explained that nothing has been submitted and no approval to perform the CWR's has been granted. QC Inspector Mundt then explained that the excavations will not
