Contract #: 04-0120F4Cty: SF/ALA Rte: 80 PM: 13.2/13.9File #: 13.28**WELDING INSPECTION REPORT****Resident Engineer:** Pursell, Gary**Address:** 333 Burma Road**City:** Oakland, CA 94607**Report No:** WIR-012235**Date Inspected:** 18-Feb-2010**Project Name:** SAS Superstructure**OSM Arrival Time:** 1000**Prime Contractor:** American Bridge/Fluor Enterprises, a JV**OSM Departure Time:** 1830**Contractor:** Oregon Iron Works Clackamas, Or.**Location:** Clackamas, OR**CWI Name:** M. Gregson, J. Salazar**CWI Present:** Yes No**Inspected CWI report:** Yes No N/A**Rod Oven in Use:** Yes No N/A**Electrode to specification:** Yes No N/A**Weld Procedures Followed:** Yes No N/A**Qualified Welders:** Yes No N/A**Verified Joint Fit-up:** Yes No N/A**Approved Drawings:** Yes No N/A**Approved WPS:** Yes No N/A**Delayed / Cancelled:** Yes No N/A**Bridge No:** 34-0006**Component:** Hinge K Pipe Beams**Summary of Items Observed:**

AG Machining (Boring, OR)

WELDING INSPECTION REPORT

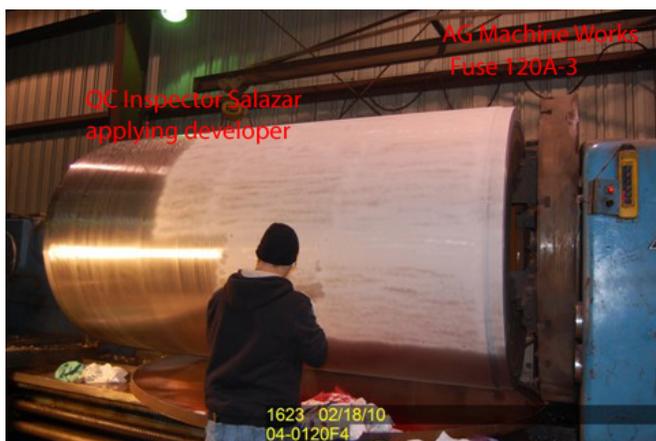
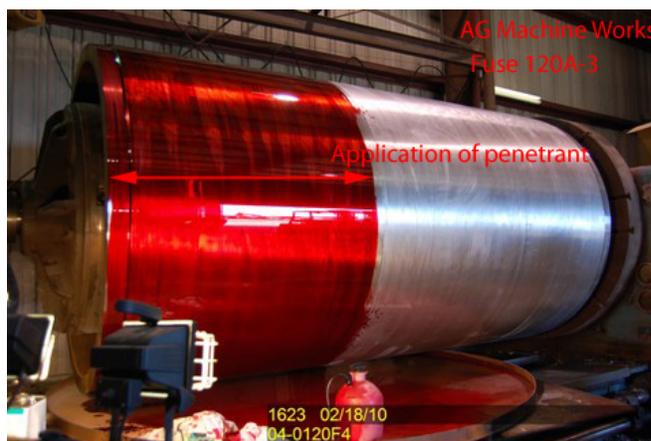
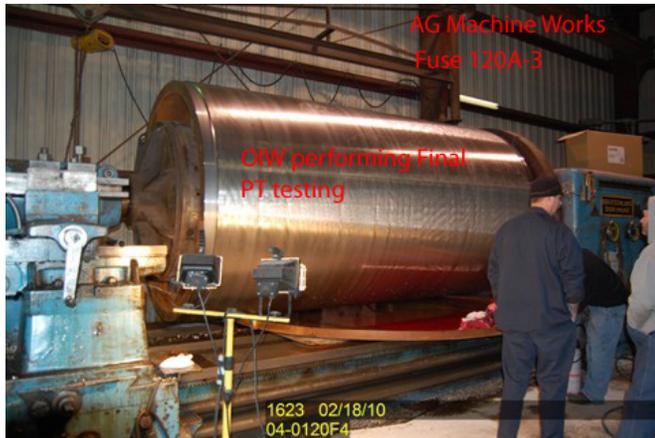
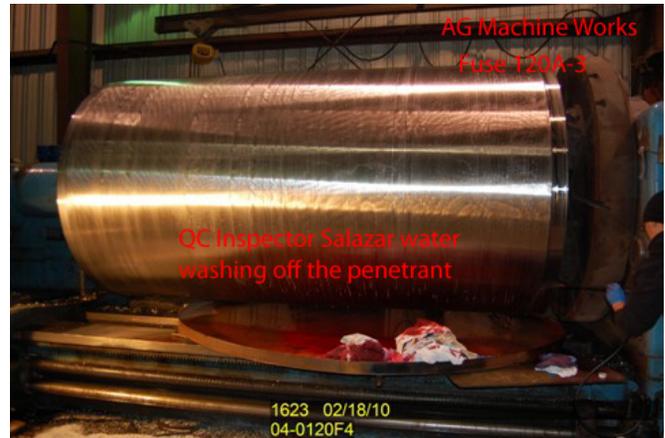
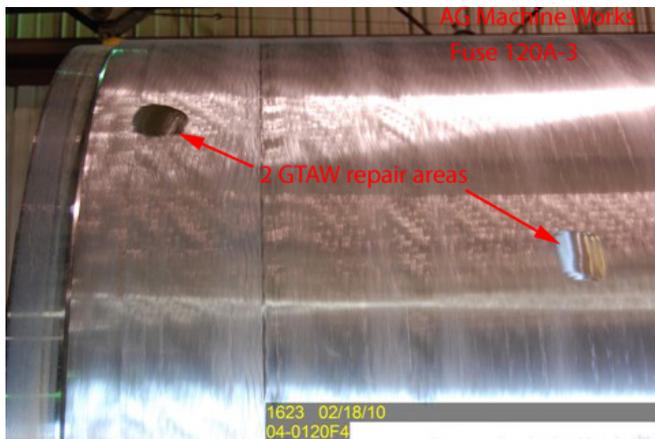
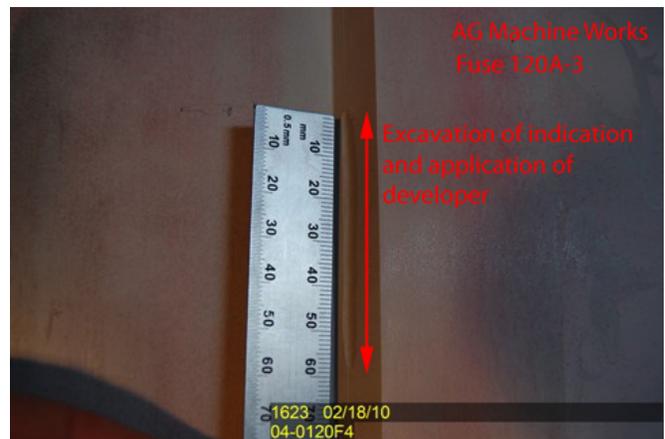
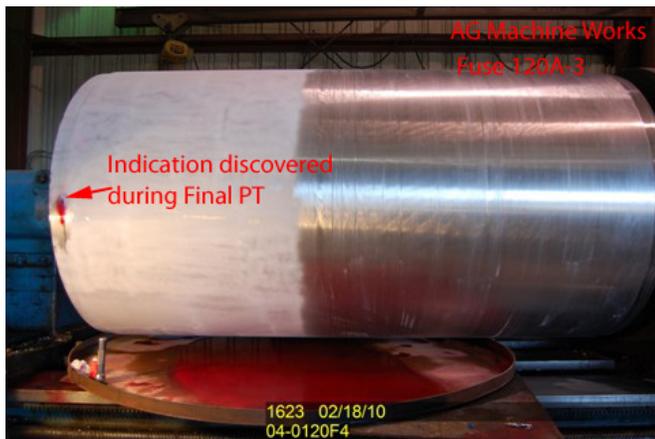
On this date, the QA Inspectors Sean Vance and Joe Adame, arrived at AG Machine shop to observe OIW perform the final Penetrant Testing (PT), on the Fuse 120A-3. The QA Inspectors arrived at approximately 1000 and met with OIW QC Inspector Jose Salazar, Mark Craig (OIW WID #C34), an OIW Machinist and an AG Machinist. The AG Machinist explained that he had previously arrived at approximately 0600 to apply heat to the Fuse 120A-3, utilizing 2 propane heaters, prior to the penetrant testing to be performed by QC Inspector Salazar. QC Inspector Salazar explained to the QA Inspectors that he had previously arrived at AG at approximately 0800, to verify surface temperature of the Fuse, prior to the penetrant testing. QC Inspector Salazar also explained that WID #C34 had performed 2 spot weld repairs to the overlay, utilizing the Gas Tungsten Arc Welding (GTAW) process. QC Inspector Salazar explained that Mr. Craig was currently qualified to perform these repairs and had performed the GTAW per welding procedure specification (WPS 8022). QC Inspector Salazar explained that prior to welding, pre-heat was applied, utilizing a torch and then a temperature of approximately 150 degrees Fahrenheit, was verified. The QA Inspector noted that 125 degrees Fahrenheit minimum was required, per WPS 8022. QC Inspector Salazar explained that the AG Machinist had rotated the Fuse, to access the weld repair areas in the flat position. QC Inspector Salazar explained that he had recorded the in-process welding parameters of 121 amps and 16.5 volts. The QC Inspector then explained that after completion of these weld repair areas, the OIW Machinist then performed the grinding with a buffer wheel on the completed weld repair to "flush" with the finished overlay surface. QC Inspector Salazar explained to the QA Inspectors that the final PT testing is being performed, utilizing OIW's procedure QC-114, sect. 8.0, Water Washable Visible Die Penetrant. QC Inspector Salazar explained that he had previously cleaned the entire Fuse 120A-3 with acetone, to remove all surface irregularities, which would otherwise mask the indications of unacceptable indications. The QA Inspectors then witnessed Mr. Salazar

performing pre-heat checks, utilizing a digital thermometer and noted that the surface temperature was approximately 74 degrees Fahrenheit (23 C). QA Inspectors witnessed Mr. Salazar then applying DP50 penetrant, utilizing a hand pump sprayer, to approximately one-half of the entire surface finish. QA Inspectors noted that the penetrant was applied evenly and Mr. Salazar explained that the DP 50 will sit for approximately 25-30 minutes (dwell time). QA Inspectors then verified the dwell time to be approximately 25 minutes and noted that Mr. Salazar had started to wipe the penetrant off with lint free rags. The QA Inspectors then witnessed Mr. Salazar applying water, with a hand sprayer, to remove the excess DP50. QA Inspectors then witness Mr. Salazar applying D-100 spray can type developer, over the entire one-half surface, in a thin uniform coating. QA Inspectors noted that during the application of the D-100, that no relevant indications were present at the time. After approximately 20 minutes dwell time, QA Inspectors witnessed Mr. Salazar performing visual testing on the tested area. Mr. Salazar then explained to QA Inspectors that no relevant indications were present and was acceptable. QA Inspectors then witnessed Mr. Salazar cleaning off the applied developer with a water hose. The QA Inspector noted that Mr. Salazar performed the final PT testing, on the remaining one-half surface, in the same manner as mentioned above. The QA Inspector noted that QC Inspector Salazar had found one relevant indication during the Final PT on the overlay. QC Inspector Salazar explained that this indication will require a excavation and a weld repair. The QA Inspector then witnessed the OIW Machinist begin excavating on the indication with a mechanical grinder. The QA Inspector noted that after the excavation, QC Inspector performed 100 % PT on the excavated area, in the same manner as mentioned above. QC Inspector Salazar explained that no rejectable indications were found. The QA Inspector then measured the excavation to be approximately 60 mm L x 1 mm W x 2 MM D. QC Inspector Salazar explained that he and WID # C34 were then instructed to arrive at AG in the morning, to perform the GTAW and final PT on the area. The QA Inspector noted that Mr. Salazar appeared to be in compliance with AWS D1.5 visual acceptance criteria and QC-114. See attached pictures below.
