**DEPARTMENT OF TRANSPORTATION**

Contract #: 04-0120F4Cty: SF/ALA Rte: 80 PM: 13.2/13.9File #: 13.28**WELDING INSPECTION REPORT****Resident Engineer:** Pursell, Gary**Address:** 333 Burma Road**City:** Oakland, CA 94607**Report No:** WIR-012454**Date Inspected:** 03-Mar-2010**Project Name:** SAS Superstructure**OSM Arrival Time:** 1000**Prime Contractor:** American Bridge/Fluor Enterprises, a JV**OSM Departure Time:** 1830**Contractor:** Oregon Iron Works Clackamas, Or.**Location:** Clackamas, OR**CWI Name:** M. Gregson, J. Salazar**CWI Present:** Yes No**Inspected CWI report:** Yes No N/A**Rod Oven in Use:** Yes No N/A**Electrode to specification:** Yes No N/A**Weld Procedures Followed:** Yes No N/A**Qualified Welders:** Yes No N/A**Verified Joint Fit-up:** Yes No N/A**Approved Drawings:** Yes No N/A**Approved WPS:** Yes No N/A**Delayed / Cancelled:** Yes No N/A**Bridge No:** 34-0006**Component:** Hinge K Pipe Beams**Summary of Items Observed:**

## WELDING INSPECTION REPORT

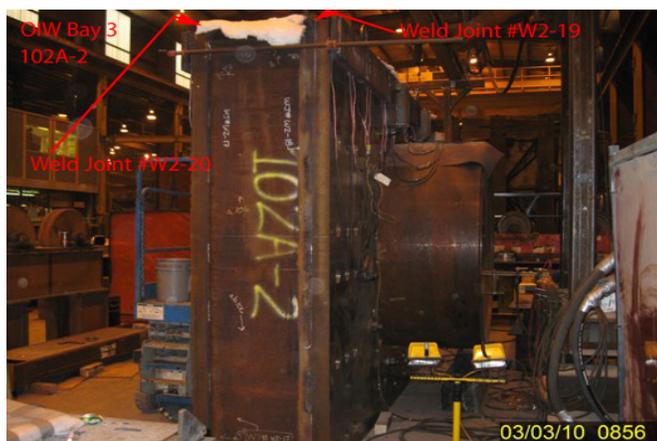
The QA Inspector witnessed WID #B62 (Marcus Belgarde), performing the submerged arc welding (SAW) on the a109 Post Tension Cap plate to a106 HPS 485W stiffener. The QA Inspector noted that this weld joint was designated as a partial joint penetration (AWS D1.5 TC-P4-S), weld joint (WJ) #W2-19 and WID #B62 was performing the SAW in the flat (1G) position. The QA Inspector noted that the SAW cover passes were currently in-process and noted that the OIW approved welding procedure specification (WPS 4020), was being utilized. The QA Inspector noted that QC Inspector Jose Salazar, was present and QC Inspector Salazar explained that the in-process welding parameters/pre-heat temperatures, were intermittently verified. QC Inspector Salazar explained that the average welding parameters for these SAW cover passes, were recorded at 600 amps/34.9 volts, with a pre-heat of approximately 350 degrees Fahrenheit (177 C). The QA Inspector randomly verified pre-heat of approximately 350 degrees Fahrenheit (177 C) and welding parameters to be in compliance with the applicable WPS 4020. The QA Inspector noted that there were approximately 2 cover passes left to complete this WJ #W2-19. The QA Inspector was later informed by QC Inspector Salazar that the weld joint #W2-19 was complete and that WID #B62 was in-process of performing the SAW root passes, on weld joint #W2-20. QC Inspector Salazar explained that he was present during the SAW and the welding parameters and pre-heat temperatures were

intermittently monitored. QC Inspector Salazar explained that the average welding parameters for the SAW root pass, were recorded at 470 amps/32 volts, with a pre-heat of approximately 350 degrees Fahrenheit (177 C). The QA Inspector noted that this WJ #W2-20 was designated, per the contract drawings, as piece mark a110-2 /a106 and the SAW appeared to be in compliance with AWS D1.5 and the applicable WPS. See attached picture below.

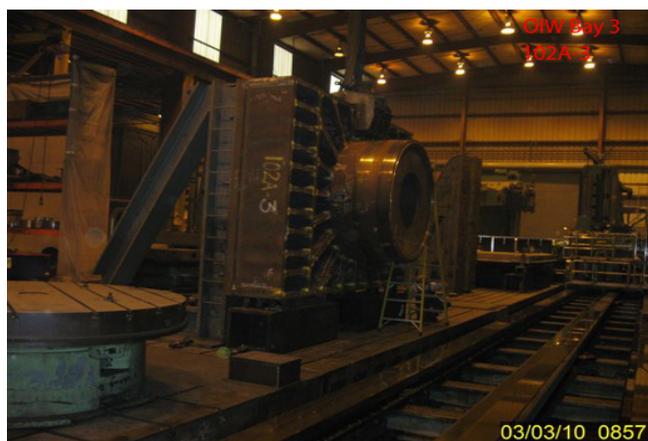
The QA Inspector noted that OIW production personell had previously removed this assembly 120A-3 from the welding fixture and had placed the assembly in the machining fixture. The QA Inspector noted that OIW had placed the assembly in preparation for machining the completed HPS 485 W, mill-to-bear stiffeners. The QA Inspector noted that OIW did not start machining on the stiffeners, on this date. See attached picture below.

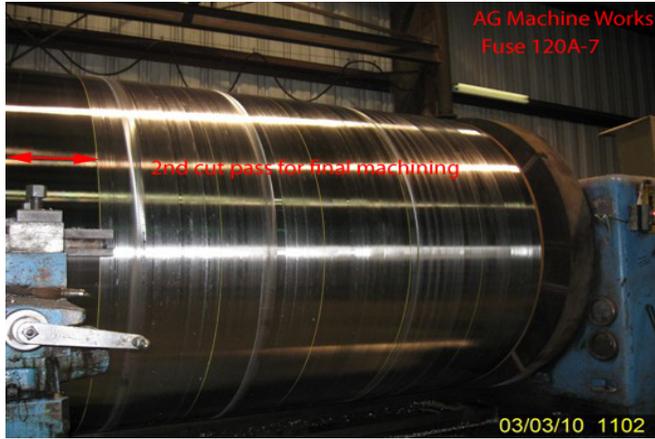
On this date, the QA Inspector arrived at AG Machine Works to witness the final machining on the Fuse 120A-7. The QA Inspector met with the AG Machinist and AG explained that the second cut pass was currently in-process and was approximately 25% complete. AG explained that approximately 15 visual indications were present in the machined overlay surface that will require weld repairs. AG Explained that due to the depth of the indications, up to 3mm, the indications will not completely machine out and the repairs will be needed. AG explained that OIW will be arriving on 3/4/10 to assess the repairs and possibly perform these on 3/5/10. See attached picture below.
