**DEPARTMENT OF TRANSPORTATION**

Contract #: 04-0120F4Cty: SF/ALA Rte: 80 PM: 13.2/13.9File #: 1.28**WELDING INSPECTION REPORT****Resident Engineer:** Pursell, Gary**Address:** 333 Burma Road**City:** Oakland, CA 94607**Report No:** WIR-012480**Date Inspected:** 06-Mar-2010**Project Name:** SAS Superstructure**OSM Arrival Time:** 630**Prime Contractor:** American Bridge/Fluor Enterprises, a JV**OSM Departure Time:** 1500**Contractor:** American Bridge/Fluor Enterprises, a JV**Location:** Job Site

# WELDING INSPECTION REPORT

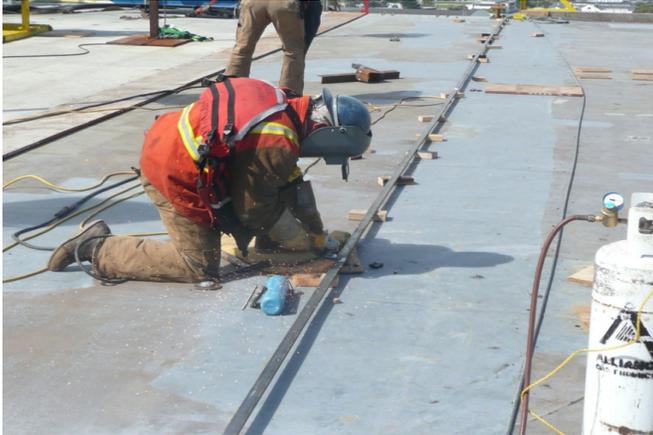
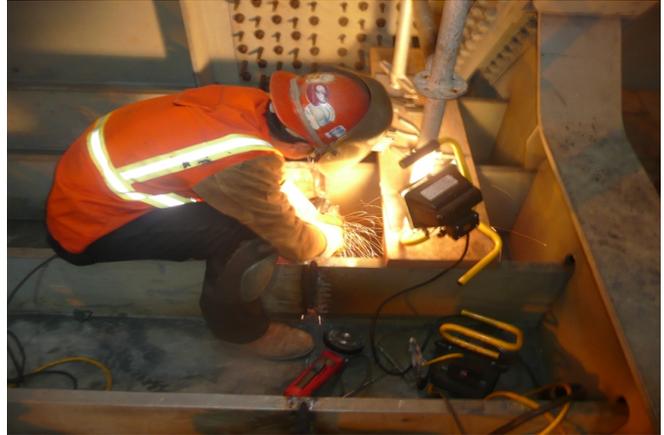
Inspector randomly observed the ABF welders install weld tabs to either side of the joints to perform the CJP groove welds. The QA Inspector randomly observed the ABF welders complete 4 of the 4 steel backing bar splices from the front side of the joint. The QA Inspector randomly observed the ABF welders back gouge the 4 splices with a grinding disc. After the CJP groove welds had been back gouged to bright metal, the SE QC Inspector Bnifacio Daquinag performed magnetic particle testing (MT). The QA Inspector randomly observed no relevant indications were located at the time of the testing.
