Contract #: 04-0120F4Cty: SF/ALA Rte: 80 PM: 13.2/13.9File #: 13.28**WELDING INSPECTION REPORT****Resident Engineer:** Pursell, Gary**Address:** 333 Burma Road**City:** Oakland, CA 94607**Report No:** WIR-012481**Date Inspected:** 04-Mar-2010**Project Name:** SAS Superstructure**OSM Arrival Time:** 1000**Prime Contractor:** American Bridge/Fluor Enterprises, a JV**OSM Departure Time:** 1830**Contractor:** Oregon Iron Works Clackamas, Or.**Location:** Clackamas, OR

Summary of Items Observed:

Hinge-K Pipe Beam Assembly 102A-2:

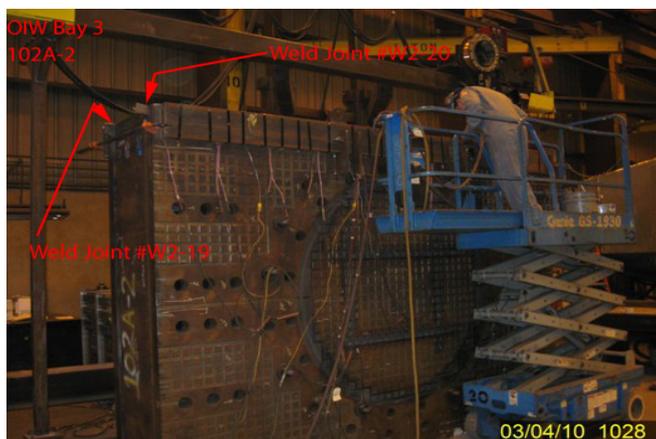
The QA Inspector witnessed WID #B62 (Marcus Belgarde), performing the submerged arc welding (SAW) on the a110-2 Base plate to a106 HPS 485W stiffener. The QA Inspector noted that this weld joint was designated as a partial joint penetration (AWS D1.5 TC-P4-S), weld joint (WJ) #W2-20 and WID #B62 was performing the SAW in the flat (1G) position. The QA Inspector noted that the SAW root passes were currently in-process and noted that the OIW approved welding procedure specification (WPS 4020), was being utilized. The QA Inspector noted that QC Inspector Jose Salazar, was present and QC Inspector Salazar explained that the in-process welding parameters/pre-heat temperatures, were intermittently verified. QC Inspector Salazar explained that the average welding parameters for these SAW root passes, were recorded at 470 amps/32 volts, with a pre-heat of approximately 350 degrees Fahrenheit (177 C) and travel speed of 18 inches per minute (i.p.m). The QA Inspector randomly verified pre-heat of approximately 350 degrees Fahrenheit (177 C) and welding parameters to be in compliance with the applicable WPS 4020. The QA Inspector was later informed by QC Inspector Salazar that the weld joint #W2-20 root pass was complete. QC Inspector Salazar then explained that the root pass had cooled to ambient temperature and he then performed 100% visual (VT) and magnetic particle testing (MT). QC Inspector Salazar explained that no rejectable indications, per AWS D1.5 and OIW MT procedure QC-113, Rev. #3. The

QA Inspector noted that the SAW and VT/MT Inspection appeared to be in compliance with AWS D1.5, the applicable WPS and OIW approved procedures. See attached picture below.

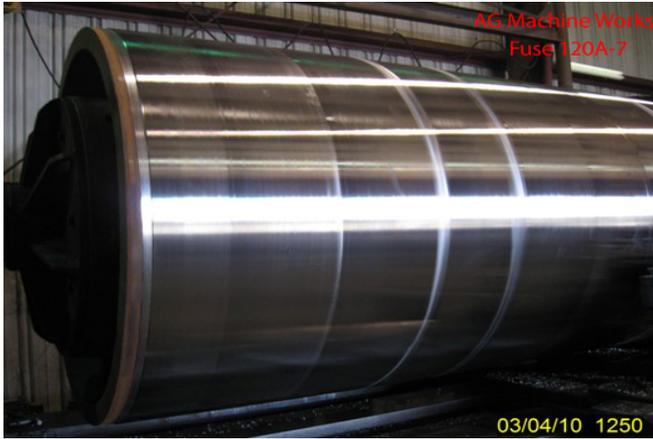
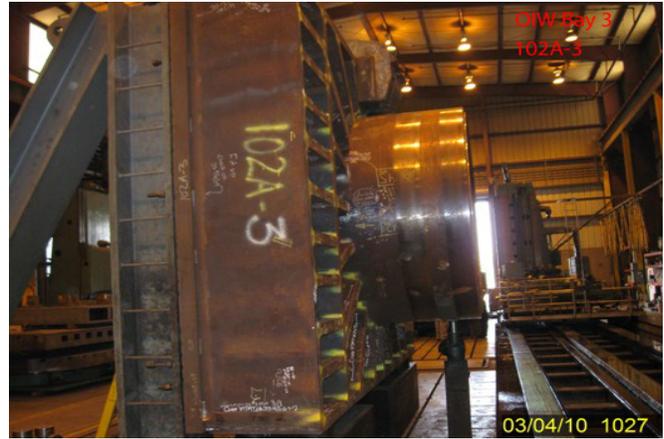
On this date, the QA Inspector arrived at AG Machine Works, to witness the final machining on the Fuse 120A-7. The QA Inspector met with the AG machinist and the machinist explained that the second cut pass was currently in-process and was approximately 90% complete. The machinist explained that approximately 50 + visual indications were now present in the machined overlay surface, that will require weld repairs. The machinist explained that due to the depths, up to 3mm and lengths up to 145 mm, the indications will not completely machine out and the repairs will be needed. The machinist then explained that OIW will probably be arriving on 3/5/10, to perform the weld repairs and explained that once the repairs are complete, no blending will be required, as one more additional cut pass will be required of approximately .5 mm deep and then the finish honing will start. See attached picture below.
