**DEPARTMENT OF TRANSPORTATION**

Contract #: 04-0120F4Cty: SF/ALA Rte: 80 PM: 13.2/13.9File #: 13.28**WELDING INSPECTION REPORT****Resident Engineer:** Pursell, Gary**Address:** 333 Burma Road**City:** Oakland, CA 94607**Report No:** WIR-012483**Date Inspected:** 08-Mar-2010**Project Name:** SAS Superstructure**OSM Arrival Time:** 900**Prime Contractor:** American Bridge/Fluor Enterprises, a JV**OSM Departure Time:** 1730**Contractor:** Oregon Iron Works Clackamas, Or.**Location:** Clackamas, OR**CWI Name:** M. Gregson, J. Salazar**CWI Present:** Yes No**Inspected CWI report:** Yes No N/A**Rod Oven in Use:** Yes No N/A**Electrode to specification:** Yes No N/A**Weld Procedures Followed:** Yes No N/A**Qualified Welders:** Yes No N/A**Verified Joint Fit-up:** Yes No N/A**Approved Drawings:** Yes No N/A**Approved WPS:** Yes No N/A**Delayed / Cancelled:** Yes No N/A**Bridge No:** 34-0006**Component:** Hinge K Pipe Beams**Summary of Items Observed:**

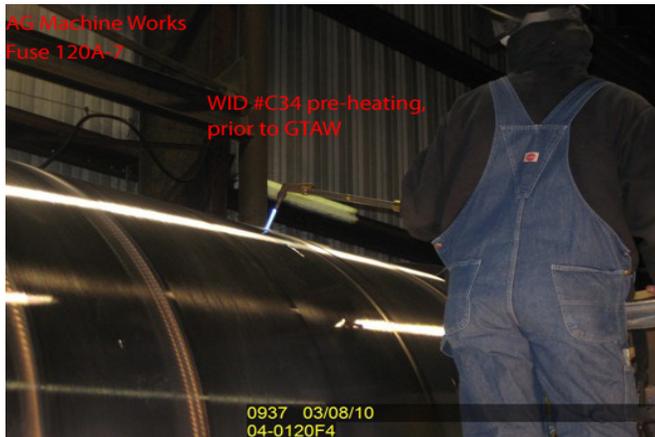
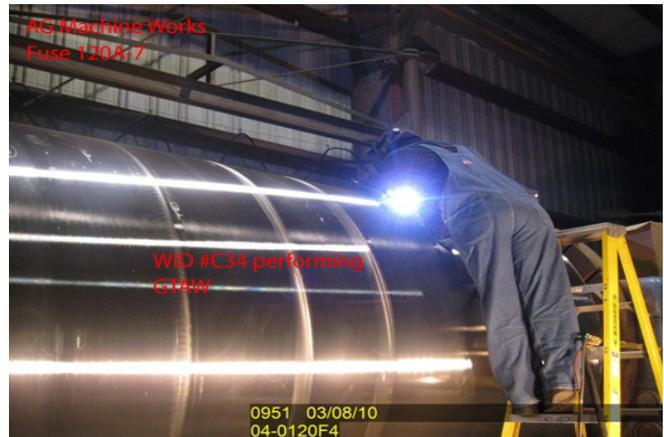
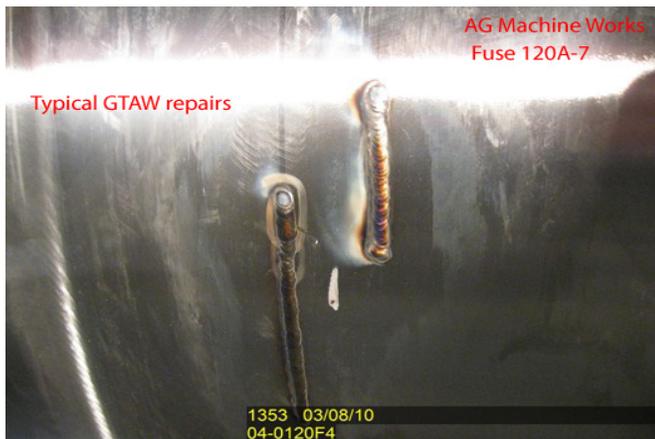
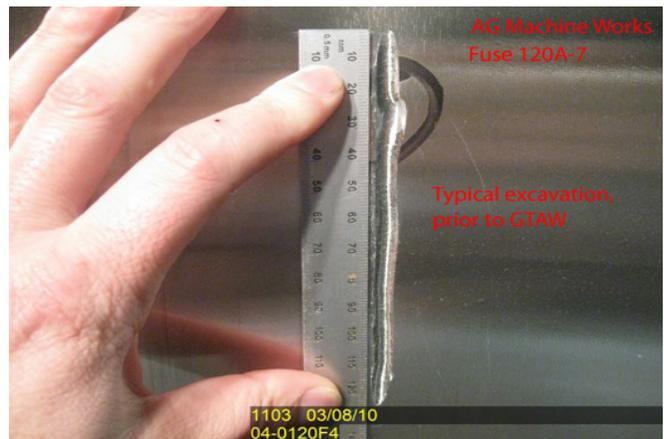
On this date, the QA Inspector arrived at AG Machine to observe OIW perform the weld repairs, on the previously discovered indications on the finished overlay surface, on this Fuse 120A-7. The QA Inspector met with OIW QC Inspector Jose Salazar, OIW welder (WID# C34) Mark Craig and an AG Machinist. QC Inspector Salazar explained to the QA Inspector that he had previously performed visual testing (VT) on 100% of the overlay and WID #C34 is continuing to perform the GTAW weld repairs. The QA Inspector noted that the indications, currently present in the overlay, appeared after AG completed the 2nd final cut pass, for final machining and appeared to be small clusters of slag inclusions.

The QA Inspector noted that Mr. Craig was currently qualified to perform these repairs and would be utilizing welding procedure specification (WPS 8022). The QA Inspector witnessed the AG Machinist rotating the fuse assembly to access the weld repair areas in the flat position. The QA Inspector then witnessed WID #C34, performing the pre-heat required, utilizing a torch and then observed a temperature of approximately 150 degrees Fahrenheit, after the pre-heat was complete. The QA Inspector noted that 125 degrees Fahrenheit minimum was required, per WPS 8022. The QA Inspector then observed Mr. Mark Craig performing the GTAW on the previously excavated repair areas. The QA Inspector also observed QC Inspector Jose Salazar recording the in-process welding parameters of 123 amps, 16 volts and travel speed of 4 inches per minute (i.p.m.). The QA

Inspector also verified these welding parameters. The QA Inspector then observed the AG Machinist rotating the Fuse, to access several more excavations, that would need to go through the above mentioned repair procedure. At approximately 1430, QC Inspector Salazar explained that the GTAW repairs were complete and the penetrant testing (PT) on the overlay, will be performed, after AG completes the final cutting pass and finish honing. QC Inspector Salazar explained that the PT testing will either be a preliminary inspection or possibly a final, depending upon the number of surface discrepancies and indications, which are discovered and GTAW repaired, after AG completes the final machining and finish honing. On this date, the QA Inspector observed that Mr. Salazar was present the entire time in which the GTAW welding was being performed. The QA Inspector was then informed by the AG Machinist that the final cut pass will be started on 3/9/10 and finish honing will then start, after this cut pass is complete. See attached pictures below.
