DEPARTMENT OF TRANSPORTATION

Quality Assurance and Source Inspection

Contract #: 04-0120F4Cty: SF/ALA Rte: 80 PM: 13.2/13.9File #: 1.28**WELDING INSPECTION REPORT****Resident Engineer:** Pursell, Gary**Address:** 333 Burma Road**City:** Oakland, CA 94607**Report No:** WIR-012487**Date Inspected:** 10-Mar-2010**Project Name:** SAS Superstructure**OSM Arrival Time:** 1200**Prime Contractor:** American Bridge/Fluor Enterprises, a JV**OSM Departure Time:** 2030**Contractor:** American Bridge/Fluor Enterprises, a JV**Location:** Job Site**CWI Name:** See below for names.**CWI Present:** Yes No**Inspected CWI report:** Yes No N/A**Rod Oven in Use:** Yes No N/A**Electrode to specification:** Yes No N/A**Weld Procedures Followed:** Yes No N/A**Qualified Welders:** Yes No N/A**Verified Joint Fit-up:** Yes No N/A**Approved Drawings:** Yes No N/A**Approved WPS:** Yes No N/A**Delayed / Cancelled:** Yes No N/A**Bridge No:** 34-0006**Component:** Orthotropic Box Girders (OBG)**Summary of Items Observed:**

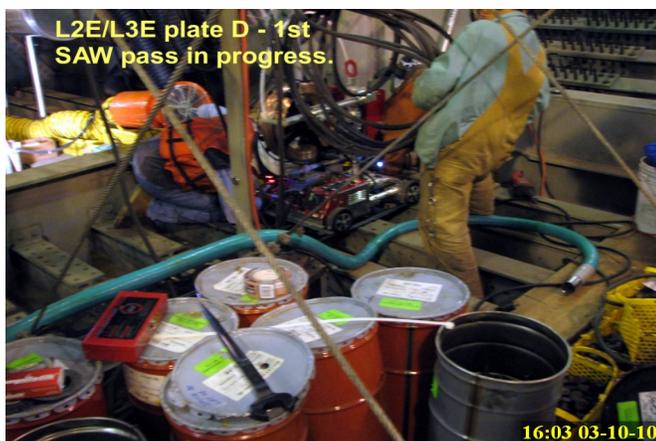
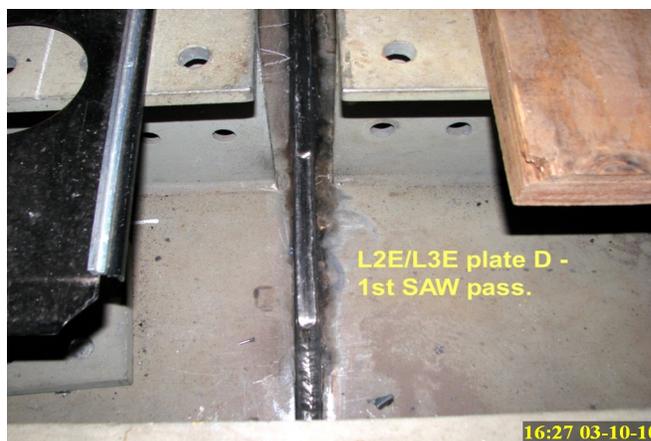
2) The QAI arrived at the L2E/L3E plate D field splice and noted that ABF personnel are preparing to make submerged arc welds (SAW). The QAI noted that the QC Inspectors Bonifacio Daquinag Jr. and James Cunningham are monitoring the work / welding at this location. The QAI was informed that gas shielded flux cored arc welding (FCAW-G) welds have been finished, tying in the backing bar to the OBG plate bevels. The QAI made random observations of the FCAW-G welds and noted that they appeared to be visually conforming to the contract requirements at this time. As the SAW equipment was positioned and set up, the QAI was informed that the first weld pass can not be made the full length of the joint due to stiffener plate connections. The QAI noted that the weld will be made from approximately 780mm to 6800mm. The QAI was informed that the SAW

will be performed to ABF-WPS-D15-4042B-1 requirements. The QAI made random observations of the welding parameters and preheat temperatures of the 1st weld pass and noted that they appeared to be within the WPS and contract requirements. The QAI noted that after the 1st weld pass, cleaning and grinding the weld was in progress and no additional welding was performed during this shift. See the attached photos.
