DEPARTMENT OF TRANSPORTATION

Contract #: 04-0120F4Cty: SF/ALA Rte: 80 PM: 13.2/13.9File #: 69.28**WELDING INSPECTION REPORT****Resident Engineer:** Pursell, Gary**Address:** 333 Burma Road**City:** Oakland, CA 94607**Report No:** WIR-012532**Date Inspected:** 16-Feb-2010**Project Name:** SAS Superstructure**OSM Arrival Time:** 700**Prime Contractor:** American Bridge/Fluor Enterprises, a JV**OSM Departure Time:** 1900**Contractor:** Zhenhua Port Machinery Company, Ltd (ZPMC), Changxing Island **Location:** Shanghai, China**CWI Name:** Mr. You Qi Guo**CWI Present:** Yes No**Inspected CWI report:** Yes No N/A**Rod Oven in Use:** Yes No N/A**Electrode to specification:** Yes No N/A**Weld Procedures Followed:** Yes No N/A**Qualified Welders:** Yes No N/A**Verified Joint Fit-up:** Yes No N/A**Approved Drawings:** Yes No N/A**Approved WPS:** Yes No N/A**Delayed / Cancelled:** Yes No N/A**Bridge No:** 34-0006**Component:** Tower**Summary of Items Observed:**

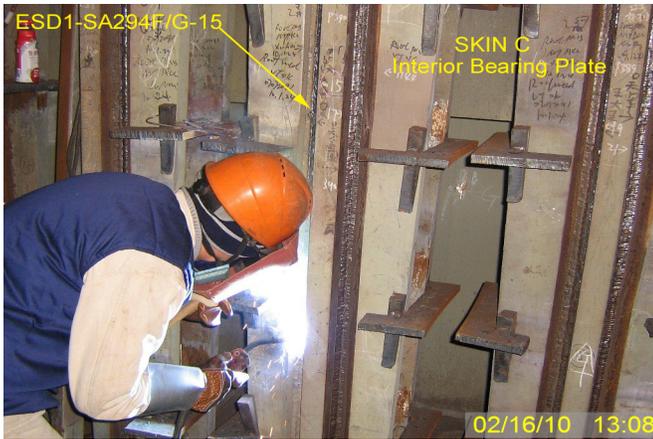
FCAW welding of weld joint no: ESD1-SA294F/G-15 located on Skin C Interior Bearing Plate. Welder is identified as 040736. ZPMC CWI is identified as Mr. You Qi Guo. The welding variables recorded by QC appeared to comply with the WPS-B-T-2333-TC-P4-F. Please see the attached picture below.

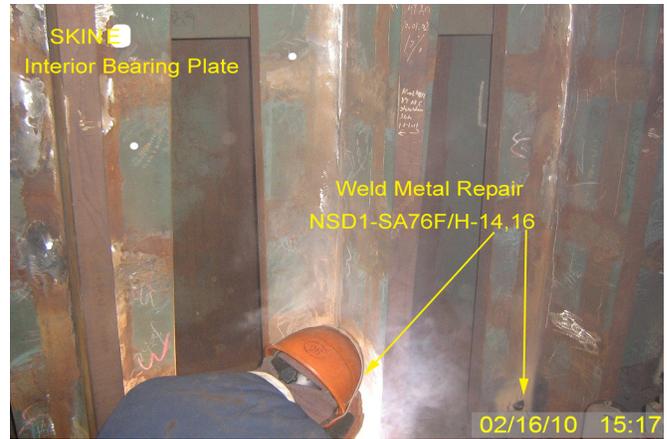
ZPMC performed Weld metal repair of Interior Bearing Plate located on Skin E (NSD1-SA76F/H-12, 14, 16). The weld metal repair areas were approximately 2mm depth and 50mm length at 2 random locations. The material is A709M Grade 345 Non-SPCM. Welder is identified as 040270.ZPMC CWI is identified as Mr. You Qi Guo. SMAW welding was been performed. The welding variables recorded by QC appeared to comply with the WPS-345-SMAW-3G (3F)-Repair. Please see the attached picture below.
