**DEPARTMENT OF TRANSPORTATION**

Contract #: 04-0120F4Cty: SF/ALA Rte: 80 PM: 13.2/13.9File #: 69.28**WELDING INSPECTION REPORT****Resident Engineer:** Pursell, Gary**Address:** 333 Burma Road**City:** Oakland, CA 94607**Report No:** WIR-012596**Date Inspected:** 06-Mar-2010**Project Name:** SAS Superstructure**OSM Arrival Time:** 1900**Prime Contractor:** American Bridge/Fluor Enterprises, a JV**OSM Departure Time:** 700**Contractor:** Zhenhua Port Machinery Company, Ltd (ZPMC), Changxing Island **Location:** Shanghai, China**CWI Name:** See Below**CWI Present:** Yes No**Inspected CWI report:** Yes No N/A**Rod Oven in Use:** Yes No N/A**Electrode to specification:** Yes No N/A**Weld Procedures Followed:** Yes No N/A**Qualified Welders:** Yes No N/A**Verified Joint Fit-up:** Yes No N/A**Approved Drawings:** Yes No N/A**Approved WPS:** Yes No N/A**Delayed / Cancelled:** Yes No N/A**Bridge No:** 34-0006**Component:** OBG**Summary of Items Observed:**

## WELDING INSPECTION REPORT

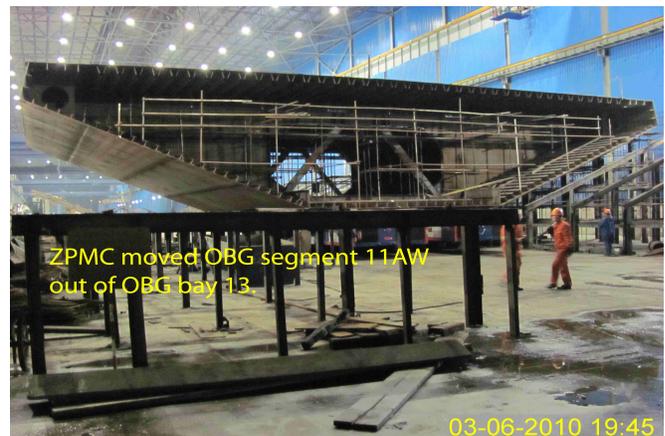
Around 1945 hours ZPMC utilized two synchronized heavy haulers to move OBG Lift 11AW from the middle of OBG Bay 13, where it had been assembled, to the front of OBG Bays 13 / 14 where it was placed on metal stands. The move appeared to progress smoothly. See the photographs below for additional information.
