DEPARTMENT OF TRANSPORTATION

Contract #: 04-0120F4Cty: SF/ALA Rte: 80 PM: 13.2/13.9File #: 69.28**WELDING INSPECTION REPORT****Resident Engineer:** Pursell, Gary**Address:** 333 Burma Road**City:** Oakland, CA 94607**Report No:** WIR-012598**Date Inspected:** 09-Mar-2010**Project Name:** SAS Superstructure**OSM Arrival Time:** 1900**Prime Contractor:** American Bridge/Fluor Enterprises, a JV**OSM Departure Time:** 700**Contractor:** Zhenhua Port Machinery Company, Ltd (ZPMC), Changxing Island **Location:** Shanghai, China**CWI Name:** See Below**CWI Present:** Yes No**Inspected CWI report:** Yes No N/A**Rod Oven in Use:** Yes No N/A**Electrode to specification:** Yes No N/A**Weld Procedures Followed:** Yes No N/A**Qualified Welders:** Yes No N/A**Verified Joint Fit-up:** Yes No N/A**Approved Drawings:** Yes No N/A**Approved WPS:** Yes No N/A**Delayed / Cancelled:** Yes No N/A**Bridge No:** 34-0006**Component:** OBG and Tower**Summary of Items Observed:**

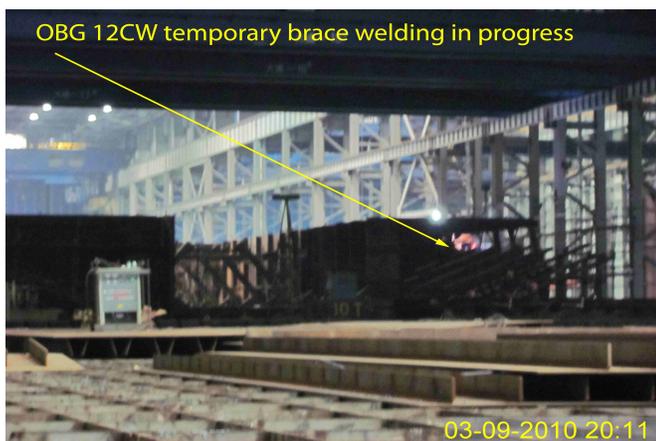
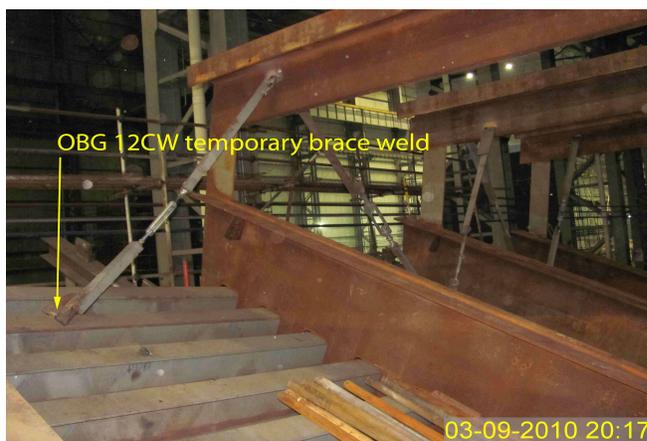
As this QA Inspector walked toward the back of OBG Bay 14 ZPMC welder Mr. Jiang Shi Zhen, stencil 048694 appeared to be using the shielded metal arc welding process to tack weld various floor beams temporary stiffeners to counterweight side plates near panel point 115 in OBG segment 12CW. This QA Inspector observed many of the overhead lights where this welding was being performed were turned off and no ZPMC QC Inspectors appeared to be working in OBG Bay 14. This QA Inspector attempted to ask Mr. Jiang Shi Zhen and the other workers if any QC Inspectors were monitoring this welding and none of the workers appeared to speak the English language. Mr. Jiang Shi Zhen appeared as if he was completed welding. This QA Inspector observed Mr. Jiang

Shi Zhen appears to be certified to make these welds. About 20 minutes later as this QA Inspector walked through the back of OBG Bay 14, this QA Inspector observed ZPMC welder Mr. Jiang Shi Zhen performing welding near the same location as listed above. This QA Inspector again asked Mr. Jiang Shi Zhen and the other welders if ZPMC QC Inspectors were monitoring this welding and Mr. Jiang Shi Zhen rolled up his welding lead and appeared to be removing his welding equipment from this location. Items observed on this date do not fully appear to comply with applicable contract documents. See the photographs below for additional information.
