Contract #: 04-0120F4Cty: SF/ALA Rte: 80 PM: 13.2/13.9File #: 13.28**WELDING INSPECTION REPORT****Resident Engineer:** Pursell, Gary**Address:** 333 Burma Road**City:** Oakland, CA 94607**Report No:** WIR-012640**Date Inspected:** 10-Mar-2010**Project Name:** SAS Superstructure**OSM Arrival Time:** 1000**Prime Contractor:** American Bridge/Fluor Enterprises, a JV**OSM Departure Time:** 1830**Contractor:** Oregon Iron Works Clackamas, Or.**Location:** Clackamas, OR**CWI Name:** M. Gregson, J. Salazar**CWI Present:** Yes No**Inspected CWI report:** Yes No N/A**Rod Oven in Use:** Yes No N/A**Electrode to specification:** Yes No N/A**Weld Procedures Followed:** Yes No N/A**Qualified Welders:** Yes No N/A**Verified Joint Fit-up:** Yes No N/A**Approved Drawings:** Yes No N/A**Approved WPS:** Yes No N/A**Delayed / Cancelled:** Yes No N/A**Bridge No:** 34-0006**Component:** Hinge K Pipe Beams**Summary of Items Observed:**

Hinge-K Pipe Beam Assembly 102A-2:

Hinge-K Pipe Beam Assembly 101A-1:

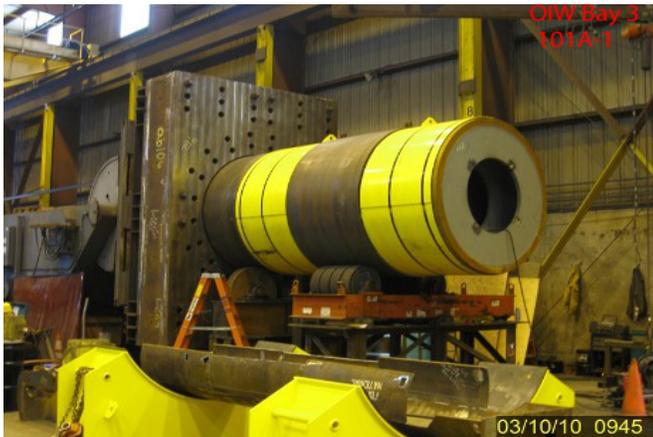
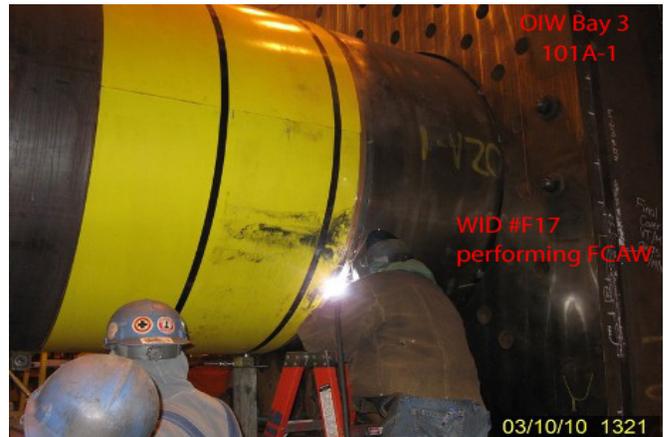
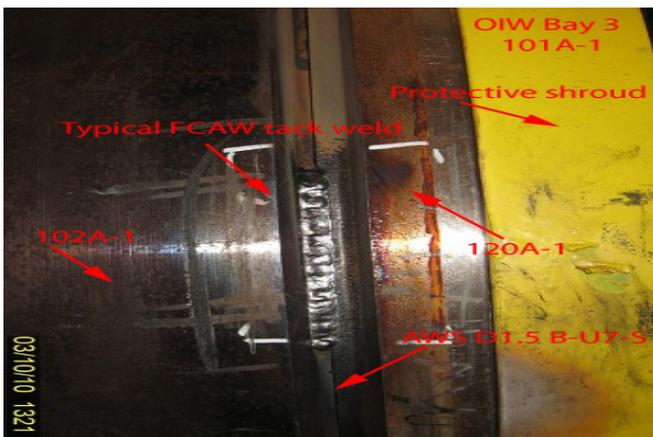
The QA Inspector witnessed WID #F17 (Igor Frolov), performing Flux Core Arc Welding (FCAW) on the Complete Joint Penetration (CJP), designated as an AWS D1.5 B-U7-S, in the vertical (3G) position. The QA Inspector noted that WID #F17 was currently performing the FCAW tack welding on the previously fit-up 120A-1 Fuse to 102A-1 Forging assembly. The QA Inspector noted that QC Inspector Mike Gregson was present during the tack welding, to monitor in process parameters (amps/volts) and pre-heat temperatures. QC Inspector Gregson explained to the QA Inspector that average parameters were previously recorded at 220 amps/23 volts, 400 degrees Fahrenheit preheat and a travel speed of 6-8 inches per minute (i.p.m.). QC Inspector explained that welding procedure specification (WPS 3050) was being utilized for the tack welding. The QA Inspector randomly verified pre-heat of approximately 400 degrees Fahrenheit (204 C) and welding parameters to be in compliance with the applicable WPS 3050. QC Inspector Gregson later explained that he will verify the joint fit-up, after the tack welding is complete. See attached pictures below.
