**DEPARTMENT OF TRANSPORTATION**

Contract #: 04-0120F4Cty: SF/ALA Rte: 80 PM: 13.2/13.9File #: 13.28**WELDING INSPECTION REPORT****Resident Engineer:** Pursell, Gary**Address:** 333 Burma Road**City:** Oakland, CA 94607**Report No:** WIR-012662**Date Inspected:** 16-Mar-2010**Project Name:** SAS Superstructure**OSM Arrival Time:** 1000**Prime Contractor:** American Bridge/Fluor Enterprises, a JV**OSM Departure Time:** 1830**Contractor:** Oregon Iron Works Clackamas, Or.**Location:** Clackamas, OR**CWI Name:** M. Gregson, J. Salazar**CWI Present:** Yes No**Inspected CWI report:** Yes No N/A**Rod Oven in Use:** Yes No N/A**Electrode to specification:** Yes No N/A**Weld Procedures Followed:** Yes No N/A**Qualified Welders:** Yes No N/A**Verified Joint Fit-up:** Yes No N/A**Approved Drawings:** Yes No N/A**Approved WPS:** Yes No N/A**Delayed / Cancelled:** Yes No N/A**Bridge No:** 34-0006**Component:** Hinge K Pipe Beams**Summary of Items Observed:**

**Hinge-K Pipe Beam Assembly 102A-2:**

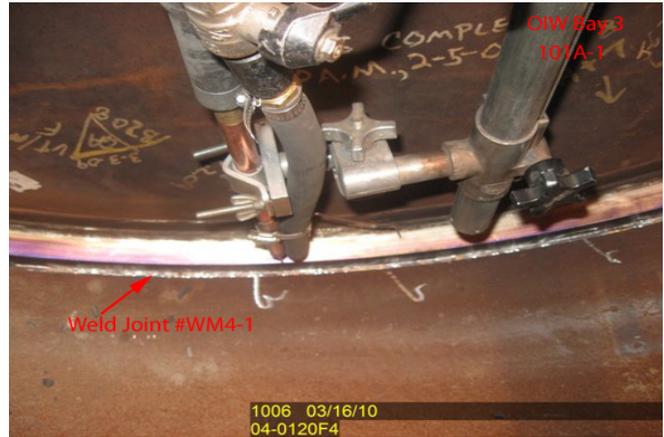
The QA Inspector witnessed WID #S53 (Jerry Shepherd), performing Submerged Arc Welding (SAW) on the Complete Joint Penetration (CJP), Fuse 120A-1 to Forging 102A-1, in the flat (1G) position. The QA Inspector noted that the SAW fill passes, on this weld joint #WM4-1, were currently in-process and noted that the OIW approved welding procedure specification (WPS 4016), was being utilized. The QA Inspector noted that the SAW was being performed on the interior portion of the weld joint and that OIW production lead, Troy Smith was present at the time of the welding. Lead Troy Smith explained to the QA Inspector that the SAW on the interior portion of the CJP will be completed first and that once complete, the backgouge of the root passes will then be performed from the exterior of the weld joint. Lead Troy Smith then explained that OIW had previously set-up a continuous water flow cooling system, utilizing 2 carbon steel welded boxes, with an inlet and outlet water flow through the boxes. Troy Smith explained that this system was previously attached next to the stainless steel overlay, to protect it during the pre-heating and welding of the CJP. The QA Inspector noted that OIW had previously set-up two torches on the exterior of the weld joint and had started the pre-heat, earlier in the shift. The QA Inspector noted that QC Inspector Mike Gregson, was currently present and QC Inspector Gregson explained that the in-process welding parameters/pre-heat temperatures, were intermittently verified. QC Inspector Gregson explained that the average welding parameters for this SAW fill pass, was recorded at 570 amps/34 volts, with a pre-heat of approximately 350 degrees Fahrenheit (177 C) and travel speed of 20 inches per minute (i.p.m). QC Inspector Gregson explained that the pre-heat was verified on the interior side. The QA Inspector randomly verified pre-heat of approximately 350 degrees Fahrenheit (177 C) and welding parameters to be in compliance with the applicable WPS 4016. The QA Inspector noted that the SAW appeared to be in compliance with AWS D1.5 and the applicable WPS. See attached pictures below.

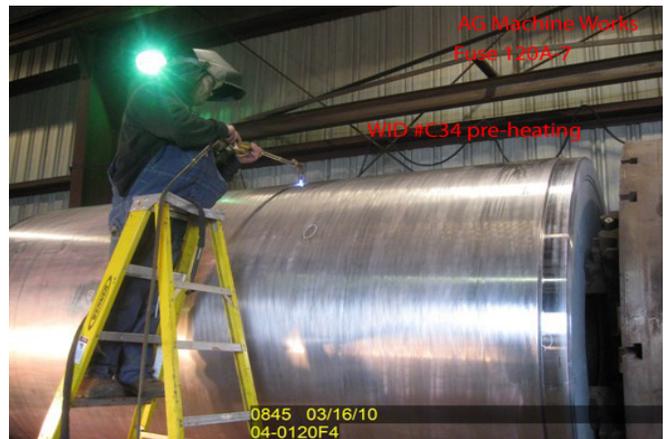
On this date, the QA Inspector arrived at AG Machine to observe OIW perform the weld repairs, on the finished overlay surface, on this Fuse 120A-7. The QA Inspector met with OIW QC Inspector Jose Salazar and OIW welder (WID# C34) Mark Craig. QC Inspector Salazar explained that WID #C34 is currently performing the Gas Tungsten Arc Welding (GTAW), on the previously excavated areas, on the finished overlay. QC Inspector Salazar explained that WID #C34 was currently qualified to perform these repairs and is utilizing welding procedure specification (WPS 8022). The QA Inspector then witnessed WID #C34 performing the pre-heat required, utilizing a torch and then observed a temperature of approximately 175 degrees Fahrenheit, after the pre-heat was complete. The QA Inspector noted that 125 degrees Fahrenheit minimum was required, per WPS 8022. The QA Inspector then witnessed the AG Machinist rotating the fuse assembly, in the horizontal lathe, to access the weld repair areas in the flat position. The QA Inspector then observed WID #C34 continue to perform the GTAW on the previously excavated repair areas. The QA Inspector also observed QC Inspector Jose Salazar recording the in-process welding parameters of 123 amps and 16 volts. The QA Inspector also verified these welding parameters. The QA Inspector was later notified by QC Inspector Salazar, that the GTAW was completed and the repaired areas still need to be smoothed flush with the overlay. QC Inspector Salazar explained that an OIW Machinist will arrive at AG to perform this task. See attached pictures below.
