**DEPARTMENT OF TRANSPORTATION**

Contract #: 04-0120F4Cty: SF/ALA Rte: 80 PM: 13.2/13.9File #: 69.28**WELDING INSPECTION REPORT****Resident Engineer:** Pursell, Gary**Address:** 333 Burma Road**City:** Oakland, CA 94607**Report No:** WIR-012692**Date Inspected:** 13-Mar-2010**Project Name:** SAS Superstructure**OSM Arrival Time:** 700**Prime Contractor:** American Bridge/Fluor Enterprises, a JV**OSM Departure Time:** 1900**Contractor:** Zhenhua Port Machinery Company, Ltd (ZPMC), Changxing Island **Location:** Shanghai, China**CWI Name:** Mr. Wuzhi Chang**CWI Present:** Yes No**Inspected CWI report:** Yes No N/A**Rod Oven in Use:** Yes No N/A**Electrode to specification:** Yes No N/A**Weld Procedures Followed:** Yes No N/A**Qualified Welders:** Yes No N/A**Verified Joint Fit-up:** Yes No N/A**Approved Drawings:** Yes No N/A**Approved WPS:** Yes No N/A**Delayed / Cancelled:** Yes No N/A**Bridge No:** 34-0006**Component:** Orthotropic Box Girder (OBG)**Summary of Items Observed:**

**OBG TRIAL ASSEMBLY**

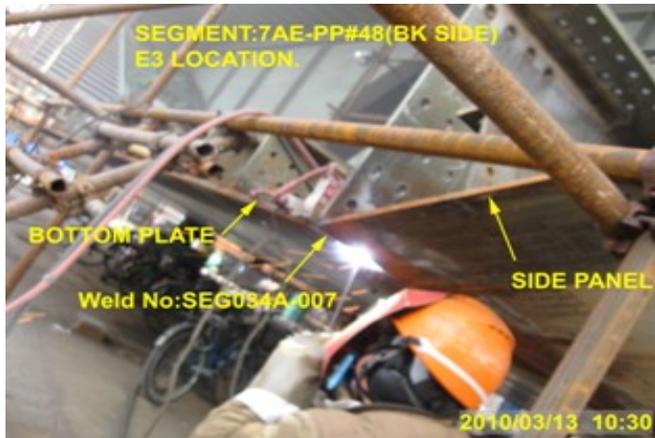
Shielded Metal Arc Welding (SMAW) welding of Repair weld joint SEG034A-007 (Corner split weld). Welder is identified as 048659. ZPMC Quality Control (QC) is identified as Mr. Wang Zhu. The welding variables recorded by QC appeared to comply with the Applicable WPS: WPS-345-SMAW-4G (4F) FCM-Repair-1. The repair welding was performed against the Caltrans Engineer Approved Critical Welding Repair Report (CWR) No: B-CWR 1211 and American Bridge/Fluor (AB/F) UT report # UT-7E-029 dated: 02/18/2010. The attached photographs provide additional detail.

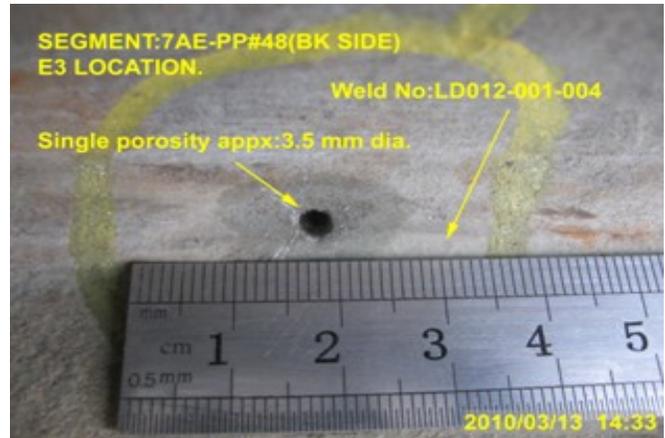
This QA Inspector observed ZPMC personnel's performing weld flush grinding for the splice joint welds at Segment 7AE-7BE Bottom panel and side panels.  
The attached photographs provide additional detail.

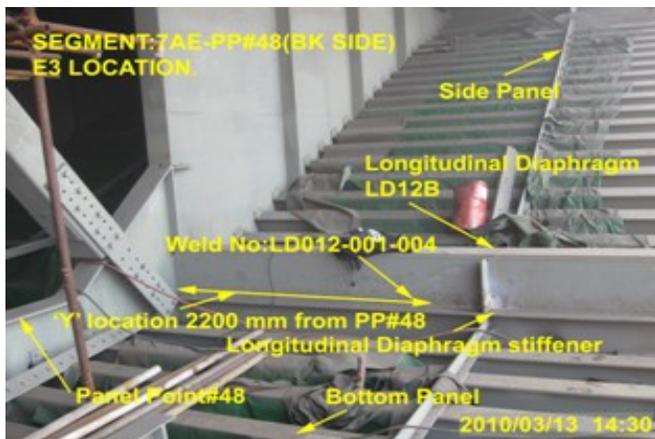
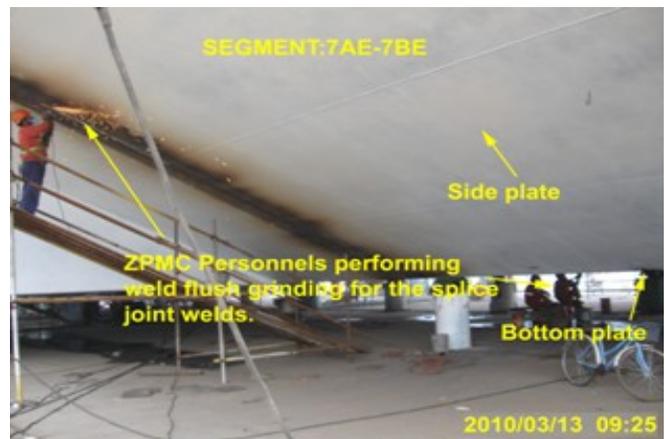
This QA Inspector performed random VT of Segment 7AE-Panel Point (PP) #48 (Bike Path side).  
During Quality Assurance VT review of welds located on Segment 7AE-Panel Point (PP) #48, this Quality Assurance Inspector (QA) discovered the following issue:

- One (1) Rounded indication (Single porosity) on weld measuring approximately 3.5 mm dia.
- The weld is identified as: LD012-001-004.
- The weld is a fillet weld joining Longitudinal Diaphragm to Longitudinal Diaphragm stiffener plate.
- SEGMENT: 7AE is located near the OBG TRIAL ASSEMBLY AREA.
- Y Location is approximately 2200 mm from the Panel Point #48.

AWS D1.5 2002 figure 6.8 – specifies for fillet weld sizes between 6mm and 13mm the maximum discontinuity length is approximately 2mm to 4mm.

This QA notified ZPMC QC identified as Mr.Wuzhi Chang and ABF inspector identified as Mr. Li Jing Bo of the above issue, and reported to the Team leader for further action.
