DEPARTMENT OF TRANSPORTATION

Contract #: 04-0120F4Cty: SF/ALA Rte: 80 PM: 13.2/13.9File #: 69.28**WELDING INSPECTION REPORT****Resident Engineer:** Pursell, Gary**Address:** 333 Burma Road**City:** Oakland, CA 94607**Report No:** WIR-012697**Date Inspected:** 14-Mar-2010**Project Name:** SAS Superstructure**OSM Arrival Time:** 700**Prime Contractor:** American Bridge/Fluor Enterprises, a JV**OSM Departure Time:** 1900**Contractor:** Zhenhua Port Machinery Company, Ltd (ZPMC), Changxing Island **Location:** Shanghai, China**CWI Name:** Li Yang, Wu Chi Cheng**CWI Present:** Yes No**Inspected CWI report:** Yes No N/A**Rod Oven in Use:** Yes No N/A**Electrode to specification:** Yes No N/A**Weld Procedures Followed:** Yes No N/A**Qualified Welders:** Yes No N/A**Verified Joint Fit-up:** Yes No N/A**Approved Drawings:** Yes No N/A**Approved WPS:** Yes No N/A**Delayed / Cancelled:** Yes No N/A**Bridge No:** 34-0006**Component:** Orthotropic Box Girder (OBG)**Summary of Items Observed:**

OBG # TRIAL ASSEMBLY YARD

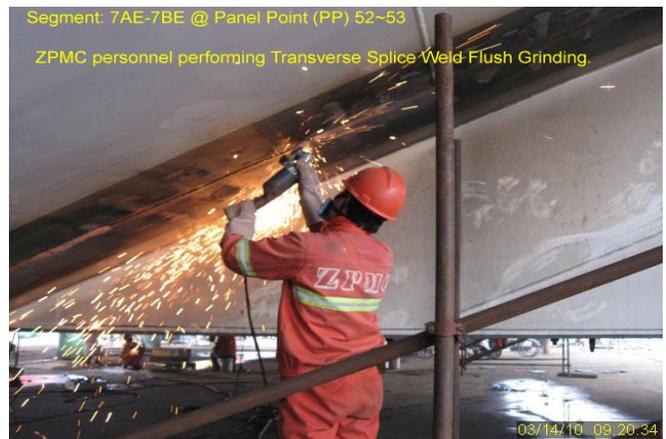
Segment# 7BE-7CE

This QA Inspector observed ZPMC personnel's performing at Segment 7BE and 7CE Panel point (PP) 52~53 Transverse Splice weld Flush Grinding is in progress. See the attached below photo.

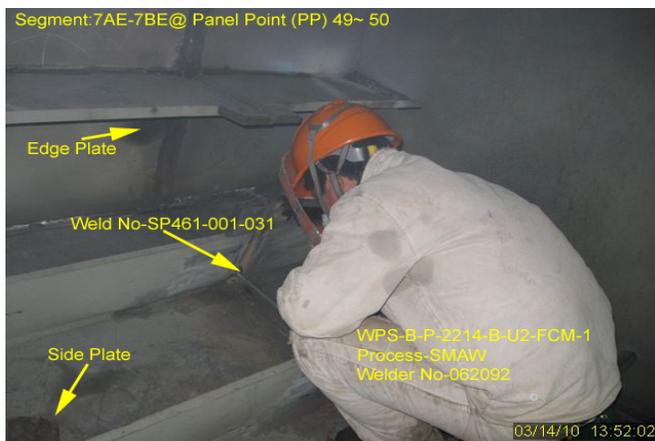
Segment# 7AE

During in process visual inspection of 7AE , This QA Inspector observed ABF personnel, identified as Mr. Lee, performing Ultrasonic Testing (UT) of the Weld connecting side panel to Bottom panel at E4 location for more comprehensive information refer the attached Photo.

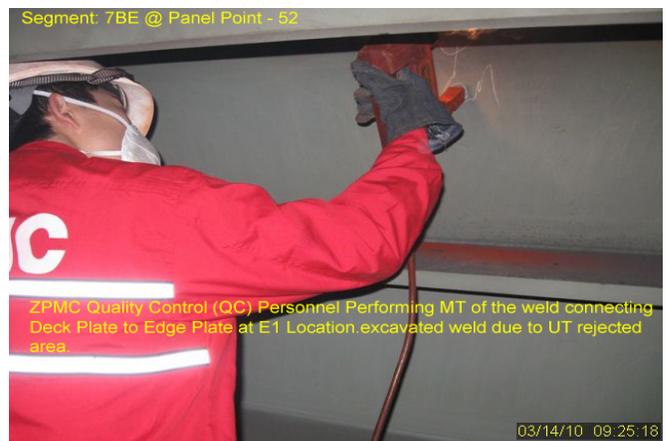
Segment# 7BE

During in process visual inspection of 7BE , This QA Inspector observed ZPMC Quality Control (QC) personnel performing Magnetic Particle testing (MT) ZPMC Technician identified as Mr. Zhang Xu, of the Weld connecting Deck Plate to Edge Plate at E1 location for UT rejected area for more comprehensive information refer the attached Photo.
