Contract #: 04-0120F4Cty: SF/ALA Rte: 80 PM: 13.2/13.9File #: 1.28**WELDING INSPECTION REPORT****Resident Engineer:** Pursell, Gary**Address:** 333 Burma Road**City:** Oakland, CA 94607**Report No:** WIR-012727**Date Inspected:** 18-Mar-2010**Project Name:** SAS Superstructure**OSM Arrival Time:** 1100**Prime Contractor:** American Bridge/Fluor Enterprises, a JV**OSM Departure Time:** 1930**Contractor:** American Bridge/Fluor Enterprises, a JV**Location:** Job Site

**Bridge No:** 34-0006**Summary of Items Observed:**

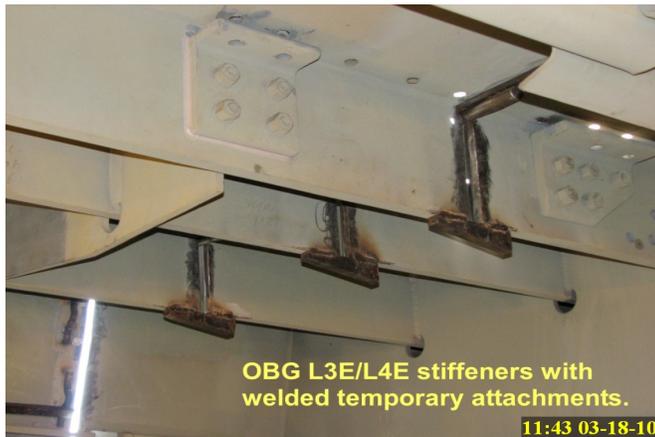
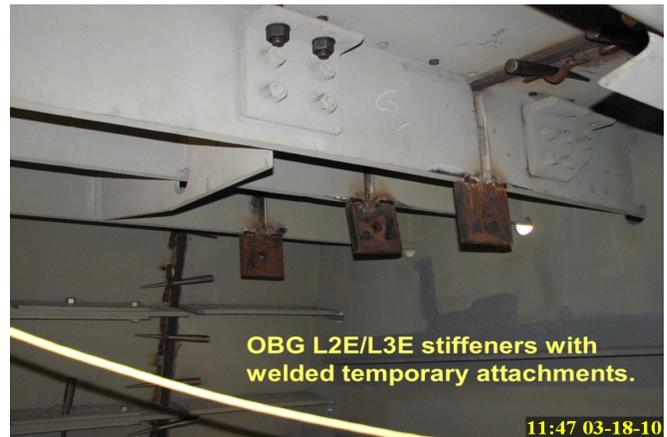
1) The QAI was asked to verify / photograph the temporary attachments that have been welded onto deck plate (A) stiffeners for the contractor's fitting-up of the OBG field splice welding. The QAI verified that temporary attachments have been welded onto the type 2 and type 10 stiffeners (grade 485W steel) at field splice locations L2E/L3E and L3E/L4E. The QAI observed that all stiffeners (12 total) at these locations have some temporary attachment welded on. It has been previously documented that this welding was being monitored by the contractor's Quality Control (QC) personnel and the QAI has witnessed the QC Inspector Jesus Cayabyab monitoring this welding. The QC Inspector was asked if he was aware that these stiffeners were grade 485W steel and that the contractor did not have an approved Welding Procedure Specification (WPS) or approved welders for this work. The QC Inspector replied that he was unaware of the different material grades during the welding. During this work, the QAI was informed by the ABF Engineer John Callaghan that ABF is documenting the non-conforming temporary attachment welds and un-qualified welder. See the attached photos.
