Quality Assurance and Source Inspection

Contract #: 04-0120F4Cty: SF/ALA Rte: 80 PM: 13.2/13.9File #: 1.28**WELDING INSPECTION REPORT****Resident Engineer:** Pursell, Gary**Address:** 333 Burma Road**City:** Oakland, CA 94607**Report No:** WIR-012729**Date Inspected:** 18-Mar-2010**Project Name:** SAS Superstructure**OSM Arrival Time:** 1300**Prime Contractor:** American Bridge/Fluor Enterprises, a JV**OSM Departure Time:** 2130**Contractor:** American Bridge/Fluor Enterprises, a JV**Location:** Job Site**CWI Name:** T. Pasqualone/J. Cunningham**CWI Present:** Yes No**Inspected CWI report:** Yes No N/A**Rod Oven in Use:** Yes No N/A**Electrode to specification:** Yes No N/A**Weld Procedures Followed:** Yes No N/A**Qualified Welders:** Yes No N/A**Verified Joint Fit-up:** Yes No N/A**Approved Drawings:** Yes No N/A**Approved WPS:** Yes No N/A**Delayed / Cancelled:** Yes No N/A**Bridge No:** 34-0006**Component:** Orthotropic Box Girders**Summary of Items Observed:**

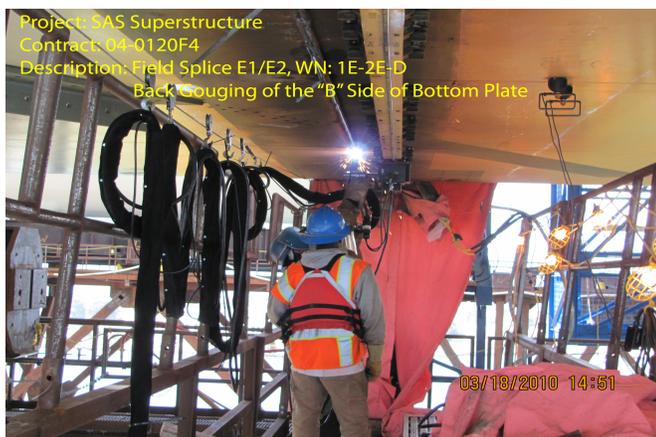
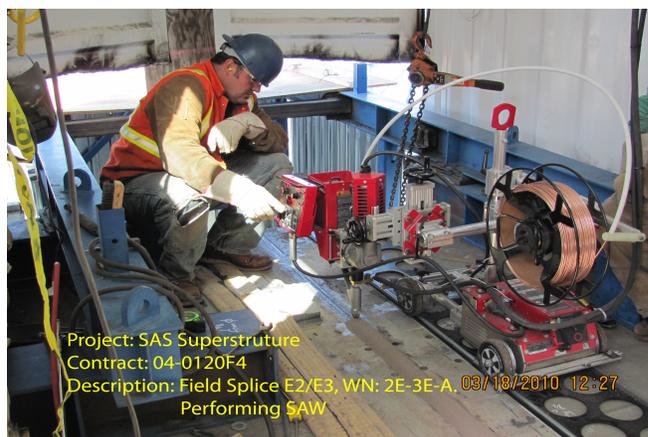
The QAI observed the Submerged Arc Welding (SAW) process of the deck plate field splice identified as Weld Number(WN): 2E-3E-A, Weld Segments A1-A5. The welding was performed by the AB/F welding personnel Mitch Sittinger ID-0315, segments A4-A5 and Jordan Hazelaar ID-2135, segments A1-A3 utilizing the Welding Procedure Specification (WPS) ABF-WPS-D15-4042B-1 Rev. 0. The WPS was also used by the AB/F Quality Control (QC) Inspector's Tom Pasqualone and James Cunningham to perform QC verification of the Direct Current Electrode Positive (DCEP) welding parameters during the Complete Joint Penetration (CJP) groove welding of the deck plate field splice. Later in the shift the QAI observed the QC inspector's verifying the welding parameters of each welder and were noted as follows: 560 amps, 32.5 volts and a travel speed measured at 381 mm/minute. The QC inspector's also monitored the surface temperatures during the field welding and the following was observed and noted by the QAI: the minimum preheat temperature of 60 degrees Celsius and the maximum interpass temperature of 230 degrees Celsius. The SAW was completed during this scheduled shift. Later in the shift, the QAI observed AB/F personnel utilizing 9" grinders to machine the CJP and the adjacent base metal to accommodate the QC ultrasonic testing and QAI verification.

Later in the shift the QAI inspector observed the backgouging of the bottom deck splice identified as 1E-2E-D, Segments D1 and D2. The backgouging was performed by AB/F personnel Salvador Sandoval utilizing the plasma arc cutting process.

The digital photographs below illustrates the work observed during this scheduled shift.
