DEPARTMENT OF TRANSPORTATION

Quality Assurance and Source Inspection

Contract #: 04-0120F4Cty: SF/ALA Rte: 80 PM: 13.2/13.9File #: 13.28**WELDING INSPECTION REPORT****Resident Engineer:** Pursell, Gary**Address:** 333 Burma Road**City:** Oakland, CA 94607**Report No:** WIR-012794**Date Inspected:** 19-Mar-2010**Project Name:** SAS Superstructure**OSM Arrival Time:** 700**Prime Contractor:** American Bridge/Fluor Enterprises, a JV**OSM Departure Time:** 1530**Contractor:** Oregon Iron Works Clackamas, Or.**Location:** Clackamas, OR**CWI Name:** M. Gregson, J. Salazar**CWI Present:** Yes No**Inspected CWI report:** Yes No N/A**Rod Oven in Use:** Yes No N/A**Electrode to specification:** Yes No N/A**Weld Procedures Followed:** Yes No N/A**Qualified Welders:** Yes No N/A**Verified Joint Fit-up:** Yes No N/A**Approved Drawings:** Yes No N/A**Approved WPS:** Yes No N/A**Delayed / Cancelled:** Yes No N/A**Bridge No:** 34-0006**Component:** Hinge K Pipe Beams**Summary of Items Observed:**

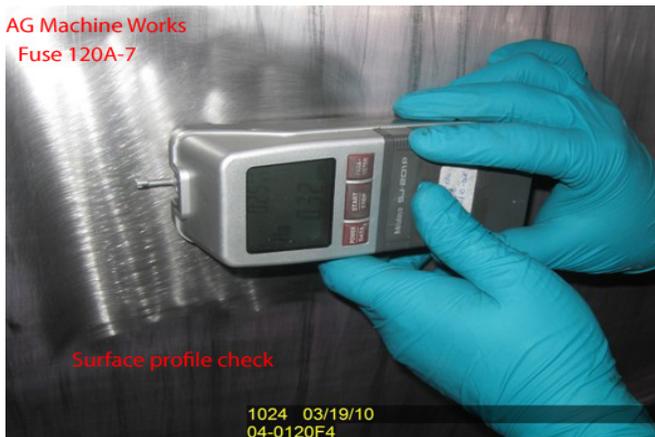
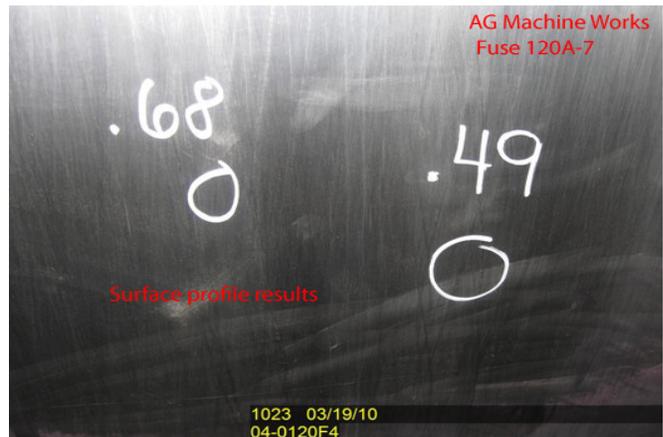
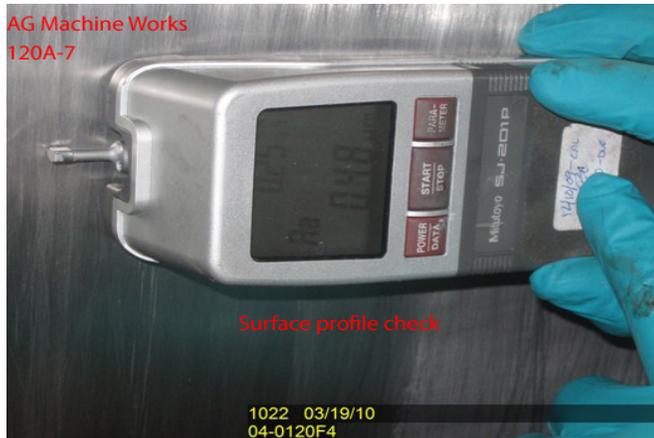
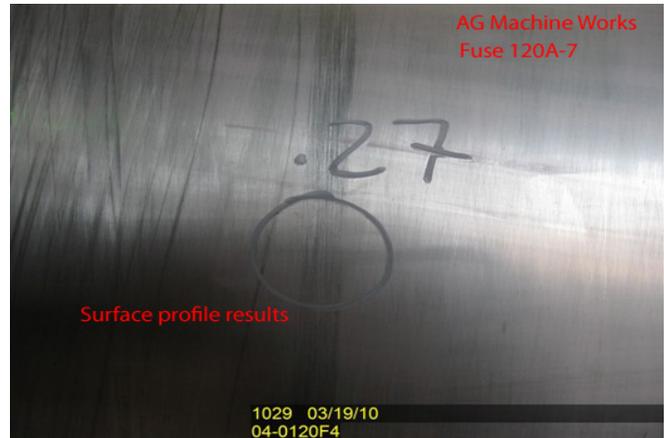
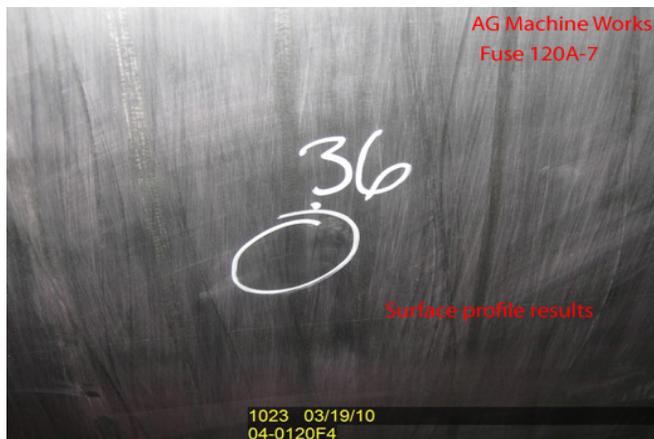
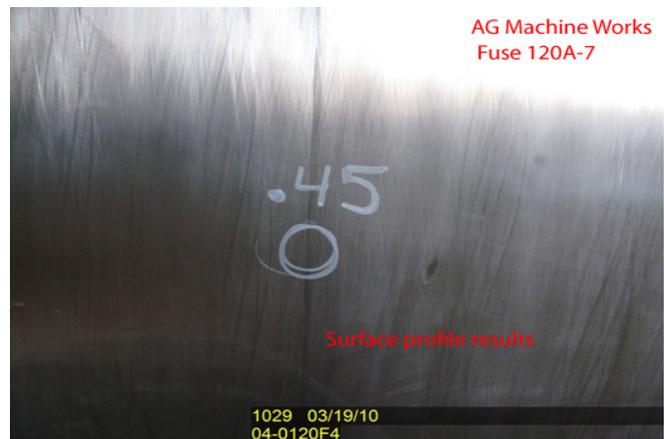
On this date, the QA Inspector arrived at AG Machine shop to observe OIW perform the final Penetrant Testing (PT) and the surface finish testing, on the Fuse 120A-7. The QA Inspector arrived at approximately 1000 and met with OIW QC Inspector Jose Salazar and an AG Machinist. Upon arriving, the AG Machinist explained that OIW Machinist Matt Ackerson had previously arrived on this date, at approximately 0700, to perform the FARO measurements, on the Fuse. The AG Machinist explained that the final outside diameter and cylindricity measurements were performed with the FARO Laser Tracker. The AG Machinist explained that after completion, Matt Ackerson explained that the measurements were within tolerance, per the contract requirements. Upon arriving, QC Inspector Salazar explained that the final surface testing will be performed, utilizing a profilometer. The QA Inspector then witnessed QC Inspector Salazar perform a calibration check on a block with a known surface finish and verified that the profilometer, had a calibration sticker attached and had been calibrated by OIW on 12/10/09, with a next due date of 12/10/10. QC Inspector Salazar explained that the profilometer had passed the calibration test. The QA Inspector then witnessed QC Inspector Salazar perform random testing on the surface finish and on the previously repaired and smoothed surfaces on the overlay. QC Inspector Salazar explained that the surface profile readings averaged .5um. The QA Inspector noted that the contract requires a surface finish, not to exceed .8 um and that this surface finish, appears to be in compliance with the contract

The QA Inspector then witnessed QC Inspector Salazar setting up to perform the Final Penetrant Testing (PT), on the Fuse 120A-7. QC Inspector Salazar explained to the QA Inspector that the final PT testing on the Fuse will be performed, utilizing OIW's procedure QC-114, sect. 8.0, Water Washable Visible Die Penetrant. The QA Inspector then witnessed QC Inspector cleaning approximately one-half of the Fuse overlay surface with acetone, to remove all surface irregularities, which would otherwise mask the indications of unacceptable indications. The QA Inspector was then informed, by QC Inspector Salazar that the pre-heat was applied, utilizing 2 propane heaters, earlier in the a.m., by AG. The QA Inspector witnessed QC Inspector Salazar performing pre-heat checks, utilizing a digital thermometer and noted that the surface temperature was approximately 72 degrees Fahrenheit (22 C). The QA Inspector witnessed QC Inspector Salazar then applying DP50 penetrant, utilizing a hand pump sprayer, on the Fuse overlay. The QA Inspector noted that the penetrant was applied evenly and QC Inspector Salazar explained that the DP 50 will sit for approximately 25-30 minutes (dwell time). The QA Inspector then verified the dwell time to be approximately 25 minutes and noted that QC Inspector had started to wipe the penetrant off with lint free rags. The QA Inspector then witnessed QC Inspector Salazar applying water, with a hand sprayer, to remove the excess DP50. The QA Inspector then witness QC Inspector Salazar applying D-100 spray can type developer, over the entire one-half surface, in a thin uniform coating. The QA Inspector noted that during the application of the D-100, that no relevant indications were present at the time. After approximately 20 minutes dwell time, the QA Inspector witnessed QC Inspector Salazar performing visual testing on the tested area. QC Inspector Salazar then explained that that no relevant indications were present and the PT was acceptable, on this one half of the Fuse. The QA Inspector then witnessed QC Inspector Salazar cleaning off the applied developer with a water hose. The QA Inspector noted that the PT testing appeared to be in compliance with AWS D1.5 visual acceptance criteria and QC-114. QC Inspector Salazar then explained that he will be arriving at AG on 3/22/10 to perform the PT on the remaining one-half surface, of the Fuse. See attached pictures below.
