Contract #: 04-0120F4Cty: SF/ALA Rte: 80 PM: 13.2/13.9File #: 13.28**WELDING INSPECTION REPORT****Resident Engineer:** Pursell, Gary**Address:** 333 Burma Road**City:** Oakland, CA 94607**Report No:** WIR-012795**Date Inspected:** 22-Mar-2010**Project Name:** SAS Superstructure**OSM Arrival Time:** 1000**Prime Contractor:** American Bridge/Fluor Enterprises, a JV**OSM Departure Time:** 1830**Contractor:** Oregon Iron Works Clackamas, Or.**Location:** Clackamas, OR**CWI Name:** M. Gregson, J. Salazar**CWI Present:** Yes No**Inspected CWI report:** Yes No N/A**Rod Oven in Use:** Yes No N/A**Electrode to specification:** Yes No N/A**Weld Procedures Followed:** Yes No N/A**Qualified Welders:** Yes No N/A**Verified Joint Fit-up:** Yes No N/A**Approved Drawings:** Yes No N/A**Approved WPS:** Yes No N/A**Delayed / Cancelled:** Yes No N/A**Bridge No:** 34-0006**Component:** Hinge K Pipe Beams**Summary of Items Observed:**

WELDING INSPECTION REPORT

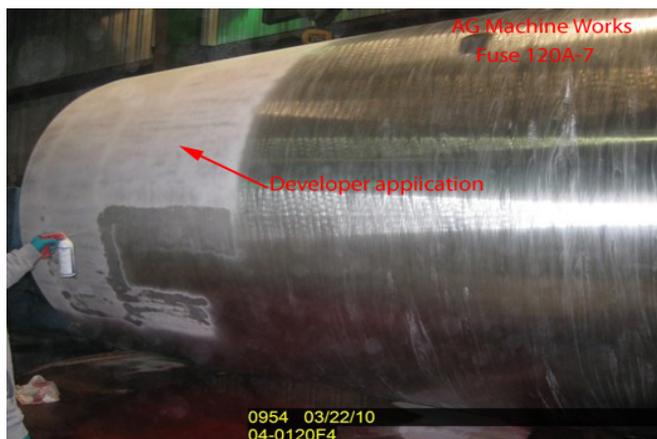
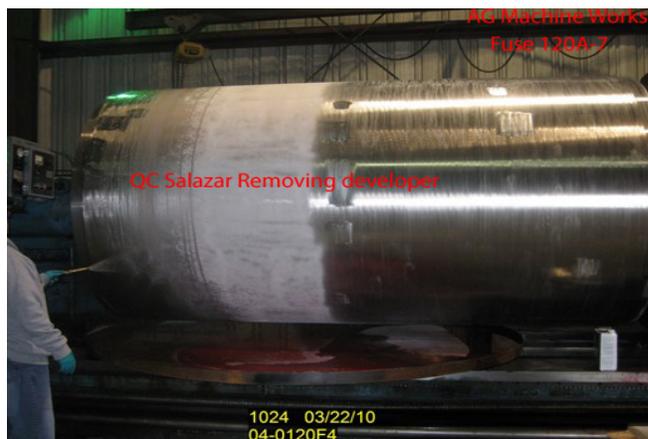
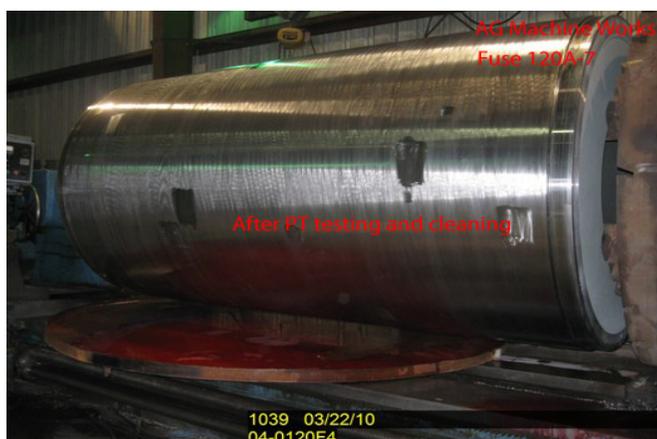
time to be approximately 25 minutes and noted that QC Inspector had started to wipe the penetrant off with lint free rags. The QA Inspector then witnessed QC Inspector Salazar applying water, with a hand sprayer, to remove the excess DP50. The QA Inspector then witness QC Inspector Salazar applying D-100 spray can type developer, over the entire one-half surface, in a thin uniform coating. The QA Inspector noted that during the application of the D-100, that no relevant indications were present at the time. After approximately 20 minutes dwell time, the QA Inspector witnessed QC Inspector Salazar performing visual testing on the tested area. QC Inspector Salazar then explained that that no relevant indications were present and the PT was acceptable, on this one half of the Fuse. The QA Inspector then witnessed QC Inspector Salazar cleaning off the applied developer with a water hose. The QA Inspector noted that the PT testing appeared to be in compliance with AWS D1.5 visual acceptance criteria and QC-114. See attached pictures below.
