DEPARTMENT OF TRANSPORTATION

Quality Assurance and Source Inspection

Contract #: 04-0120F4Cty: SF/ALA Rte: 80 PM: 13.2/13.9File #: 1x.28**WELDING INSPECTION REPORT****Resident Engineer:** Pursell, Gary**Address:** 333 Burma Road**City:** Oakland, CA 94607**Report No:** WIR-012856**Date Inspected:** 01-Apr-2010**Project Name:** SAS Superstructure**OSM Arrival Time:** 1100**Prime Contractor:** American Bridge/Fluor Enterprises, a JV**OSM Departure Time:** 1930**Contractor:** American Bridge/Fluor Enterprises, a JV**Location:** Job Site

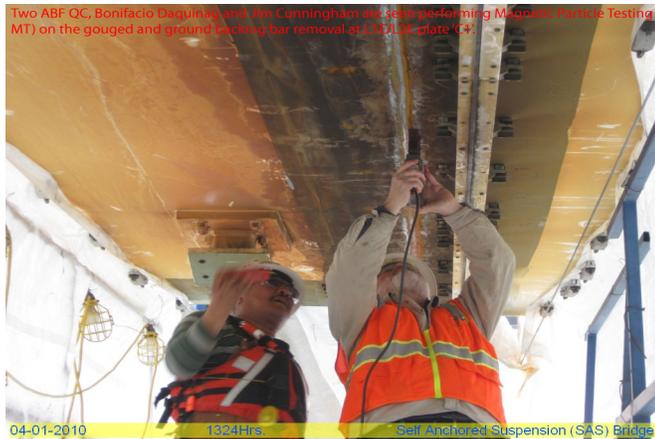
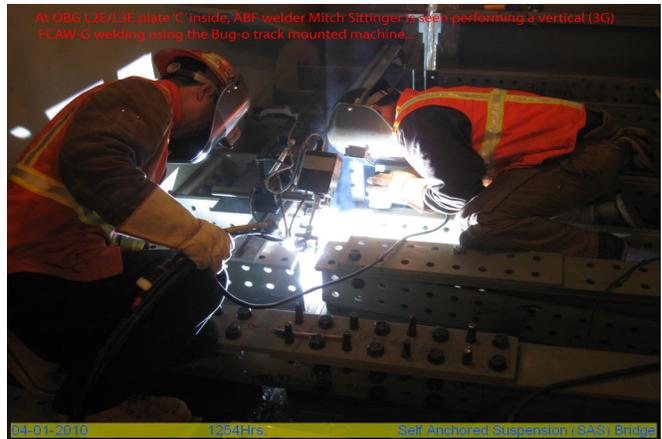
At OBG L2E/L3E plate 'C1' (800 to 2700mm) inside, QA randomly observed ABF/JV qualified welder Sungtao, Huang ID # 3794 perform CJP groove (splice) welding cover pass. The welder was observed manually welding in the 3G (vertical) position utilizing a dual shield Flux Cored Arc Welding (FCAW-G) with E71T-1M, 1/16" diameter wire electrode and implementing Caltrans approved Welding Procedure Specification (WPS) ABF-WPS-D15-3042A-1. The joint being welded has a single V-groove butt joint with backing bar. The splice joint was preheated and maintained to greater than 150 degree Fahrenheit using electric resistance heating bands prior welding. During welding, ABF Quality Control (QC) Bernie Docena was noted monitoring the welding parameters of the welder. QA performed parameter readings during welding with the following results; 280 amperes, 24.6 volts and 252mm per minute travel speed which are deemed acceptable to contract specifications.

After welding the plate at C1 location, the ABF welders moved to C2 location (7500mm to 10000mm) where ABF welder Mitch Sittinger was noted performing the task. QA observed welder Mitch Sittinger welding the root pass then the fill passes. The welder was welding in the 3G (vertical) position utilizing the same process mentioned above but using the Bug-o track mounted machine. QA noted preheat was increased to >200 degree Fahrenheit due to the increase in plate thickness. Welding parameters measured during the root pass were 270 amperes, 24.0 volts and 190mm per minute travel speed which appear acceptable to contract specifications. At the end of their shift, welding of the splice butt joint at C2 location was not complete but the welders intend to

At OBG L1E/L2E plate C1, QA observed ABF QC Bonifacio Daquinag and Jim Cunningham perform Magnetic Particle Testing (MT) on the back gouged and ground backing bar removal of the splice joint. The QC was noted using a Magnaflux electromagnetic yoke with red magnetic powder as detecting media. Plate C2 of the same OBG location was not MT'd due to still remaining backing bar on some part of plate C2 that needs to be gouged. Another ABF QC was noted performing Ultrasonic Testing (UT) in same OBG but in another plate. QA observed QC Jesse Cayabyab perform UT on the splice butt joint of plate D.

QA also observed ABF welder Rick Clayborn perform tack welding of fitting gear/temporary attachment to OBG L3E/L4E plate C (outside) that will hold the backing bar for the splice butt joint. The welder was welding in 4G (overhead) position utilizing Shielded Metal Arc Welding (SMAW) with E7018H4R, 3.2mm diameter electrode implementing Caltrans approved ABF-WPS-D15-F1200A. ABF QC Bonifacio Daquinag was noted monitoring the welder and its welding parameters. Other ABF activities QA observed include flush grinding of back weld reinforcement at OBG L2E/L3E plate D and transfer and preparation of welding equipment to OBG L2E/L3E plate E.
