Contract #: 04-0120F4Cty: SF/ALA Rte: 80 PM: 13.2/13.9File #: 1x.28**WELDING INSPECTION REPORT****Resident Engineer:** Pursell, Gary**Address:** 333 Burma Road**City:** Oakland, CA 94607**Report No:** WIR-012860**Date Inspected:** 02-Apr-2010**Project Name:** SAS Superstructure**OSM Arrival Time:** 1100**Prime Contractor:** American Bridge/Fluor Enterprises, a JV**OSM Departure Time:** 1930**Contractor:** American Bridge/Fluor Enterprises, a JV**Location:** Job Site

WELDING INSPECTION REPORT

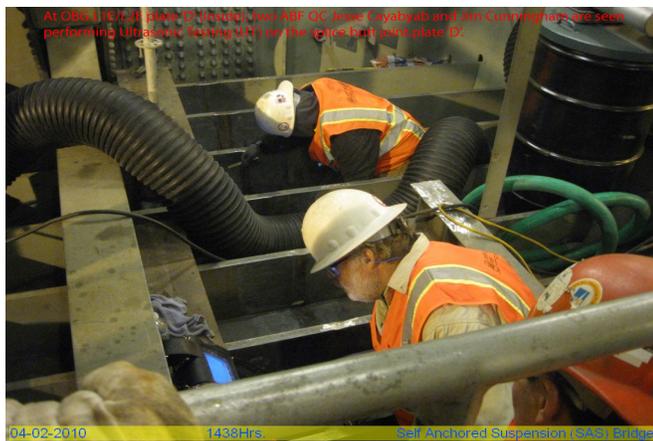
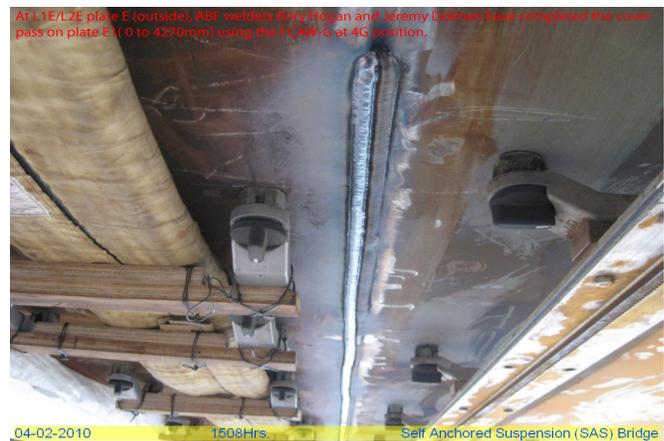
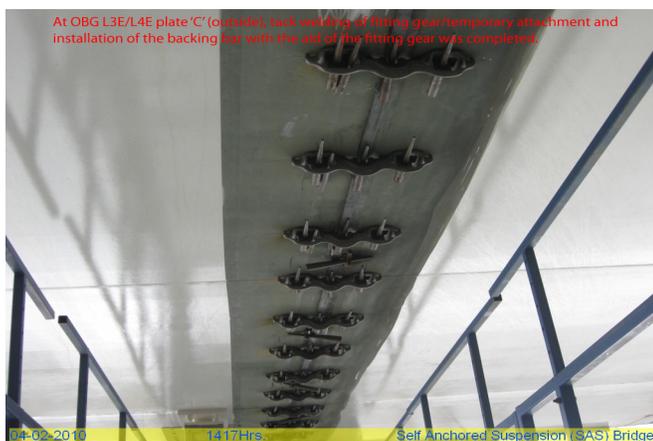
QA randomly observed ABF/JV qualified welders Rory Hogan (ID #3186) and Jeremy Dolman (ID #5042) perform Complete Joint Penetration (CJP) groove (splice) back welding fill to cover pass on Orthotropic Box Girder (OBG) L1E/L2E plate 'E1' (0 to 4250mm). The welders were observed welding in the 4G (overhead) position utilizing a dual shield Flux Cored Arc Welding (FCAW-G) with E71T-1M, 1/16" diameter wire electrode and implementing Caltrans approved Welding Procedure Specification (WPS) ABF-WPS-D15-3040A-4. The welder was using a track mounted welder holder assembly that is remotely controlled. The joint being welded has the backing bar gouged using the Esab Plasma Arc machine and was ground smooth. The gouged and ground splice butt joint was also Non Destructive Testing (NDT) tested using the Magnetic Particle Testing (MT). The splice joint was preheated to greater than 150 degree Fahrenheit prior welding and the vicinity was properly protected from wind. During welding, ABF Quality Control (QC) Mike Johnson was noted monitoring the welding parameters of the welder. At the end of the ABF shift, the cover pass of the splice butt joint back weld was completed and was ready to move to the other half of the splice butt joint.

At OBG L2E/L3E plate 'C' (0 to 10555mm) inside, QA noted that the vertical (3G) welding of the splice butt joint has been completed. The welders were also noted moving their welding equipment to another plate inside the OBG L2E/L3E plate 'E'. Inside the splice butt joint plate 'E', one welder was noted wire wheeling/cleaning the plates bevel surfaces. During the observation, ABF QC Bernie Docena informed this QA that the welders will not

At OBG L3E/L4E plate 'C' (0 to 10555mm) outside, tack welding using E7018 electrode and fit up of fitting gear/temporary attachment has been completed. The backing bar along the groove joint was also installed and supported by the fitting gear.

At OBG L1W/L2W deck plate 'A' outside, QA observed welding of tack/fillet on one side of backing bar to deck plate has been completed. At the moment, there were no ABF personnel working on the splice butt joint.
