**DEPARTMENT OF TRANSPORTATION**

Contract #: 04-0120F4Cty: SF/ALA Rte: 80 PM: 13.2/13.9File #: 1x.28**WELDING INSPECTION REPORT****Resident Engineer:** Pursell, Gary**Address:** 333 Burma Road**City:** Oakland, CA 94607**Report No:** WIR-012941**Date Inspected:** 07-Apr-2010**Project Name:** SAS Superstructure**OSM Arrival Time:** 1100**Prime Contractor:** American Bridge/Fluor Enterprises, a JV**OSM Departure Time:** 1930**Contractor:** American Bridge/Fluor Enterprises, a JV**Location:** Job Site

# WELDING INSPECTION REPORT

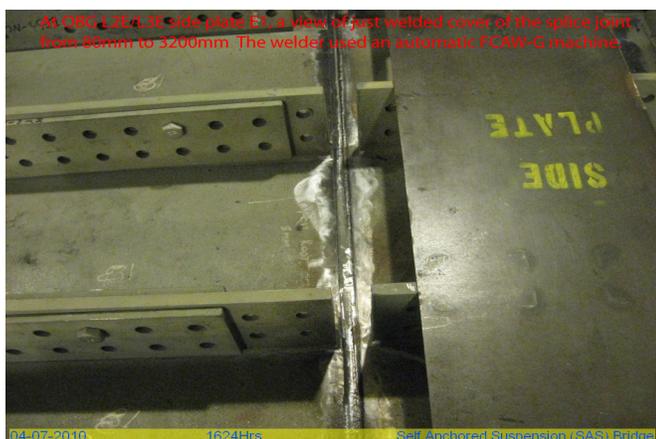
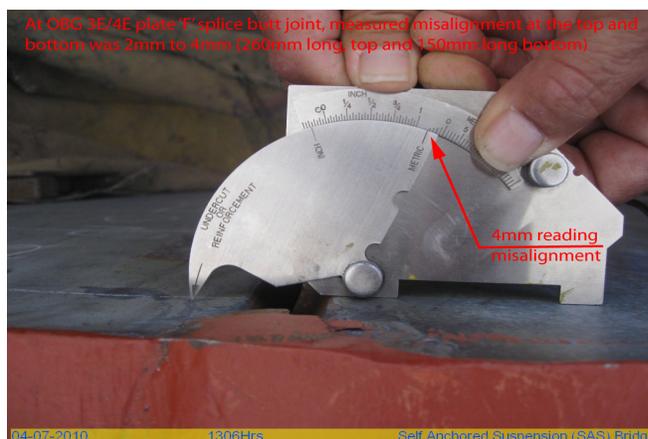
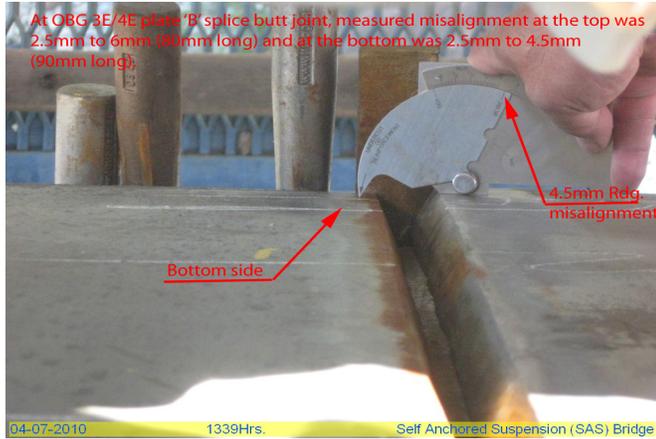
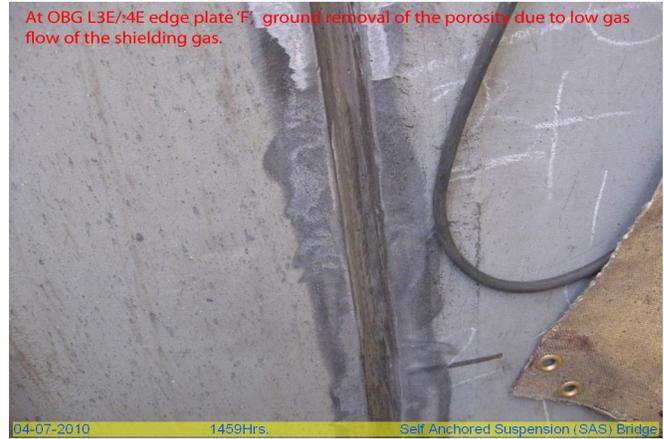
At OBG L2E/L3E plate 'E1' (80 to 3250mm) inside, QA randomly observed ABF/JV qualified welder Sungtao, Huang ID # 3794 and Mitch Sittinger ID #0315 perform CJP groove (splice) welding fill to cover pass. The welder was observed welding in the 3G (vertical) position utilizing an automatic dual shield Flux Cored Arc Welding (FCAW-G) with E71T-1M, 1/16" diameter wire electrode and implementing Caltrans approved Welding Procedure Specification (WPS) ABF-WPS-D15-3042A-1. The joint being welded has a single V-groove butt joint with backing bar. The splice joint was preheated and maintained to greater than 150 degree Fahrenheit using electric resistance heating bands prior welding. During welding, ABF Quality Control (QC) Bernie Docena was noted monitoring the welding parameters of the welder. QA performed parameter readings during welding with the following results; 260 amperes, 23.5 volts and 200mm per minute travel speed which are deemed acceptable to contract specifications. The ABF welders have completed welding the cover of the splice butt joint in this mentioned area and was noted visually inspected by ABF QC Bernie Docena. QA also performed initial visual check on the completed weld and appears acceptable to contract requirements.

At OBG L3E/L4E plate 'F' (outside), QA randomly observed ABF/JV qualified welder James Zhen ID #6001 perform CJP groove (splice) welding root to fill pass. The welder was observed welding in the 3G (vertical) position utilizing an automatic dual shield Flux Cored Arc Welding (FCAW-G) with E71T-1M, 1/16" diameter wire electrode and implementing Caltrans approved Welding Procedure Specification (WPS)

ABF-WPS-D15-3040B-3. The joint being welded has a single V-groove butt joint with backing bar. The splice joint (18mm plate thickness) was preheated to greater than 150 degree Fahrenheit using propane gas torch prior welding. During welding, ABF Quality Control (QC) Mike Johnson was noted monitoring the welding parameters of the welder. The ABF welder was having porosity in his weld during root pass and this was attributed to the low supply of shielding gas. When QC measured the gas flow it was noted to be only 20 CFH. QC has instructed the welder to grind off/remove the porosity in the weld pass while other ABF personnel was fixing the gas problem. After completing grinding, QC have visually inspected the ground/removal of porosity and accepted. This QA confirmed the acceptance of the ground/removal of porosity. The welder resumed working on the splice joint by preheating the joint then welding. Welding parameters measured during welding were 240 amperes and 22.8 voltages which appear in compliance to the contract requirements.

At OBG L3E/L4E plate 'E1' inside (300mm long), ABF welder Chun Fai Tsui (ID # 3426) was noted welding in vertical (3G) position using Shielded Metal Arc Welding (SMAW). QA randomly observed the welder perform Complete Joint Penetration (CJP) groove (splice) welding root to fill pass. The welder was using E7018H4R, 1/8" diameter electrode implementing Caltrans approved ABF-WPS-D15-1040B. Welding parameter measured during welding was 135 amperes which is deemed in compliance to contract requirements. The short length of weld being welded is done due to the Bug-o machine cannot reach the area.

At OBG 3E/4E edge plate 'F' (18mm thickness) outside, this QA performed alignment check on the fit up prior welding the splice butt joint. QA noted that the top part of the splice has an offset of 2mm to 4mm to a length of 260mm while the bottom part has an offset of 2mm to 4mm to a length of 150mm. At OBG 3E/4E edge plate 'B' (25mm thickness) outside, QA also performed alignment check on the fit up while the splice joint is still idle. QA measured an offset reading of 2.5mm to 6.0mm to a length of 80mm to the top part while the bottom was measured with an offset reading of 2.5mm to 4.5mm to a length of 90mm. Areas that were mentioned out of alignment are considered unacceptable based on AWS D1.5 section 3 paragraph 3.3.3. QA informed ABF QC Jesse Cayabyab about the result but said QC takes their own measurement and submit them to ABF. Due to this infraction, QA issued a separate incident report for each edge plate.
