DEPARTMENT OF TRANSPORTATION

Contract #: 04-0120F4Cty: SF/ALA Rte: 80 PM: 13.2/13.9File #: 1.28**WELDING INSPECTION REPORT****Resident Engineer:** Pursell, Gary**Address:** 333 Burma Road**City:** Oakland, CA 94607**Report No:** WIR-012973**Date Inspected:** 09-Apr-2010**Project Name:** SAS Superstructure**OSM Arrival Time:** 1100**Prime Contractor:** American Bridge/Fluor Enterprises, a JV**OSM Departure Time:** 1930**Contractor:** American Bridge/Fluor Enterprises, a JV**Location:** Job Site**CWI Name:** See Below**CWI Present:** Yes No**Inspected CWI report:** Yes No N/A**Rod Oven in Use:** Yes No N/A**Electrode to specification:** Yes No N/A**Weld Procedures Followed:** Yes No N/A**Qualified Welders:** Yes No N/A**Verified Joint Fit-up:** Yes No N/A**Approved Drawings:** Yes No N/A**Approved WPS:** Yes No N/A**Delayed / Cancelled:** Yes No N/A**Bridge No:** 34-0006**Component:** Orthotropic Box Girders**Summary of Items Observed:**

WELDING INSPECTION REPORT

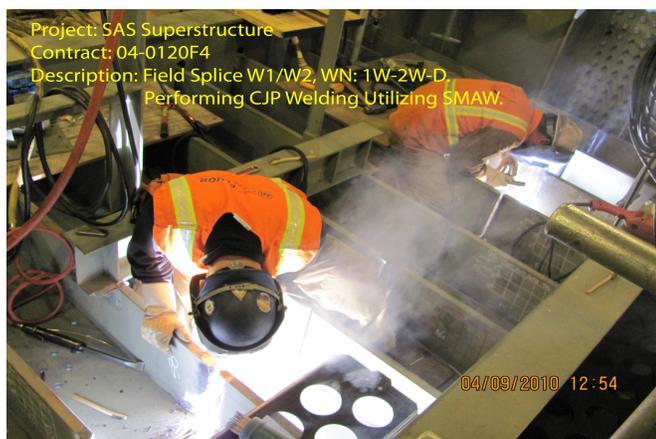
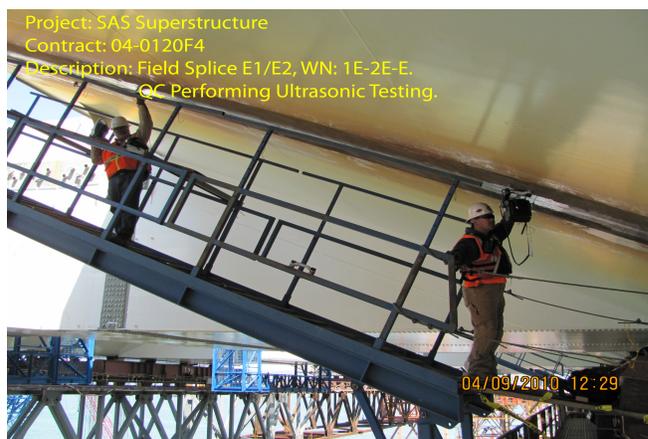
The QAI observed the Shielded Metal Arc Welding (SMAW) process of the bottom plate field splice identified as Weld Number (WN): 1W-2W-D. The Complete Joint Penetration (CJP) groove welding was performed in the area of the weld access hole of the longitudinal stiffeners located on the bottom plate of the Orthotropic Box Girder (OBG) for a measured length of approximately 250mm. The welding was performed by AB/F welding personnel Jordan Hazelaar ID-2135, Chun Fai Tsui ID-3426 and James Zhen ID-6001 utilizing the Welding Procedure Specification (WPS) ABF-WPS-D15-1040C Rev. 1. The WPS was also used by the AB/F Quality Control (QC) Inspector Bernie Docena as a reference when performing QC verification of the Direct Current Electrode Positive (DCEP) welding parameters during the CJP welding of the groove joint identified as B-U2a. Later in the shift the QAI observed the QC inspector verifying the welding parameters during the fillet welding and the average amperage was noted as follows: 164 amps. The QC inspector also monitored the surface temperatures during the field welding and the following was observed and noted by the QAI: the minimum preheat temperature of 20 degrees Celsius and the maximum interpass temperature of 230 degrees Celsius. Also

The UT technician performed the required longitudinal and shear wave scanning techniques during the testing which was performed utilizing a 1" diameter transducer for base metal soundness and a .75 x .75 rectangular transducer used to perform the angle beam technique for weld soundness. The testing was not completed during this scheduled shift and thus far there are approximately 3 rejectable discontinuities noted and marked by the QC technicians.

The digital photographs, below, illustrate the work observed during this scheduled shift.
