DEPARTMENT OF TRANSPORTATION

Quality Assurance and Source Inspection

Contract #: 04-0120F4Cty: SF/ALA Rte: 80 PM: 13.2/13.9File #: 13.28**WELDING INSPECTION REPORT****Resident Engineer:** Pursell, Gary**Address:** 333 Burma Road**City:** Oakland, CA 94607**Report No:** WIR-012976**Date Inspected:** 08-Apr-2010**Project Name:** SAS Superstructure**OSM Arrival Time:** 1000**Prime Contractor:** American Bridge/Fluor Enterprises, a JV**OSM Departure Time:** 1830**Contractor:** Oregon Iron Works Clackamas, Or.**Location:** Clackamas, OR**CWI Name:** M. Gregson, J. Salazar**CWI Present:** Yes No**Inspected CWI report:** Yes No N/A**Rod Oven in Use:** Yes No N/A**Electrode to specification:** Yes No N/A**Weld Procedures Followed:** Yes No N/A**Qualified Welders:** Yes No N/A**Verified Joint Fit-up:** Yes No N/A**Approved Drawings:** Yes No N/A**Approved WPS:** Yes No N/A**Delayed / Cancelled:** Yes No N/A**Bridge No:** 34-0006**Component:** Hinge K Pipe Beams**Summary of Items Observed:**

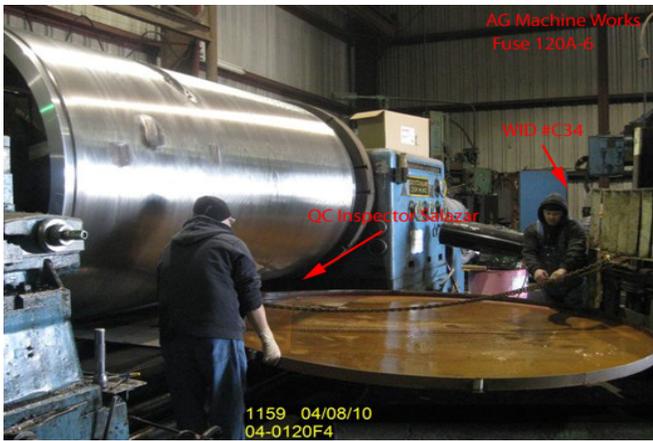
The QA Inspector then witnessed QC Inspector Salazar setting up to perform the Final Penetrant Testing (PT), on the Fuse 120A-6. QC Inspector Salazar explained to the QA Inspector that the final PT testing on the remaining first-half Fuse will be performed, utilizing OIW's procedure QC-114, sect. 8.0, Water Washable Visible Die Penetrant. The QA Inspector then witnessed QC Inspector cleaning approximately one-half of the Fuse overlay surface with acetone, to remove all surface irregularities, which would otherwise mask the indications of unacceptable indications. The QA Inspector witnessed QC Inspector Salazar performing pre-heat checks, utilizing a digital thermometer and noted that the surface temperature was approximately 68-74 degrees Fahrenheit (20-23 C). The QA Inspector witnessed QC Inspector Salazar then applying DP50 penetrant, utilizing a hand pump sprayer, on the Fuse overlay. The QA Inspector noted that the penetrant was applied evenly and QC Inspector Salazar explained that the DP 50 will sit for approximately 25-30 minutes (dwell time). The QA Inspector then verified the dwell time to be approximately 25 minutes and noted that QC Inspector had started to wipe the penetrant off with lint free rags. The QA Inspector then witnessed QC Inspector Salazar applying water, with a hand sprayer, to remove the excess DP50. The QA Inspector then witness QC Inspector Salazar applying D-100 spray can type developer, over the entire one-half surface, in a thin uniform coating. The QA Inspector noted that during the application of the D-100, that no relevant indications were present at the time. After approximately 20 minutes dwell time, the QA Inspector witnessed QC Inspector Salazar performing visual testing on the tested area. QC Inspector Salazar then explained that that no relevant indications were present and the PT was acceptable, on this one half of the Fuse. The QA Inspector then witnessed QC Inspector Salazar cleaning off the applied developer with a water hose. The QA Inspector noted that the PT testing appeared to be in compliance with AWS D1.5 visual acceptance criteria and QC-114. QC Inspector Salazar then explained that he will be arriving on the following day, 4/9/10, to complete the Final PT on the remaining half, in the same manner, as mentioned above. See attached pictures below.

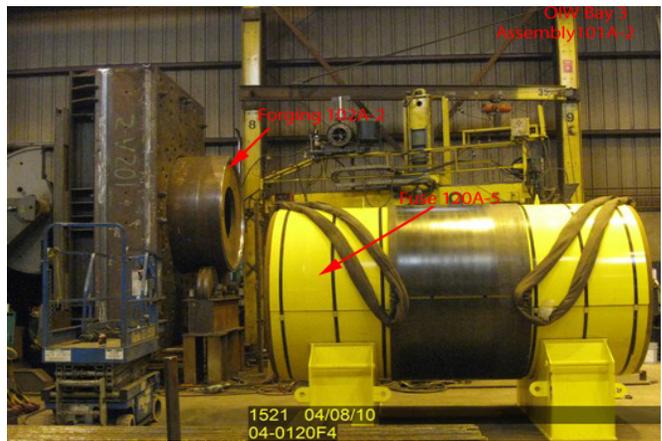
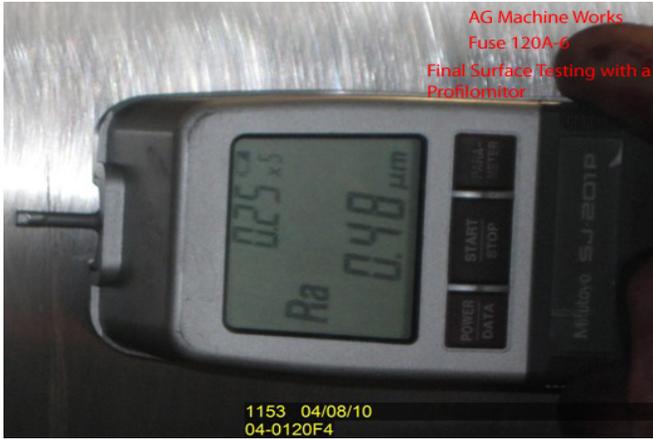
Hinge-K Pipe Beam Assembly 101A-2:

The QA Inspector noted that OIW production personell had previously transferred the Fuse 120A-5, into production bay 3. The QA Inspector noted that Production Lead Troy Smith, was present in Bay 3 and he explained that the Fuse had been previously placed on a flatbed trailer, from the laydown yard and transferred to the production bay. Lead Troy Smith explained that the assembly 102A-2 had been previously picked up, utilizing the overhead bay crane and placed in the welding manipulator. Lead Troy Smith then explained that the Fuse 120A-5, will be eventually fit-up and tack welded, to the Forging 102A-2. The QA Inspector noted that this is the second final assembly, to be fit-up and welded. See attached picture below.
