Contract #: 04-0120F4Cty: SF/ALA Rte: 80 PM: 13.2/13.9File #: 13.28**WELDING INSPECTION REPORT****Resident Engineer:** Pursell, Gary**Address:** 333 Burma Road**City:** Oakland, CA 94607**Report No:** WIR-012977**Date Inspected:** 09-Apr-2010**Project Name:** SAS Superstructure**OSM Arrival Time:** 1000**Prime Contractor:** American Bridge/Fluor Enterprises, a JV**OSM Departure Time:** 1830**Contractor:** Oregon Iron Works Clackamas, Or.**Location:** Clackamas, OR**CWI Name:** M. Gregson, J. Salazar**CWI Present:** Yes No**Inspected CWI report:** Yes No N/A**Rod Oven in Use:** Yes No N/A**Electrode to specification:** Yes No N/A**Weld Procedures Followed:** Yes No N/A**Qualified Welders:** Yes No N/A**Verified Joint Fit-up:** Yes No N/A**Approved Drawings:** Yes No N/A**Approved WPS:** Yes No N/A**Delayed / Cancelled:** Yes No N/A**Bridge No:** 34-0006**Component:** Hinge K Pipe Beams**Summary of Items Observed:**

WELDING INSPECTION REPORT

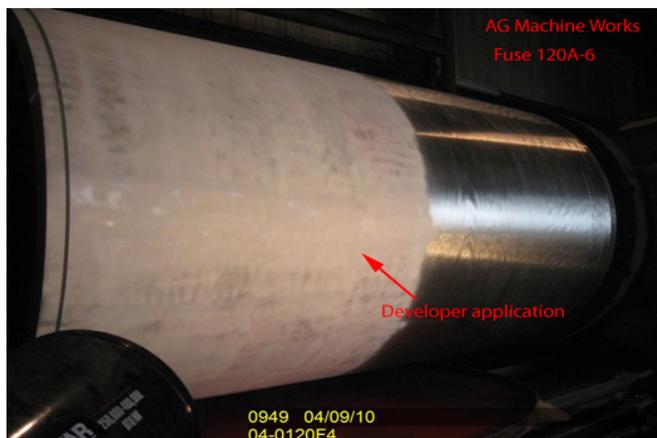
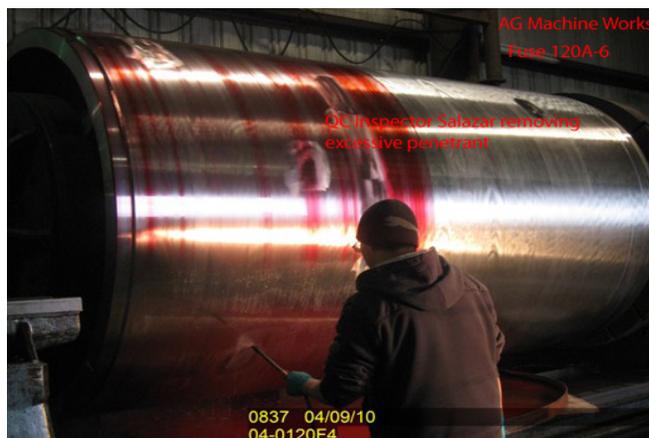
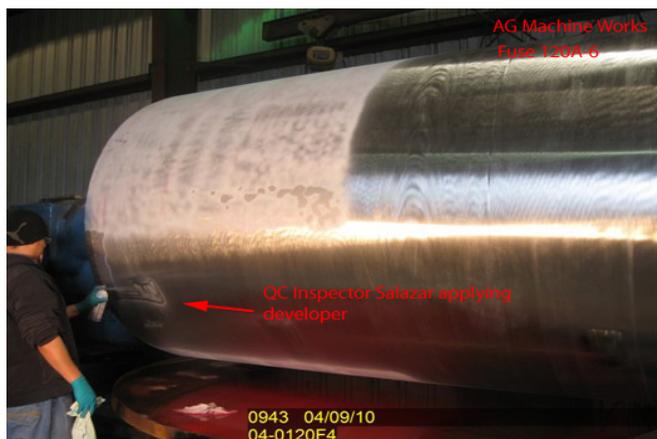
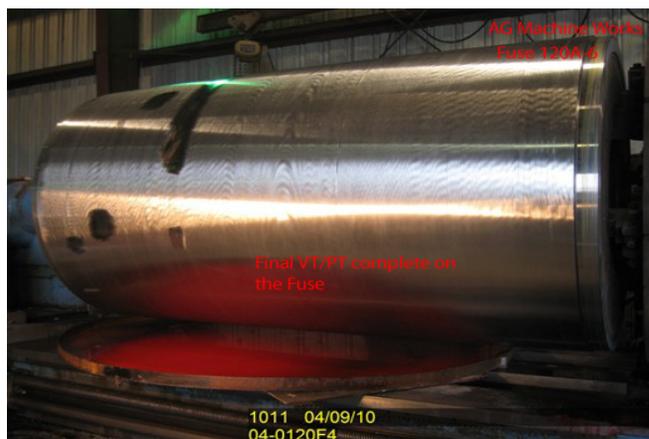
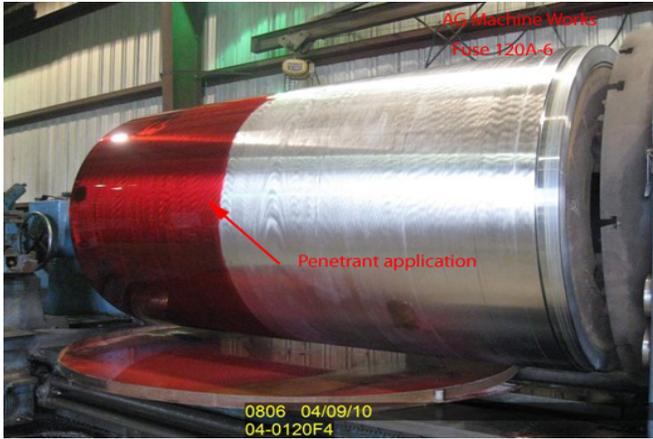
On this date, the QA Inspector arrived at AG Machine shop to observe OIW continue to perform the final Penetrant Testing (PT), on the Fuse 120A-6. The QA Inspector arrived at approximately 1000 and met with OIW QC Inspector Jose´ Salazar and AG Machinist, Terry Schmale. Upon arriving, QC Inspector Salazar explained that he had previously setup 2 propane heaters, to heat the remaining one-half fuse prior, to the PT. The QA Inspector noted that the minimum temperature required is 60 degrees Fahrenheit (16 C). The QA Inspector then witnessed QC Inspector Salazar setting up to perform the Final Penetrant Testing (PT), on the Fuse 120A-6. QC Inspector Salazar explained to the QA Inspector that the final PT testing on the remaining one-half Fuse will be performed, utilizing OIW's procedure QC-114, sect. 8.0, Water Washable Visible Die Penetrant. The QA Inspector then witnessed QC Inspector cleaning the remaining one-half of the Fuse overlay surface with acetone, to remove all surface irregularities, which would otherwise mask the indications of unacceptable indications. The QA Inspector witnessed QC Inspector Salazar performing pre-heat checks, utilizing a digital thermometer and noted that the surface temperature was approximately 72 degrees Fahrenheit (22 C). The QA Inspector witnessed QC Inspector Salazar then applying DP50 penetrant, utilizing a hand pump sprayer, on the Fuse overlay. The QA Inspector noted that the penetrant was applied evenly and QC Inspector Salazar explained that the DP 50 will sit for approximately 25-30 minutes (dwell time). The QA Inspector then verified the dwell time to be approximately 25

minutes and noted that QC Inspector had started to wipe the penetrant off with lint free rags. The QA Inspector then witnessed QC Inspector Salazar applying water, with a hand sprayer, to remove the excess DP50. The QA Inspector then witness QC Inspector Salazar applying D-100 spray can type developer, over the entire one-half surface, in a thin uniform coating. The QA Inspector noted that during the application of the D-100, that no relevant indications were present at the time. After approximately 20 minutes dwell time, the QA Inspector witnessed QC Inspector Salazar performing visual testing on the tested area. QC Inspector Salazar then explained that that no relevant indications were present and the PT was acceptable, on this remaining one half of the Fuse. The QA Inspector then witnessed QC Inspector Salazar cleaning off the applied developer with a water hose. The QA Inspector noted that the PT testing appeared to be in compliance with AWS D1.5 visual acceptance criteria and OIW Procedure QC-114. QC Inspector Salazar then explained that the VT/PT is 100% complete and acceptable per AWS D1.5 and QC-114. See attached pictures below.
