DEPARTMENT OF TRANSPORTATION

Quality Assurance and Source Inspection

Contract #: 04-0120F4Cty: SF/ALA Rte: 80 PM: 13.2/13.9File #: 1x.28**WELDING INSPECTION REPORT****Resident Engineer:** Pursell, Gary**Address:** 333 Burma Road**City:** Oakland, CA 94607**Report No:** WIR-013059**Date Inspected:** 16-Apr-2010**Project Name:** SAS Superstructure**OSM Arrival Time:** 1100**Prime Contractor:** American Bridge/Fluor Enterprises, a JV**OSM Departure Time:** 1930**Contractor:** American Bridge/Fluor Enterprises, a JV**Location:** Job Site

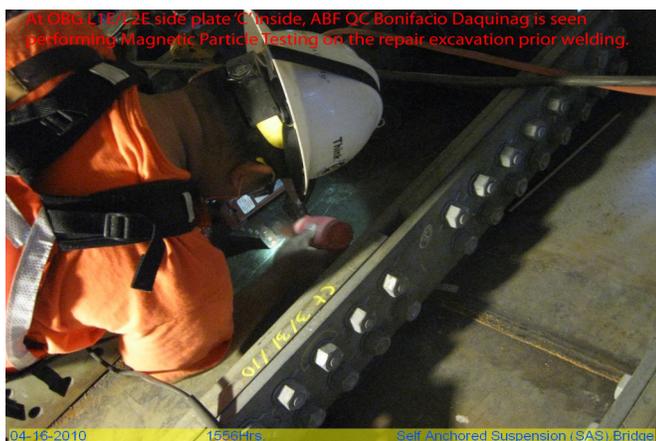
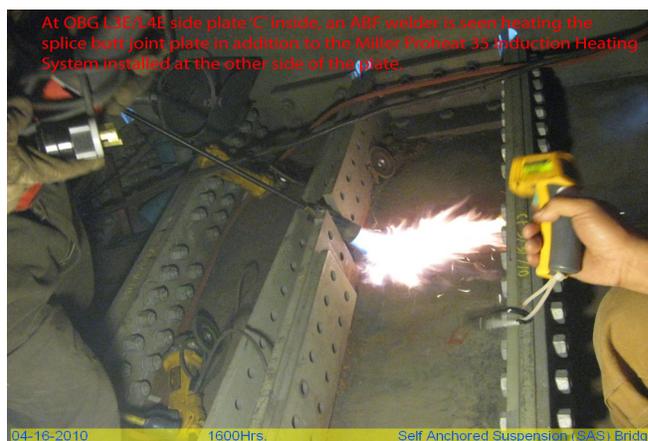
At OBG L3E/L4E plate 'C2' (5355 to 7955mm) inside, QA randomly observed ABF/JV qualified welder Sungtao, Huang ID # 3794 and Mitch Sittinger ID #0315 continue perform CJP groove (splice) welding fill to cover pass. The welder was observed welding in the 3G (vertical) position utilizing an automatic dual shield Flux Cored Arc Welding (FCAW-G) with E71T-1M, 1/16" diameter wire electrode and implementing Caltrans approved Welding Procedure Specification (WPS) ABF-WPS-D15-3042B-1. The joint being welded has a single V-groove butt joint with backing bar. The splice joint was preheated and maintained to greater than 200 degree Fahrenheit using Miller Proheat 35 Induction Heating System located at the other side of the plate prior welding. During welding, ABF Quality Control (QC) Tom Pasqualone was noted monitoring the welding parameters of the welder. QA performed parameter readings during welding with the following results; 250 amperes, 24.3 volts and 230mm per minute travel speed which are deemed acceptable to contract specifications. During the shift, welding of the weld cover on the area mentioned above was completed and welders were noted moving to the same plate but in higher elevation area.

At OBG L1E/L2E side plate 'C' inside, QA randomly observed ABF/JV qualified welder Rick Clayborn ID #2773 perform CJP groove welding repair. The welder was observed welding in the 3G (vertical) position utilizing Shielded metal Arc Welding (SMAW) with 1/8" and 5/32" diameter E7018H4R electrode. The plates were preheated to more than 140 degree Fahrenheit prior welding. During the shift, ABF QC Bonifacio Daquinag was

noted monitoring the welder and also noted performing Magnetic Particle Testing (MT) on the excavations prior welding. QC was using a Parker Contour electromagnetic yoke with red magnetic powder as detecting media. Before the end of the shift, the welder has completed welding repairs on five locations at this OBG.

Other ABF personnel activities noted during the shift include flush grinding of back weld reinforcement at OBG 2E/3E side plate 'C' outside and plasma arc gouging/removal of splice butt joint backing bar at OBG 2E/3E side plate 'E' outside. After finishing gouging, the welders were also noted grinding the gouged groove area. Both flush grinding of back weld reinforcement and grinding of the gouged area were still ongoing at the end of the shift.
