Contract #: 04-0120F4Cty: SF/ALA Rte: 80 PM: 13.2/13.9File #: 69.28**WELDING INSPECTION REPORT****Resident Engineer:** Pursell, Gary**Address:** 333 Burma Road**City:** Oakland, CA 94607**Report No:** WIR-013082**Date Inspected:** 25-Mar-2010**Project Name:** SAS Superstructure**OSM Arrival Time:** 700**Prime Contractor:** American Bridge/Fluor Enterprises, a JV**OSM Departure Time:** 1900**Contractor:** Zhenhua Port Machinery Company, Ltd (ZPMC), Changxing Island **Location:** Shanghai, China**CWI Name:** Mr. Wuzhi Cheng**CWI Present:** Yes No**Inspected CWI report:** Yes No N/A**Rod Oven in Use:** Yes No N/A**Electrode to specification:** Yes No N/A**Weld Procedures Followed:** Yes No N/A**Qualified Welders:** Yes No N/A**Verified Joint Fit-up:** Yes No N/A**Approved Drawings:** Yes No N/A**Approved WPS:** Yes No N/A**Delayed / Cancelled:** Yes No N/A**Bridge No:** 34-0006**Component:** Orthotropic Box Girder (OBG)**Summary of Items Observed:**

WELDING INSPECTION REPORT

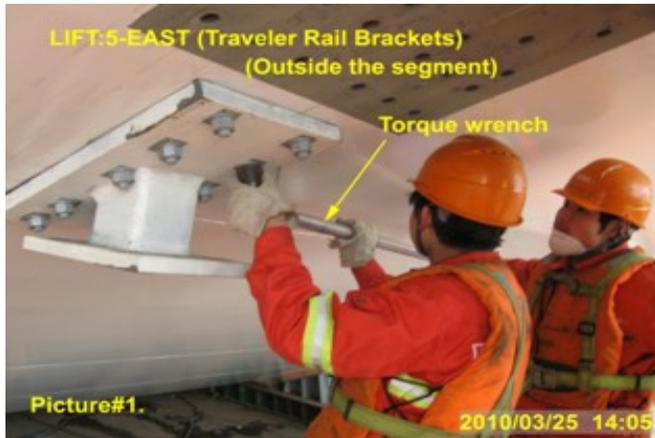
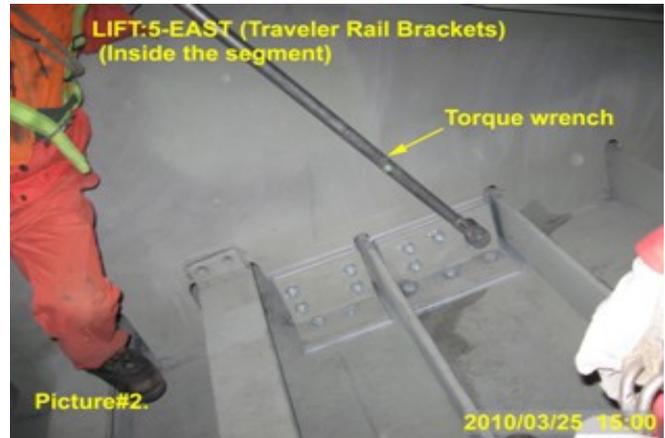
The attached photographs (Picture #1 and 2) provide additional detail

LIFT:5 East-Panel Point(PP)#29~36 (Traveler Rail).

This Quality Assurance (QA) Inspector witnessed final tension verification for the Traveler Brackets at LIFT:5 East-Panel Point(PP)#29~36 (Bike Path side). Inspected 100 % (outside the segment) 10% (inside the segment) on a random basis and found the tension to be in general compliance. Inspection was performed against the ZPMC submitted Notification No. 00304 Dated: March 25, 2010.

Bolt sizes used were M20X160, RC Set# DHGM200006 and final torque value was 340 N-m, Total number of bolts: 72 No's. (Inside the segment).

Bolt sizes used were M22X120, RC Set# DHGM220083 and final torque value was 440 N-m, Total number of bolts: 80 No's. (Outside the segment).

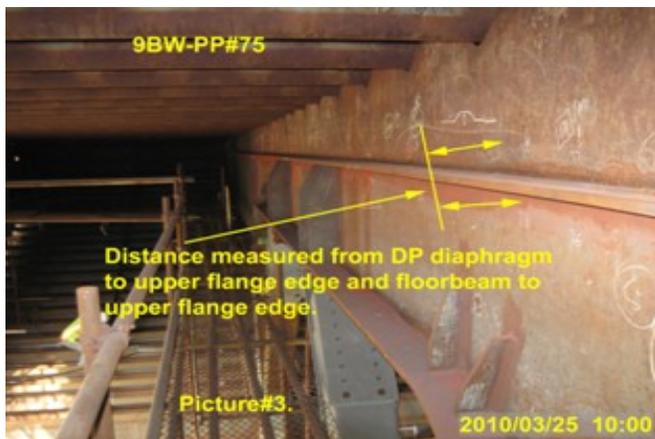
This QA generated a report on this date and submitted to the Task Leader for further action.
The attached photograph (Picture #3) provides additional detail.

SEGMENT: 9BW -Panel Point (PP) #75.

This QA Inspector performed Inspection for the Panels Upper Floor beam flange deformation measured at SEGMENT: 9BW PP#75(FL1 and FL2 Locations). The deformation was measured only at location which was susceptible. The maximum deformation measured as follows.

- The maximum Deformation was measured to be approximately 17 mm in 9000 mm Maximum template size.
- The Segment and Panel Point no is 9BW-PP#75(flange bend) Looking West at FL2 Location.

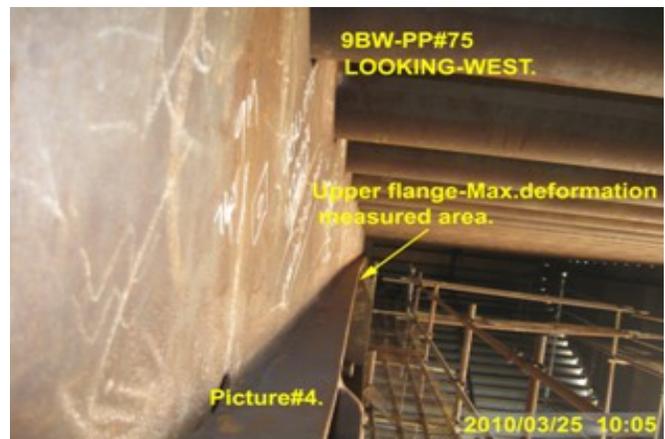
SEGMENT: 9BW -Panel Point (PP) #75.

This QA Inspector performed dimension check for the Deck panel diaphragm to Upper flange edge and floor beam to upper flange edge distance for OBG SEGMENT: 9BW -Panel Point (PP) #75 at FL1 and FL2 Locations. The measured readings were data recorded, generated the report and submitted to the Task Leader.
The attached photograph (Picture #4) provides additional detail.
