Contract #: 04-0120F4Cty: SF/ALA Rte: 80 PM: 13.2/13.9File #: 69.28**WELDING INSPECTION REPORT****Resident Engineer:** Pursell, Gary**Address:** 333 Burma Road**City:** Oakland, CA 94607**Report No:** WIR-013150**Date Inspected:** 28-Mar-2010**Project Name:** SAS Superstructure**OSM Arrival Time:** 700**Prime Contractor:** American Bridge/Fluor Enterprises, a JV**OSM Departure Time:** 1900**Contractor:** Zhenhua Port Machinery Company, Ltd (ZPMC), Changxing Island **Location:** Shanghai, China**CWI Name:** Li Yang**CWI Present:** Yes No**Inspected CWI report:** Yes No N/A**Rod Oven in Use:** Yes No N/A**Electrode to specification:** Yes No N/A**Weld Procedures Followed:** Yes No N/A**Qualified Welders:** Yes No N/A**Verified Joint Fit-up:** Yes No N/A**Approved Drawings:** Yes No N/A**Approved WPS:** Yes No N/A**Delayed / Cancelled:** Yes No N/A**Bridge No:** 34-0006**Component:** OBG Segment**Summary of Items Observed:**

ZPMC SHIP # 17

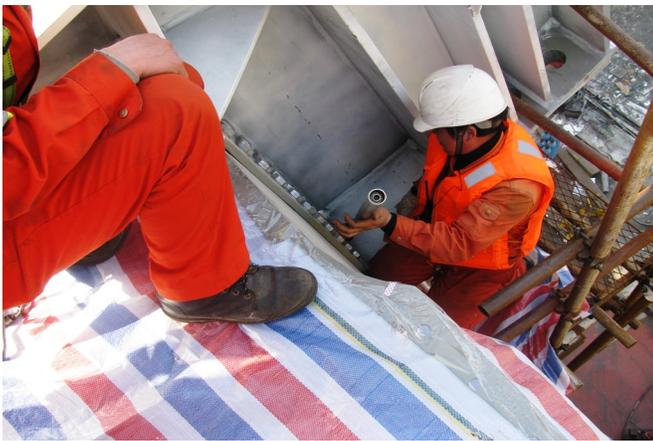
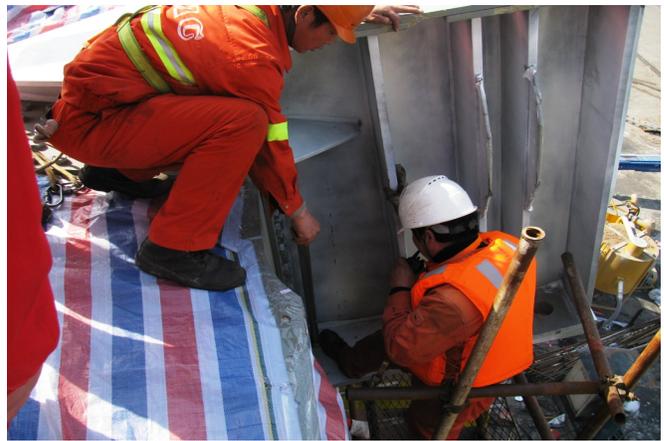
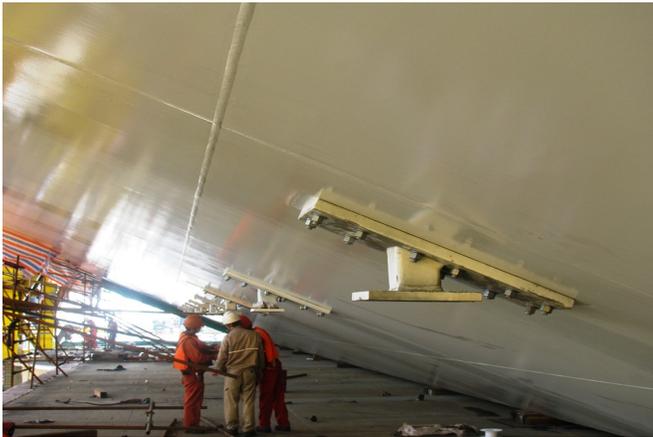
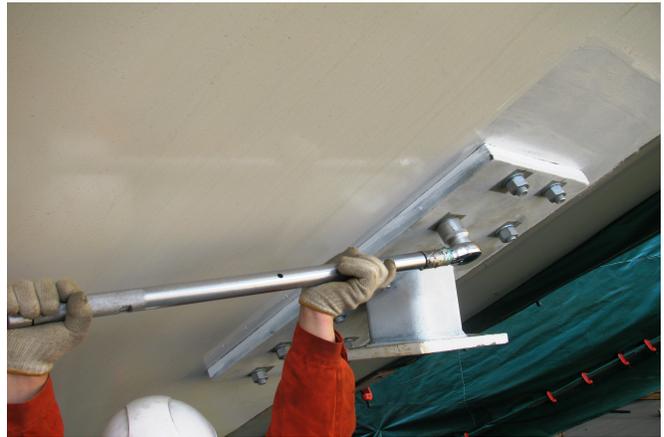
This QA inspector witnessed final tension verification on Traveler rail of Lift 6W. Witnessed 10% on a random basis the bolts and found the tension to be in general compliance. The panel point and bolt size designations are as follows:

This QA inspector witnessed final tension verification on Suspender bracket of Lift 6W. Witnessed 10% on a random basis the bolts and found the tension to be in general compliance. The panel point and bolt size

PP38, PP 40, PP 42, PP 44 and PP46
M24 X 75 – DHGM 240020 – 600 NM
M24 X 95 – DHGM 240021 – 540 NM
M27 X 85 – DHGM 270001 – 853 NM

Unless otherwise noted, all work observed on this date appeared to generally comply with applicable contract documents.
