Quality Assurance and Source Inspection

Contract #: 04-0120F4Cty: SF/ALA Rte: 80 PM: 13.2/13.9File #: 69.28**WELDING INSPECTION REPORT****Resident Engineer:** Pursell, Gary**Address:** 333 Burma Road**City:** Oakland, CA 94607**Report No:** WIR-013213**Date Inspected:** 07-Mar-2010**Project Name:** SAS Superstructure**OSM Arrival Time:** 700**Prime Contractor:** American Bridge/Fluor Enterprises, a JV**OSM Departure Time:** 1900**Contractor:** Zhenhua Port Machinery Company, Ltd (ZPMC), Changxing Island **Location:** Shanghai, China**CWI Name:** Liu hua ji**CWI Present:** Yes No**Inspected CWI report:** Yes No N/A**Rod Oven in Use:** Yes No N/A**Electrode to specification:** Yes No N/A**Weld Procedures Followed:** Yes No N/A**Qualified Welders:** Yes No N/A**Verified Joint Fit-up:** Yes No N/A**Approved Drawings:** Yes No N/A**Approved WPS:** Yes No N/A**Delayed / Cancelled:** Yes No N/A**Bridge No:** 34-0006**Component:** OBG Components**Summary of Items Observed:**

WELDING INSPECTION REPORT

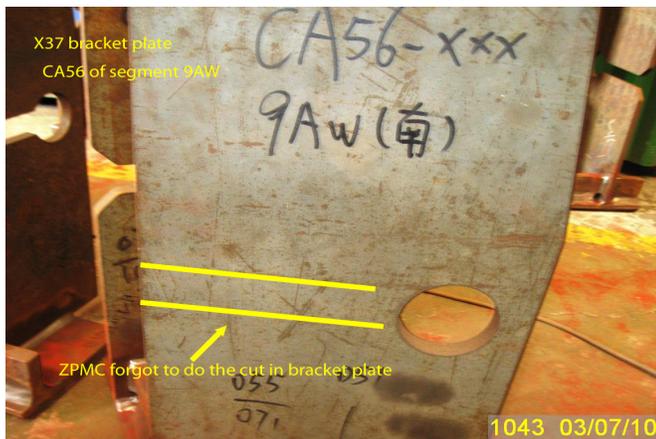
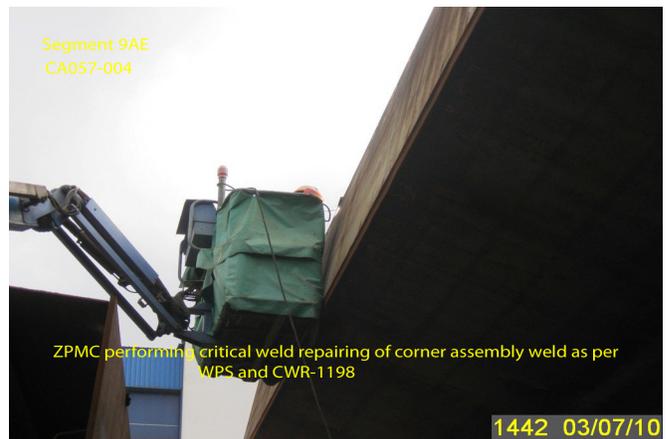
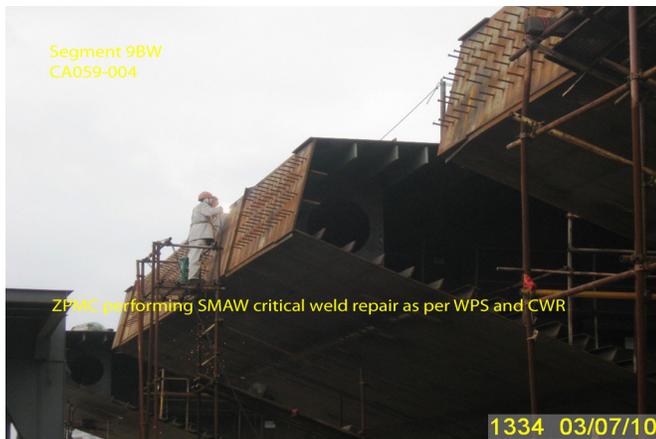
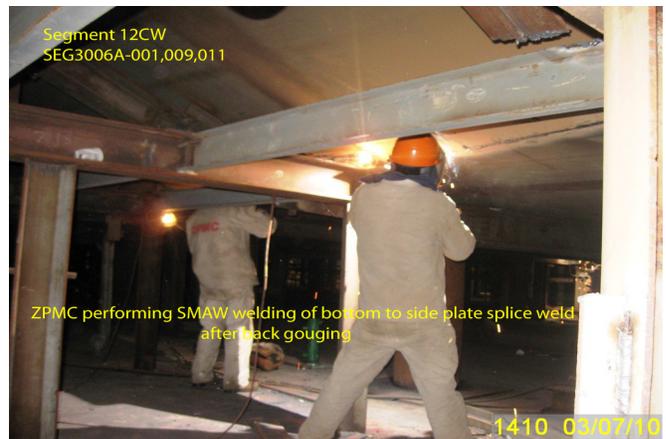
SMAW welding of weld joint 4G-046 located on PCMK SEG072* of 11DE welder is identified as 044772.ZPMC QC is identified as Mr.Guo xing hui . The welding variables recorded by QC appeared to Comply with the WPS-B-P-2214-Tc-U4b-FCM-1.

SMAW welding of weld joint 4G-009,011 located on PCMK SEG3006A of 12CW welder is identified as 047869, 037723.ZPMC QC is identified as Mr.Li ming yang . The welding variables recorded by QC appeared to Comply with the WPS-B-P-2214-B-U2-FCM-1.

FCAW welding of weld joint 3F-199,196 located on PCMK CA3009C of 12BW welder is identified as 045175. ZPMC QC is identified as Mr.Li ming yang . The welding variables recorded by QC appeared to Comply with the WPS-B-T-2133.

FCAW welding of weld joint 1G-010 located on PCMK SEG3004A of 12AW welder is identified as 202122. ZPMC QC is identified as Mr.Li ming yang . The welding variables recorded by QC appeared to Comply with the WPS-B-T-2231-B-U2-F.

During in process visual inspection it is found that X37 bracket plate CA56, SEG55D,CA74 of segment 9AW,

10BW and 9DW.ZPMC forgot to make machine cut on that. This is informed to ZPMC QC Mr.Li ming yang. He agreed and said ZPMC will do free hand cut in this location, but the free hand length will be approximately 300mm.

SMAW critical weld repair welding of weld joint 2G-047 located on PCMK SEG057* of 9BE welder is identified as 054013.ZPMC QC is identified as Mr.wang wei ming . The welding variables recorded by QC appeared to Comply with the WPS-345-SMAW-2G(2F)-FCM-repair-1 And approved B-CWR1202.

SMAW critical weld repair welding of weld joint 2G-004 located on PCMK CA057 of 9AE welder is identified as 048661.ZPMC QC is identified as Mr.wang wei ming . The welding variables recorded by QC appeared to Comply with the WPS-345-SMAW-2G(2F)-FCM-repair-1 And approved B-CWR1198.
