DEPARTMENT OF TRANSPORTATION

Quality Assurance and Source Inspection

Contract #: 04-0120F4Cty: SF/ALA Rte: 80 PM: 13.2/13.9File #: 69.28**WELDING INSPECTION REPORT****Resident Engineer:** Pursell, Gary**Address:** 333 Burma Road**City:** Oakland, CA 94607**Report No:** WIR-013218**Date Inspected:** 08-Mar-2010**Project Name:** SAS Superstructure**OSM Arrival Time:** 700**Prime Contractor:** American Bridge/Fluor Enterprises, a JV**OSM Departure Time:** 1900**Contractor:** Zhenhua Port Machinery Company, Ltd (ZPMC), Changxing Island **Location:** Shanghai, China**CWI Name:** Zhou Cheng**CWI Present:** Yes No**Inspected CWI report:** Yes No N/A**Rod Oven in Use:** Yes No N/A**Electrode to specification:** Yes No N/A**Weld Procedures Followed:** Yes No N/A**Qualified Welders:** Yes No N/A**Verified Joint Fit-up:** Yes No N/A**Approved Drawings:** Yes No N/A**Approved WPS:** Yes No N/A**Delayed / Cancelled:** Yes No N/A**Bridge No:** 34-0006**Component:** OBG Components**Summary of Items Observed:**

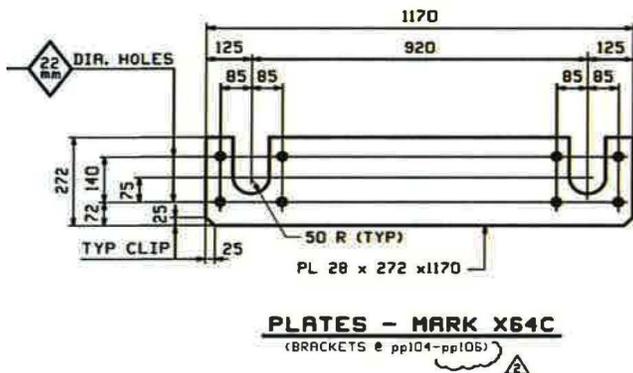
-During the Flux Cored Arc Welding (FCAW) welding Suspender bracket SB23-106E, ZPMC personal have welded over the 25mm clipped corners of sub component X64C.

-The cope holes are located in-between welds identified as: SB23-106-049 & 047 and SB23-106-049&051

- The plate X64C is identified as non SPCM.

-The Component is located in OBG fabrication Bay#19.

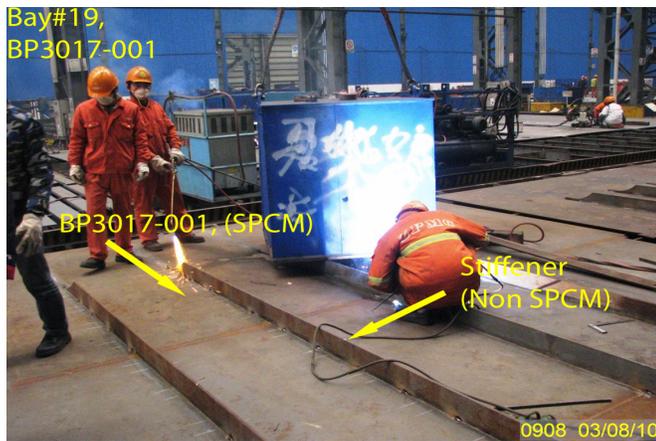
During random in process inspection of Bottom plate BP3017-001, this QA inspector observed that ZPMC personal use 2 ton weight during joint fit up of stiffeners. The bottom plate is SPCM material and stiffeners are non SPCM material. The tack welds of the stiffeners to bottom plates are performed by SMAW welding process. For further information, please see the attached pictures below.
