DEPARTMENT OF TRANSPORTATION

Quality Assurance and Source Inspection

Contract #: 04-0120F4Cty: SF/ALA Rte: 80 PM: 13.2/13.9File #: 69.28**WELDING INSPECTION REPORT****Resident Engineer:** Pursell, Gary**Address:** 333 Burma Road**City:** Oakland, CA 94607**Report No:** WIR-013285**Date Inspected:** 07-Mar-2010**Project Name:** SAS Superstructure**OSM Arrival Time:** 700**Prime Contractor:** American Bridge/Fluor Enterprises, a JV**OSM Departure Time:** 1900**Contractor:** Zhenhua Port Machinery Company, Ltd (ZPMC), Changxing Island **Location:** Shanghai, China**CWI Name:** Yu Dong Ping, Tu Jun**CWI Present:** Yes No**Inspected CWI report:** Yes No N/A**Rod Oven in Use:** Yes No N/A**Electrode to specification:** Yes No N/A**Weld Procedures Followed:** Yes No N/A**Qualified Welders:** Yes No N/A**Verified Joint Fit-up:** Yes No N/A**Approved Drawings:** Yes No N/A**Approved WPS:** Yes No N/A**Delayed / Cancelled:** Yes No N/A**Bridge No:** 34-0006**Component:** Tower**Summary of Items Observed:**

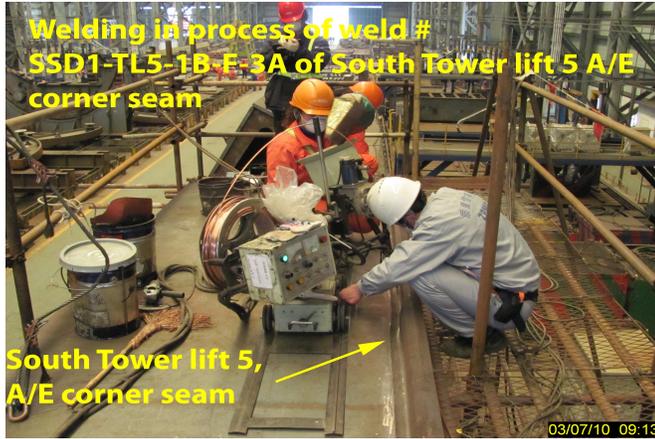
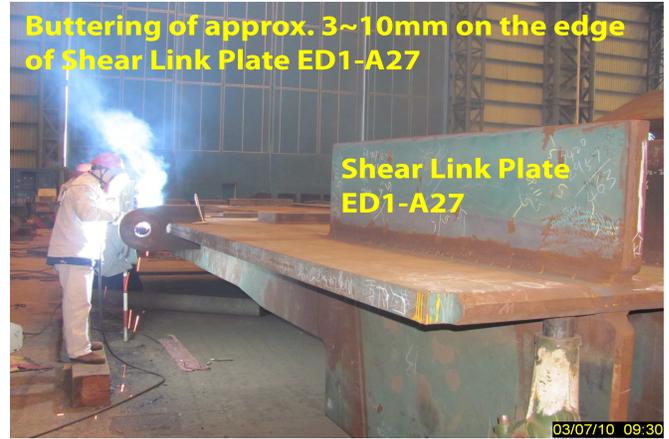
During random in process inspection this QA inspector observed that buttering of about 3~10mm on the edge of Shear Plate ED1-A27. Welders are identified as 037705 and 068501. ZPMC QC is identified as Mr. Li Peng Fei.
