**DEPARTMENT OF TRANSPORTATION**

Contract #: 04-0120F4Cty: SF/ALA Rte: 80 PM: 13.2/13.9File #: 69.28**WELDING INSPECTION REPORT****Resident Engineer:** Pursell, Gary**Address:** 333 Burma Road**City:** Oakland, CA 94607**Report No:** WIR-013345**Date Inspected:** 23-Mar-2010**Project Name:** SAS Superstructure**OSM Arrival Time:** 700**Prime Contractor:** American Bridge/Fluor Enterprises, a JV**OSM Departure Time:** 1900**Contractor:** Zhenhua Port Machinery Company, Ltd (ZPMC), Changxing Island **Location:** Shanghai, China**CWI Name:** Zhou Cheng/Zhu Zhong Hai**CWI Present:** Yes No**Inspected CWI report:** Yes No N/A**Rod Oven in Use:** Yes No N/A**Electrode to specification:** Yes No N/A**Weld Procedures Followed:** Yes No N/A**Qualified Welders:** Yes No N/A**Verified Joint Fit-up:** Yes No N/A**Approved Drawings:** Yes No N/A**Approved WPS:** Yes No N/A**Delayed / Cancelled:** Yes No N/A**Bridge No:** 34-0006**Component:** OBG Components**Summary of Items Observed:**

# WELDING INSPECTION REPORT

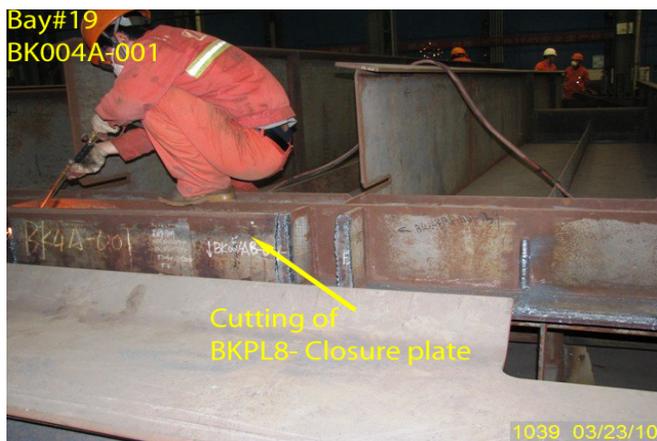
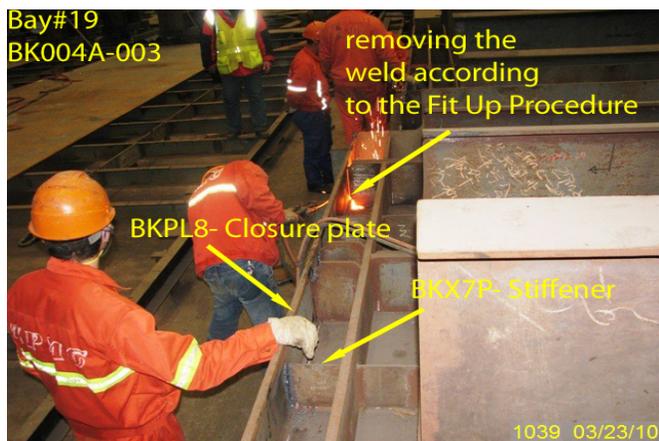
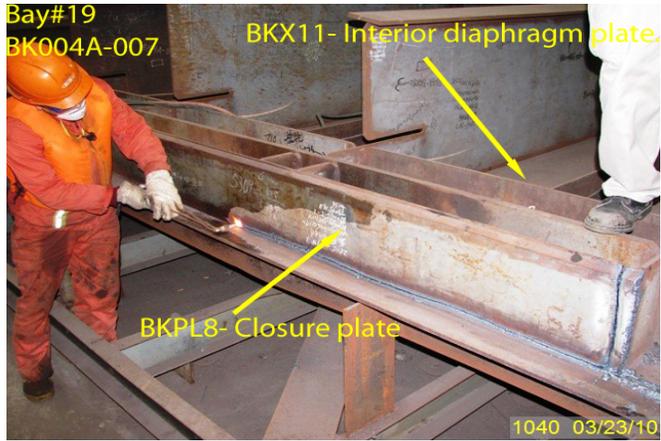
During random in process inspection of Bike Path, BK4A, this QA inspector observed following issue. ZPMC personal performed cutting the parts of BK004A-003, BK004A-001 and BK004A-007. According to fit up procedure ZPMC personal remove the weld of the closure plate and interior diaphragm plates and longitudinal stiffeners from bike path. After removing the parts ZPMC personal performed grinding to make smooth surface. ZPMC personal will performed MT for surface cracks detection because of cutting the welds. The removed parts are identified as:

BKPL8- Closure plate,

BKX7P- Stiffener

BKX11E~G / BKX11EA~GA- Interior diaphragm plate.

For further information, please see the attached pictures below.
