**DEPARTMENT OF TRANSPORTATION**

Contract #: 04-0120F4Cty: SF/ALA Rte: 80 PM: 13.2/13.9File #: 69.28**WELDING INSPECTION REPORT****Resident Engineer:** Pursell, Gary**Address:** 333 Burma Road**City:** Oakland, CA 94607**Report No:** WIR-013346**Date Inspected:** 24-Mar-2010**Project Name:** SAS Superstructure**OSM Arrival Time:** 700**Prime Contractor:** American Bridge/Fluor Enterprises, a JV**OSM Departure Time:** 1900**Contractor:** Zhenhua Port Machinery Company, Ltd (ZPMC), Changxing Island **Location:** Shanghai, China**CWI Name:** Zhou Cheng/Liu Hua Jie**CWI Present:** Yes No**Inspected CWI report:** Yes No N/A**Rod Oven in Use:** Yes No N/A**Electrode to specification:** Yes No N/A**Weld Procedures Followed:** Yes No N/A**Qualified Welders:** Yes No N/A**Verified Joint Fit-up:** Yes No N/A**Approved Drawings:** Yes No N/A**Approved WPS:** Yes No N/A**Delayed / Cancelled:** Yes No N/A**Bridge No:** 34-0006**Component:** OBG Components**Summary of Items Observed:**

## WELDING INSPECTION REPORT

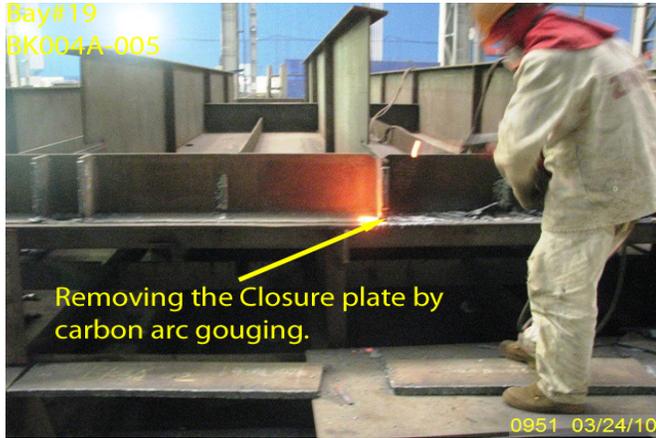
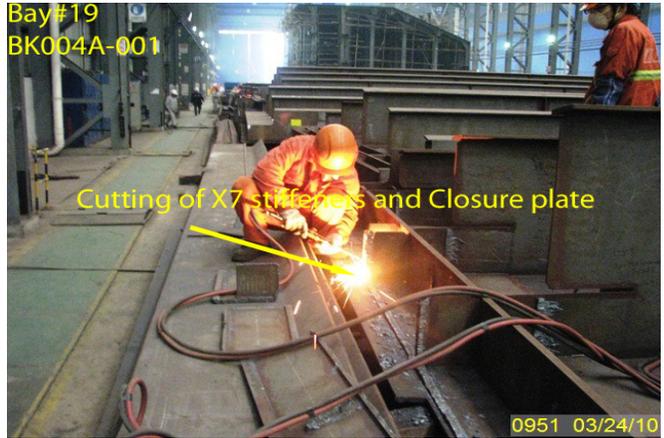
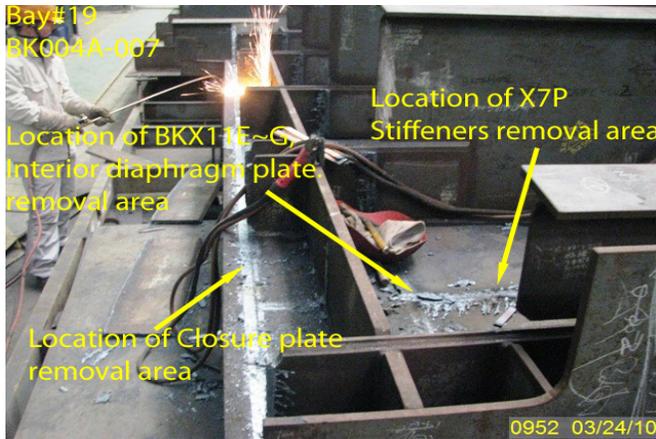
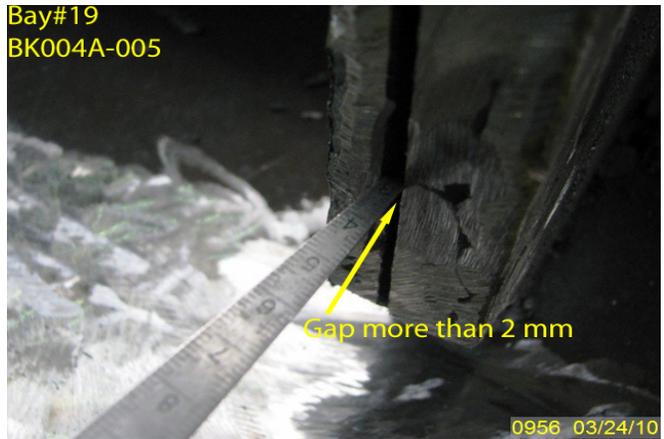
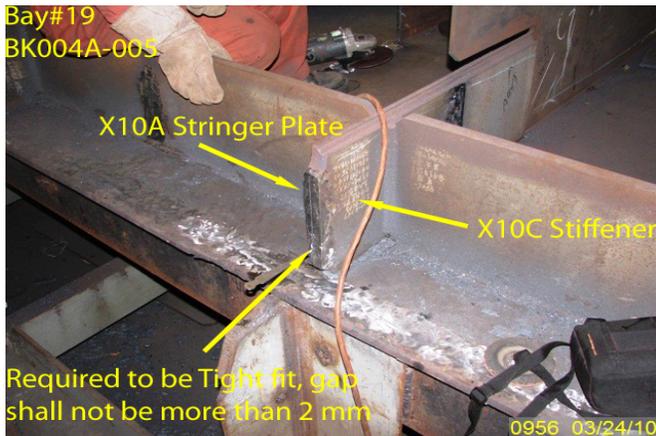
During random in process inspection of Bike Path, BK4A, this QA inspector observed following issue. ZPMC personal performed carbon arc gouging of the parts of BK004A-002, BK004A-005, BK004A-003, BK004A-001 and BK004A-007. According to fit up procedure ZPMC personal remove the weld of the closure plate and interior diaphragm plates and longitudinal stiffeners from bike path. After removing the parts ZPMC personal performed grinding to make smooth surface. ZPMC personal will performed MT for surface cracks detection because of cutting the welds. The removed parts are identified as:

BKPL8- Closure plate,

BKX7P- Stiffener

BKX11E~G / BKX11EA~GA- Interior diaphragm plate.

For further information, please see the attached pictures below.

During random in process inspection of Bike Path, BK4A-005, this QA inspector observed that more than 2mm gap between plates X10A and X10C. According to approved drawings this joint is a tight fit. ZPMC personal has to minimize the gap between these plates and make it less than 2mm.
