**DEPARTMENT OF TRANSPORTATION**

Contract #: 04-0120F4Cty: SF/ALA Rte: 80 PM: 13.2/13.9File #: 69.28**WELDING INSPECTION REPORT****Resident Engineer:** Pursell, Gary**Address:** 333 Burma Road**City:** Oakland, CA 94607**Report No:** WIR-013351**Date Inspected:** 30-Mar-2010**Project Name:** SAS Superstructure**OSM Arrival Time:** 700**Prime Contractor:** American Bridge/Fluor Enterprises, a JV**OSM Departure Time:** 1900**Contractor:** Zhenhua Port Machinery Company, Ltd (ZPMC), Changxing Island **Location:** Shanghai, China

## WELDING INSPECTION REPORT

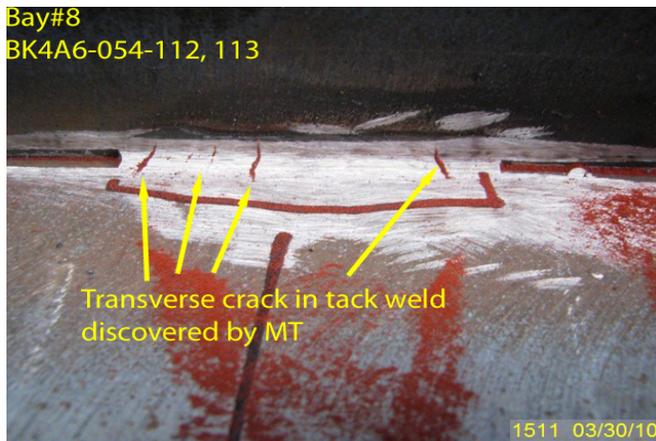
During random in process inspection of Bike Path, BK6A and BK5A this QA inspector observed following issue. ZPMC personal performed carbon arc gouging of the parts of BK006A-001, BK005A-001. According to fit up procedure ZPMC personal remove the weld of the closure plate and interior diaphragm plates and longitudinal stiffeners from bike path. After removing the parts ZPMC personal performed grinding to make smooth surface. ZPMC personal will performed MT for surface cracks because of cutting the welds. For further information, please see the attached pictures below.
