**DEPARTMENT OF TRANSPORTATION**

Contract #: 04-0120F4Cty: SF/ALA Rte: 80 PM: 13.2/13.9File #: 99.28**WELDING INSPECTION REPORT****Resident Engineer:** Pursell, Gary**Address:** 333 Burma Road**City:** Oakland, CA 94607**Report No:** WIR-013397**Date Inspected:** 24-Mar-2010**Project Name:** SAS Superstructure**OSM Arrival Time:** 700**Prime Contractor:** American Bridge/Fluor Enterprises, a JV**OSM Departure Time:** 1900**Contractor:** Zhenhua Port Machinery Company, Ltd (ZPMC) Chanxing Island**Location:** Shanghai, China**CWI Name:** Mr. Liu Hua Jie**CWI Present:** Yes No**Inspected CWI report:** Yes No N/A**Rod Oven in Use:** Yes No N/A**Electrode to specification:** Yes No N/A**Weld Procedures Followed:** Yes No N/A**Qualified Welders:** Yes No N/A**Verified Joint Fit-up:** Yes No N/A**Approved Drawings:** Yes No N/A**Approved WPS:** Yes No N/A**Delayed / Cancelled:** Yes No N/A**Bridge No:** 34-0006**Component:** OBG Segment**Summary of Items Observed:**

## Visual Inspection after Blast

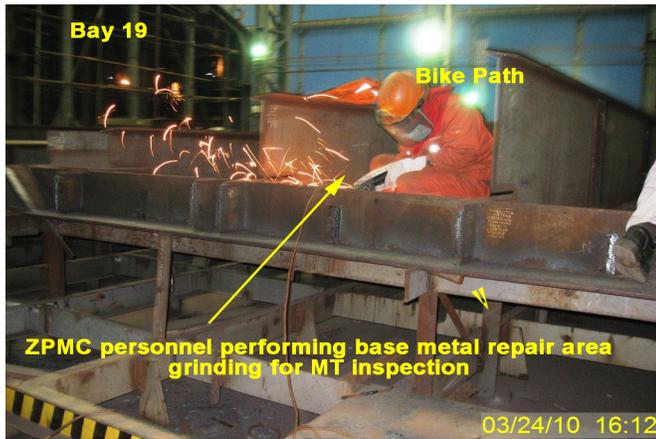
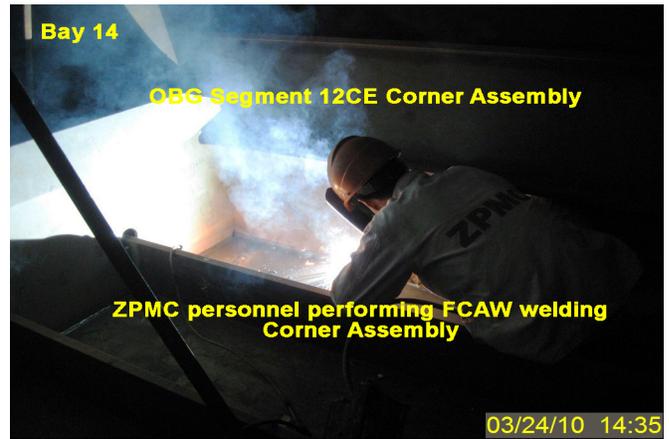
This QA inspector observed ZPMC qualified welding personnel identified as 2233 perform SMAW Welding on OBG Segment 12CW, weld joint identified as SEG3006J-011 and 012. ZPMC QC is identified as Mr. Li Ming Yang. The welding parameters as measured using QC's calibrated instruments appeared to be in general compliance with WPS-B-P-2114-FCM-1. See the attached pictures.

This QA Inspector performed a preliminary random visual inspection after the grit blast of the exterior components of the deck panel, floor beams and corner assemblies of this segment. Areas of visual weld defects that will require welding were taped and will be repaired after the coating is applied. ZPMC QC personnel are aware of these areas and were present during the inspection.
