DEPARTMENT OF TRANSPORTATION

Contract #: 04-0120F4Cty: SF/ALA Rte: 80 PM: 13.2/13.9File #: 13.28**WELDING INSPECTION REPORT****Resident Engineer:** Pursell, Gary**Address:** 333 Burma Road**City:** Oakland, CA 94607**Report No:** WIR-013403**Date Inspected:** 22-Apr-2010**Project Name:** SAS Superstructure**OSM Arrival Time:** 1000**Prime Contractor:** American Bridge/Fluor Enterprises, a JV**OSM Departure Time:** 1830**Contractor:** Oregon Iron Works Clackamas, Or.**Location:** Clackamas, OR

Hinge-K Pipe Beam Assembly 101A-2:

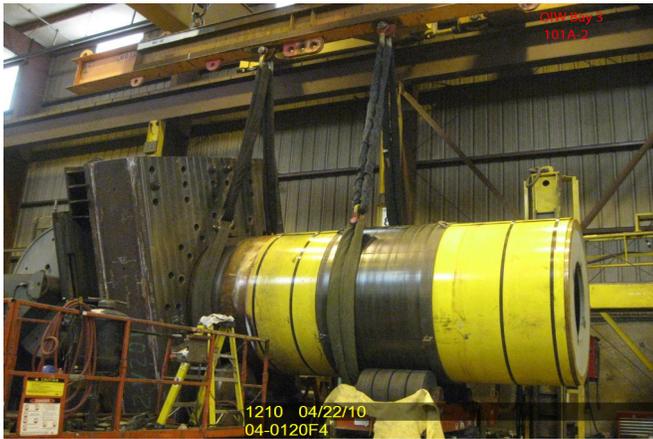
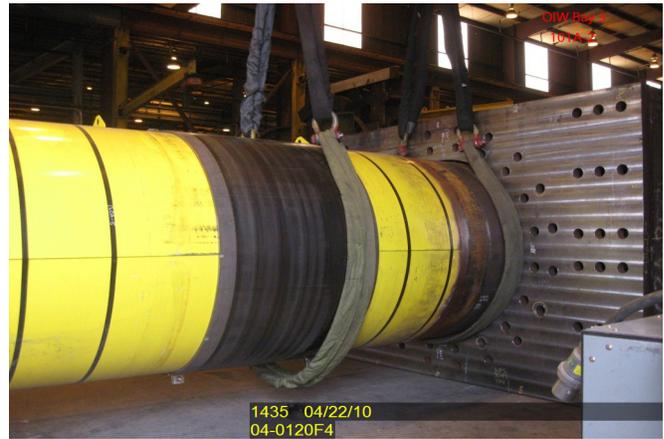
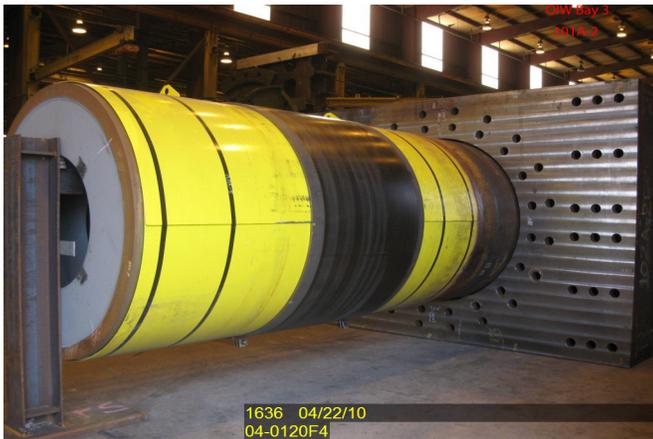
4 slings and shackles around the Fuse section of the assembly. The QA Inspector then witnessed the slings being attached to the overhead crane and lifted up from the positioner and placed on the South end of the production Bay 3. The QA Inspector then witnessed OIW Production placing a previously fabricated carbon steel end piece, into the Fuse end section for support, after the slings are removed. Production Lead Troy Smith explained to the QA Inspector that the outer shrouds will eventually be removed, for an inspection on the stainless steel overlay, after welding of the CJP. Lead Troy Smith explained that this will probably be performed on the following day and an OIW QC Inspector, will be notified to perform the inspection. See attached pictures below.
